Load-carrying capacity test of a long-span timber truss

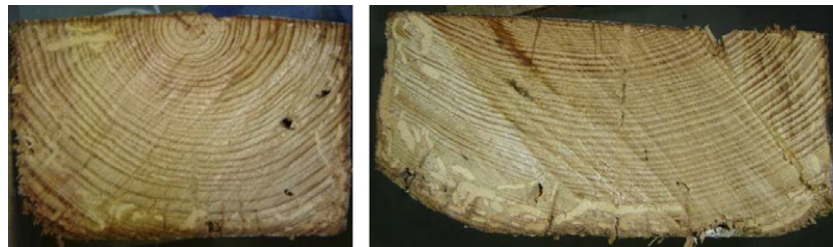
case of the maritime pine (*Pinus pinaster*, Ait.), the heartwood can be assumed to be durable to biological and insect attacks, whereas the sapwood is not (FICHA M2, 1997). Figure 2 shows examples of cross-sections where the eccentricity of the pith is visible and the degradation is concentrated in the sapwood.

Figure 2. Examples of cross-sections of the timber elements evidencing the eccentricity of the pith and the concentration of degradation in the sapwood

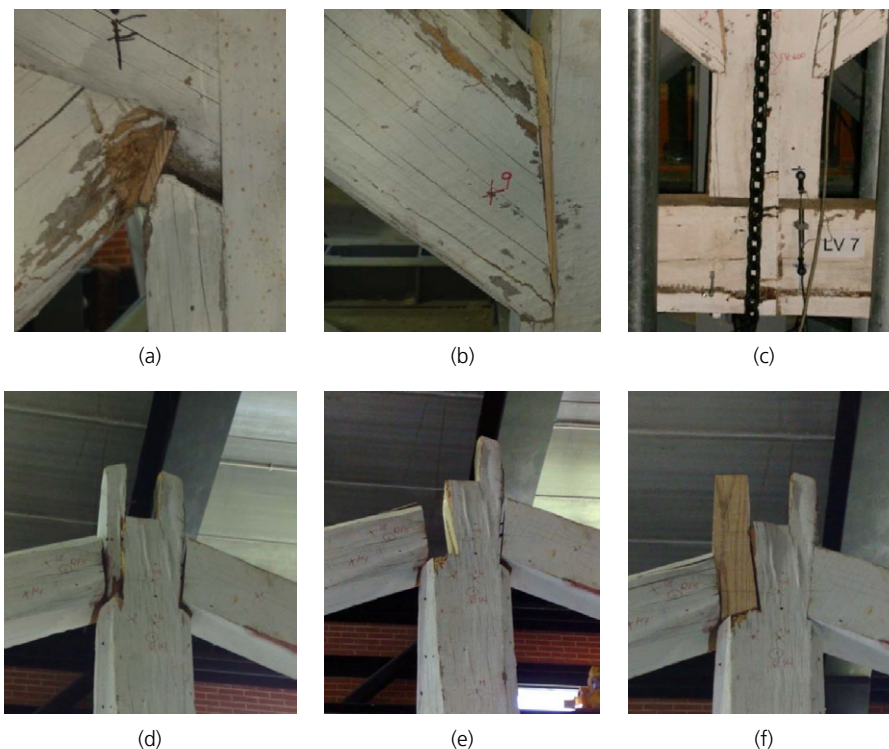
Figure 3. Reparation of some joints: (a) filling the gap with wood in a strut-rafter joint; (b) restoring the contact between connected surfaces in a strut-king post joint; (c) ensuring the separation

between the king post and the tie beam; (d) decayed end part of king post; (e) removal of decayed part of king post; (f) replacement of decayed part of king post by new piece

joint between the king post and one rafter was partially rebuilt as a result of degradation in the king post. The decayed part was replaced by a piece of the same wood species (Figures 3(d)–3(f)).

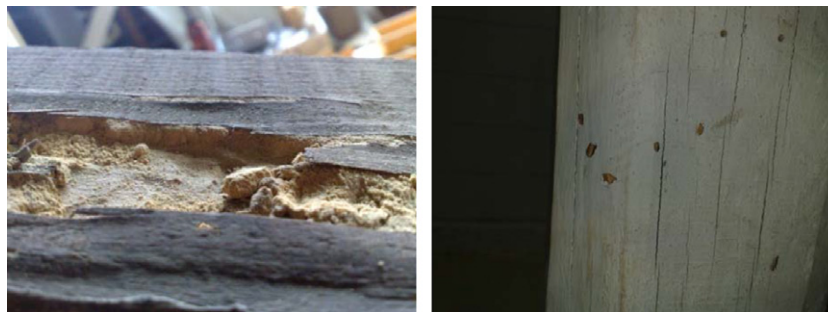
Figure 4. Superficial biological deterioration of timber caused by insects

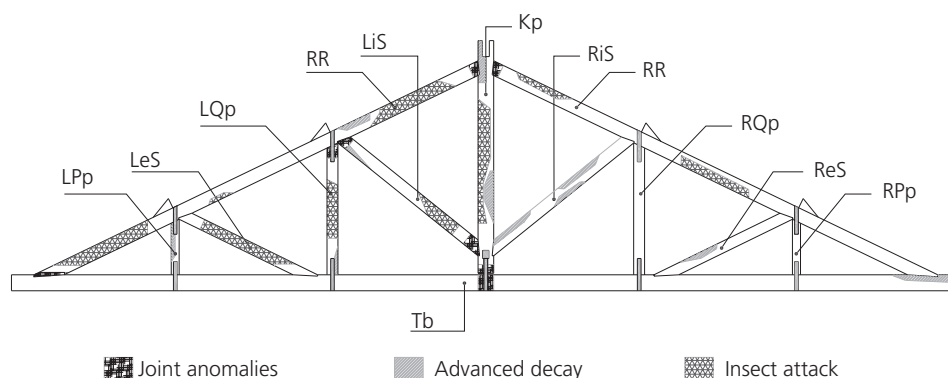
Visual inspection also allowed the abnormalities of the material to be identified – wane, twist, bow and grain slope – and the geometry of the truss – gaps in the joints, out-of-plane deformations of the elements and inappropriate contact between the king post and the tie-beam. However, the main damage observed was the biological deterioration of timber caused by insects, which although mostly superficial (Figure 4), differed in the extent of damage (in depth) in the truss elements. From the visual inspection, a map of the damage distribution was produced, identifying and locating abnormalities and superficial deterioration (Figure 5). This map proved to be fundamental to plan and choose the type of non-destructive tests (NDTs) and where they would be carried out. These tests were conducted during the second phase, in order to evaluate the condition of the timber components of the truss, beyond the superficial damage assessed through the visual inspection.

Figure 5. Map of damage detected in the truss by visual inspection

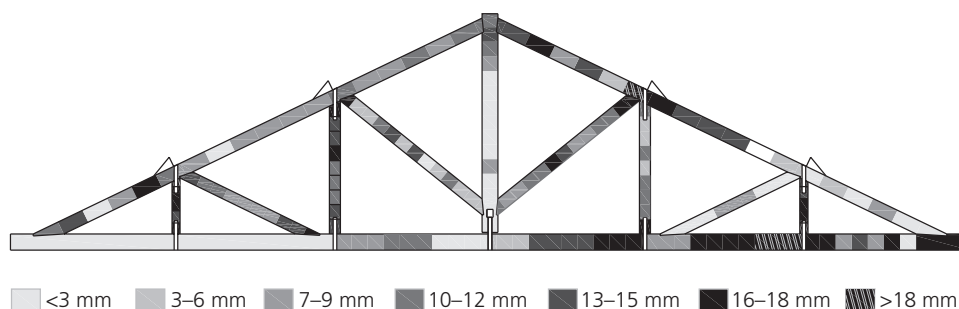
the non-deteriorated wood with the values in deteriorated zones, the extent of degradation is quantified and, therefore, the effective cross-section can also be quantified. To systematise the results of the analysis, each timber element was divided into segments 40 cm long. For each segment and for each side of the element, the mean value of the penetration depth was calculated as the average of three measurements. As an example, in Figure 6, the distribution of the penetration depth values obtained in the north side has been plotted, with the more deteriorated portions corresponding to the sapwood.

Figure 6. Penetration depth results obtained with the Pilodyn test (north side)

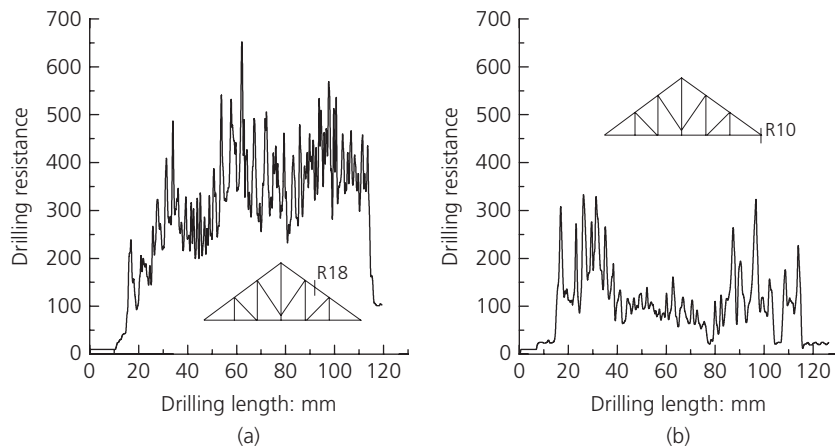
Two examples of graphs obtained with the Resistograph are presented in Figure 8. Figure 8(a) presents the identification of the extent of the internal deterioration and Figure 8(b) shows the assessment of a ring shake, in two different sections. It is important to point out that the Resistograph tests have only detected one section with an internal defect, namely, the one identified as R10.

Figure 8. Examples of the results obtained with the Resistograph: (a) test R18, superficial deterioration; (b) test R10, cross-section with a ring shake

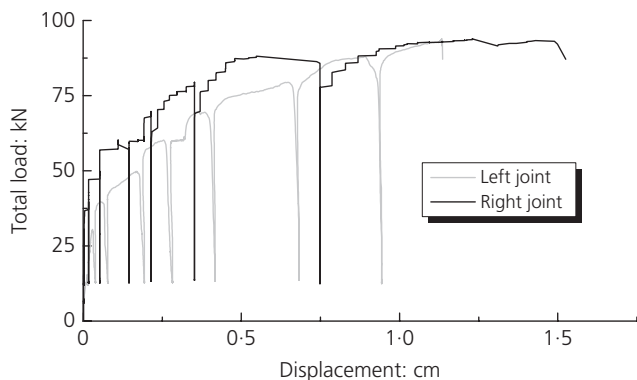
The force–displacement response measured at the left joint (Figure 16) shows a slip due to the crushing of wood in the rafter and tie beam. At the right joint (Figure 16), the slip measured is essentially due to the splitting of the tie-beam fibres (failure by shear parallel to the grain) in the final load cycle, while during most of the loading procedure the slip measured (by wood crushing) is less than that corresponding to the left joint. This shear damage observed is justified by the different degradation state of each of the connections. Moreover, on the right side of the tie beam, the shake ring defect, namely the internal fissures between the annual rings,

Figure 16. Slippage (horizontal displacement) measured at the rafter–tie beam joints

significantly reduced the shear strength of that section. This faulty behaviour of the right joint of the tie beam–rafter explains the smaller relative rotation measured in this joint during the load-carrying test in comparison with the left joint (Figure 17).

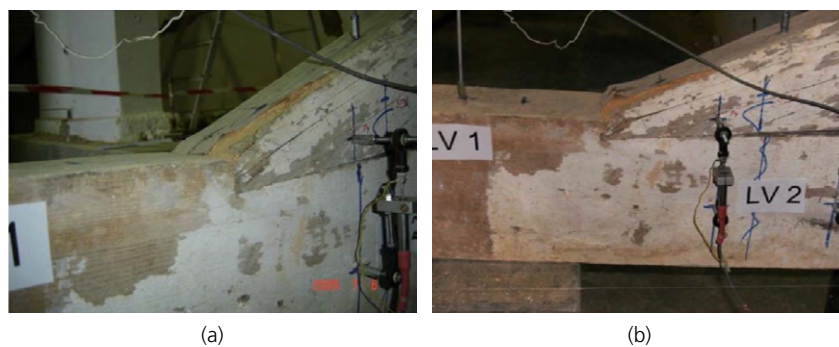
During the first loading cycle, no damage was observed. In the fifth load cycle, for a load of 60 kN, the local embedment of the wood in the left rafter–tie beam joint became visible due to the large displacements (Figure 22(a)). In the two subsequent loading cycles, with peak load values of 70 kN and 80 kN respectively, wood local embedment appeared on the right rafter–tie beam joint while, in the left joint, this damage was further developed (Figure 22(b)).

Figure 22. Evolution of wood local embedment in left rafter–tie beam joint: (a) fifth load cycle (60 kN); (b) seventh load cycle (80 kN)

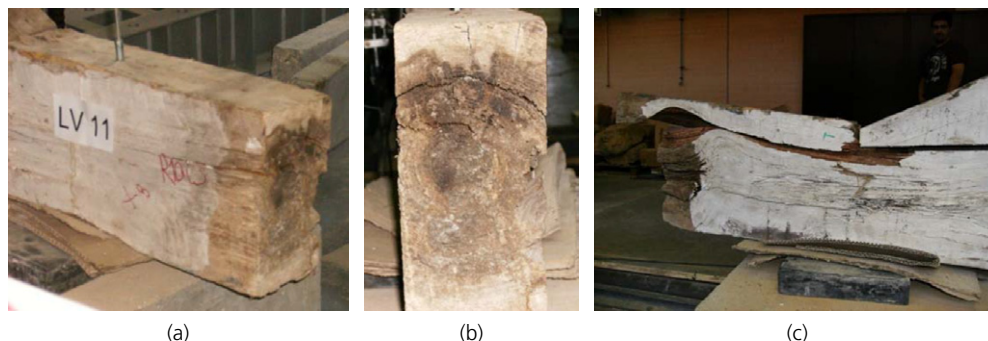
In the eighth loading cycle, for a load value of 85 kN, shear failure parallel to the grain was observed on the right rafter–tie beam (Figure 23(a)), based on the ring shake detected in the diagnosis phase (Figure 23(b)). Finally, in the ninth load cycle, for a load value of 95 kN, a complete shear failure mechanism, parallel to the grain, occurred (Figure 23(c)). The slip magnitude in this joint led to a subsequent tension failure (disconnection) in the exterior joint of the strut–tie beam (Figure 24).

The behaviour of the joints had a clear influence on the overall response of the truss. It was found that the natural defect (ring shake) present in the right rafter–tie beam joint led to the local failure mechanism and rupture of the truss. On the other hand, the joints played an important role in the deformation of the truss during the load-carrying test performed. The unrecoverable deformation observed after the first cycles (see Figure 14) results directly from the existence of gaps in the joints, despite the carpentry works of consolidation that were made (see Figure 3). But even after the gaps in the joints have been theoretically removed, the behaviour of the joints conditioned the overall deformation of the truss. In particular, the

Figure 23. Shear failure parallel to grain caused by a ring shake: (a) beginning of shear failure; (b) ring shake; (c) final position of right rafter-tie beam joint

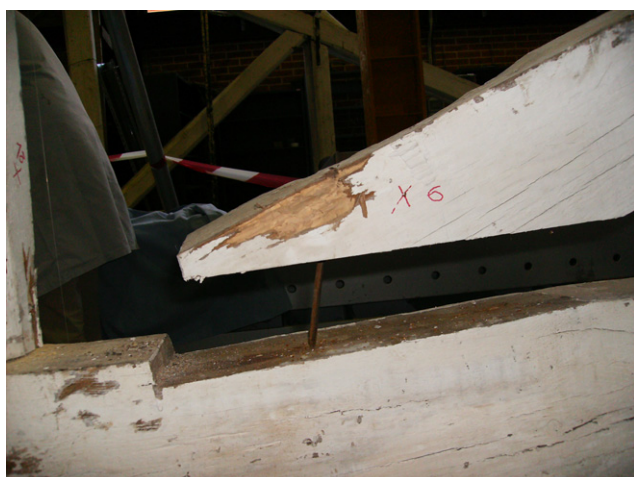
Figure 24. Opening of right strut-tie beam joint
