# RISK MANAGEMENT POTENTIAL OF TECHNICAL DATA INVENTORIES ON BUILT CULTURAL HERITAGE: A CASE STUDY FOR THE CHURCHES OF THE PORTUGUESE ROUTE OF THE ROMANESQUE

**KEY WORDS:** risk management, data inventory, built heritage

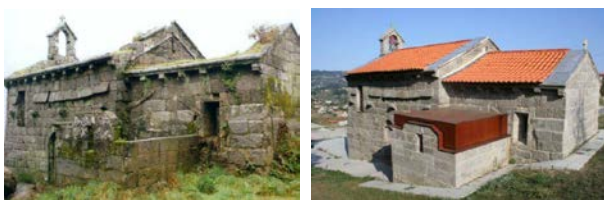
Figure 8. Church of São Mamede of Vila Verde before (left) and after (right) the restoration works.

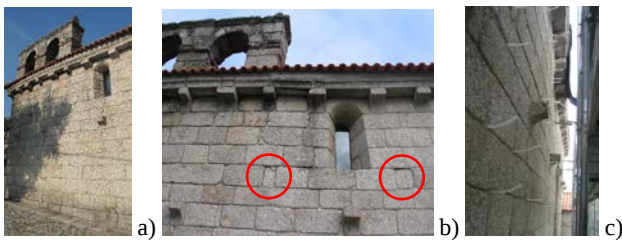
Figure 11. View of the Gondar church wall that exhibited out-of-plane deformations (a), view of two two-leaf stone connectors (b), injection of consolidation grouts (c).

As an example of a more detailed analysis that led to the development of mitigation measures to address this specific issue, reference is made to the works carried out in the Church of Gondar (Costa et al., 2007) in 2012. In this church, the exterior walls exhibited some degree of connection between the two leaves but external conditions were causing out-of-plane instability: a belfry sitting on top of part of the wall was causing an eccentric load on the external leaf (Figure 11) and the degraded roof drainage system around the belfry was allowing water to infiltrate inside the wall from the top causing additional out-of-plane thrusting. Since the connection between the two wall leaves was insufficient, the external leaf exhibited large out-of-plane deformations. In that situation, the structural conditions of the wall could be represented by the case where  $t_{ef}$  is  $0.5t$ , and  $h_{ef}$  is somewhere between  $h$  and  $2h$ . Given the results of Figure 10, mitigation actions were therefore carried out. These involved tying the masonry leaves and the corner walls with steel connectors, the injection of consolidation grouts and fixing the drainage system of the roof.

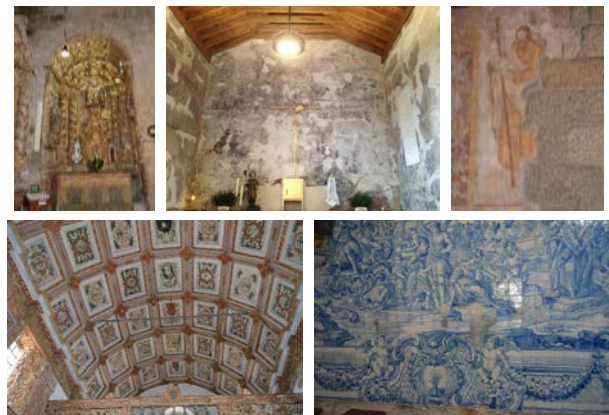
Figure 13. Examples of cultural heritage assets attached to the walls or ceilings of the churches.
