¹Esmeralda Paupério, ²António Arêde, ³Susana Moreira
CONSTRUCT-LESE, Faculty of Engineering,
University of Porto, Porto, Portugal
¹Civil Eng., MSc
email: pauperio@fe.up.pt
ORCID: 0000-0001-9370-2199
²Associate Professor
email: aarede@fe.up.pt
ORCID: 0000-0002-0901-2214
³Civil Eng., PhD
email: smtmoreira@fe.up.pt
ORCID: 0000-0002-9081-2031

CROSS-BORDER FORTRESSES IN PORTUGAL; INSPECTION AND DIAGNOSIS

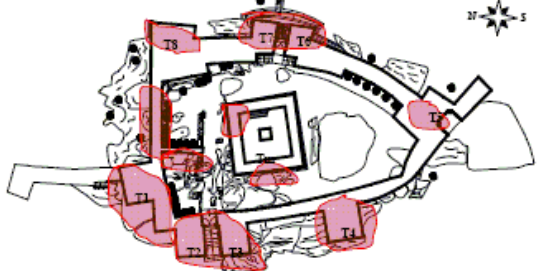
Fig. 8. Example of the inspection form for damage D1.

Descrição: Observa-se fendilhação e/ou abertura de fendas de forma generalizada na estrutura portante das muralhas e na torre de menagem, com maior incidência nas 4 torres próximas da entrada principal do Castelo no canto Noroeste (torres T1, T2, T3 e T4). Além da fendilhação referida são visíveis fissuras nas padieiras das janelas da alcáçova e de vãos de portas. Como situações mais graves referem-se a fissuração com rotação do paramento da torre T1 no troço Noroeste e a fissuração e empeno de parte da alcáçova, onde elementos da chaminé estão em risco de queda. No topo da torre de menagem são também visíveis algumas perdas e/ou fissuração de elementos de pedra.

Causas: A fissuração com alguma deformação estrutural do paramento da torre T1, parece resultar de movimentos nos maciços rochosos fracturados que a suportam. A fendilhação que afecta com maior intensidade os torreões da entrada principal (T2 e T3) e torre T4 parece ter origem em fenómenos de fadiga da pedra, visto o dano manifestar-se com maior intensidade e frequência nas torres, estruturas altas e com níveis de carga permanente mais importantes. Este fenómeno também poderá ser designado como fluência da pedra. As fendilhações ligeiras e dispersas pela generalidade do paramento exterior da muralha do Castelo, pode ter causa fenómenos de fluência ou do aparecimento de impulsos resultantes do aumento de carga e/ou da infiltração de água deficiente drenada no terreno, assim como devido a fenómenos homólogos à fadiga dos materiais. Note-se que em relação a água, a sua acção negativa não se limita à geração de impulsos sobre os paramentos, mas manifesta-se também na lavagem das juntas e do material de enchimento interno dos muros, sendo responsável pela degradação da capacidade resistente destas estruturas (ver D7).

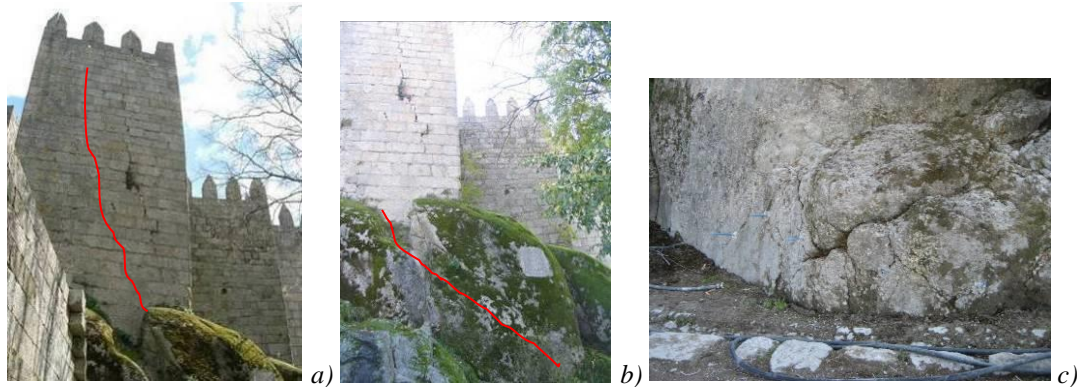
After the inspection, the constructive elements considered most affected were the T1 tower and the A fortress wall, for which urgent intervention was recommended. Particularly for the T1 tower, which presented joint openings with a V-shaped development (with apex at the corner base) and corner detachment by rotation, further studies were carried out. On the north face of the same tower, simultaneously with the joint opening, localized fracture of some ashlar stones was also observed, probably due to stones' compression crushing

caused by the stress increase resulting from the corner rotation. As causes of these damages, alterations to the rock mass outcrop were pointed out, since both the T1 tower and the other towers and walls of the Guimarães Castle are founded thereon, Fig. 9. This rock mass, which is almost 3.5m high in the support area of the T1 tower corner, presents an apparent joint/fracture and severe degradation at the base. The fracture positioning in the rock mass is in line with the direction of the joint opening observed in the North facing, where it is more pronounced.

Fig. 9. a) Corner detachment; b) fracture of the support massif; c) severe degradation of the base support of the rock massif.

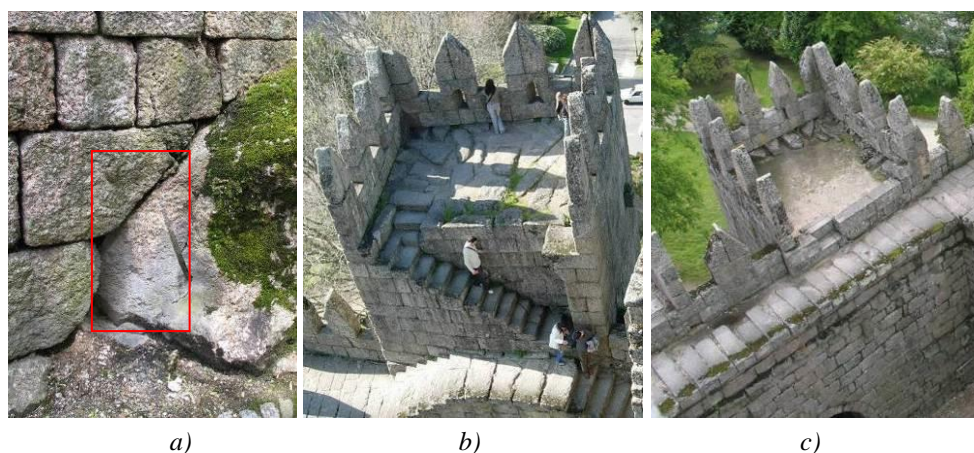
A closer look at the rock masses supporting the castle structures revealed that these were vertically cut, apparently by using dynamite, as suggested by the visible marks. These cuts, carried out within the scope of the urban arrangement of the castle surroundings in the mid-1940s, weakened the rock masses, in some cases leaving them supportless. In addition to the changes in the support conditions of the structures, the rock masses became even more vulnerable to erosion effects due to changes in the conditions of rainwater drainage. Therefore, it is considered that these cuts were responsible for some of the damage observed in the towers and walls, namely the detachment of the corner of the T1 tower. Fig. 10 a) shows a hole in a rock mass that might have been done to introduce a dynamite stick, as often used for thinning and cutting rock masses. Fig. 10 b) and c) presents images of the T1 and T2 towers that allow the visualization of the type of structure of the towers. During the inspection, and because it was considered to be an indispensable element, a survey of the dimensions of the T1 to T8 towers was carried out. Due to lack of knowledge on the construction process inside the towers, it was necessary to make a specific survey in the T1 tower (Arêde an others, 2017) in order to determine the face type and thickness of the wall, as well as the constitution of the interior filling; the location of the survey is indicated in Fig. 11 a). It is worth mentioning that part of this tower development height wise was rebuilt during interventions carried out by the former historic heritage institution called “National Monuments” in the mid-1930s/40s.

Fig. 10 (a) Mark of rock cutting with a dynamite stick; (b) Tower T1; (c) Tower T2

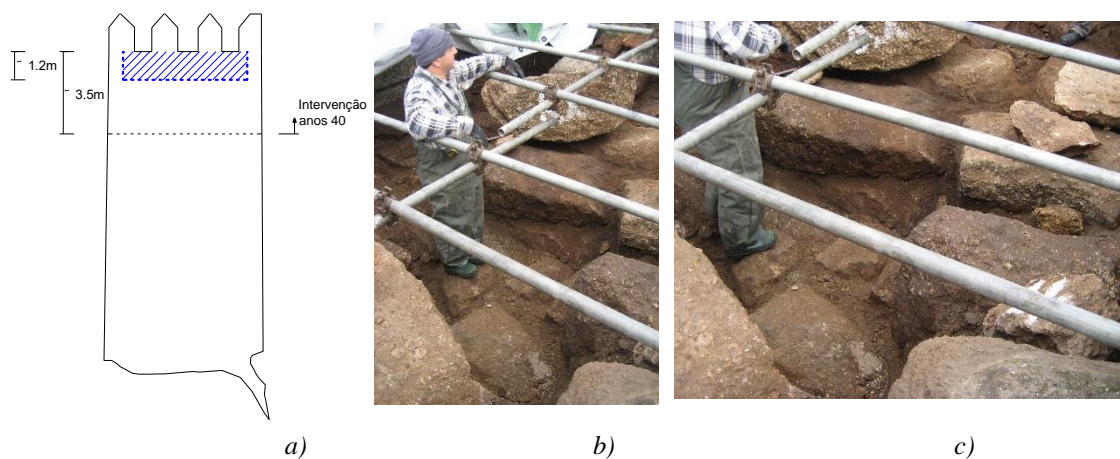
The survey carried out at the top of the tower, Fig. 11 b) and c), allowed to verify that the constructive process of the tower's facades is carried out in rows of granite stonework of about 50 cm, made of stones of approximately 50 x 60/65 cm² and with variable length between 100 cm and 140 cm. The stones' positioning in the wall face alternates between the stone placed in a row and the stone to bond faces. The infill of the tower is completed with smaller granite stone and apparently black earth.

Fig. 11. Surveys on the top of Tower T1

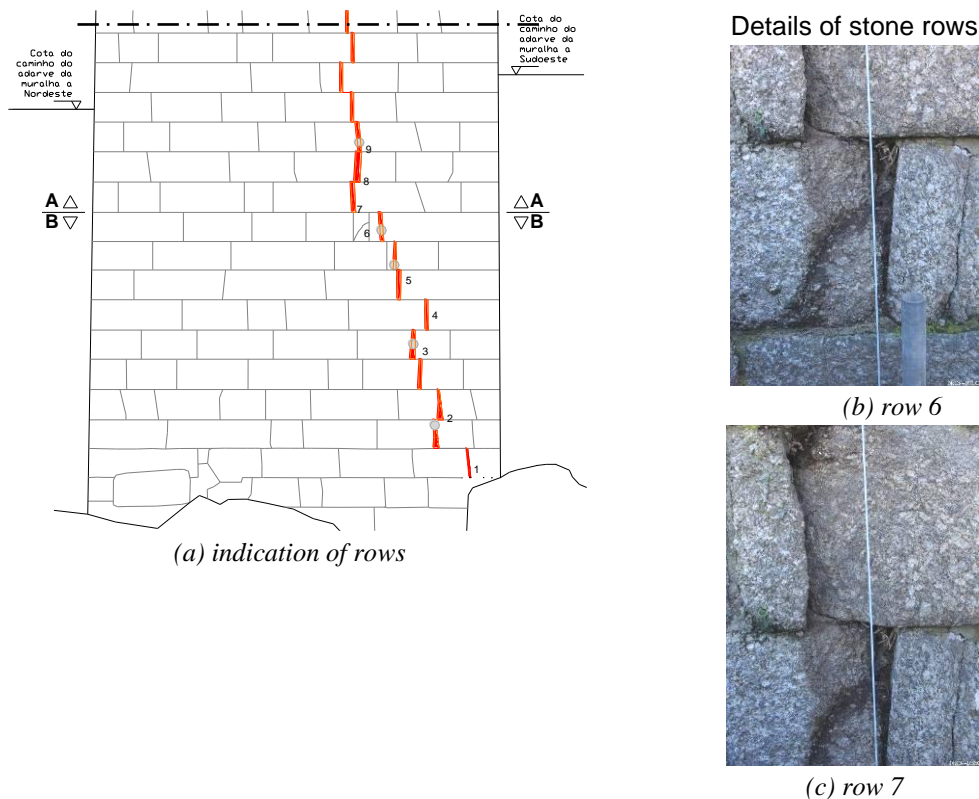
In the walls' faces and in the weakest area of the North façade, a survey of the joint openings and the observed cracking was carried out. In this survey, performed by stonework rows that were numbered from the base to the top, the wall thickness was also assessed, whenever possible. The introduction of a rod in the joints, allowed to see that, in some places, it entered about 2.0 m into the tower interior.

Fig. 12. Geometrical survey of the cracks of the North façade of tower T1

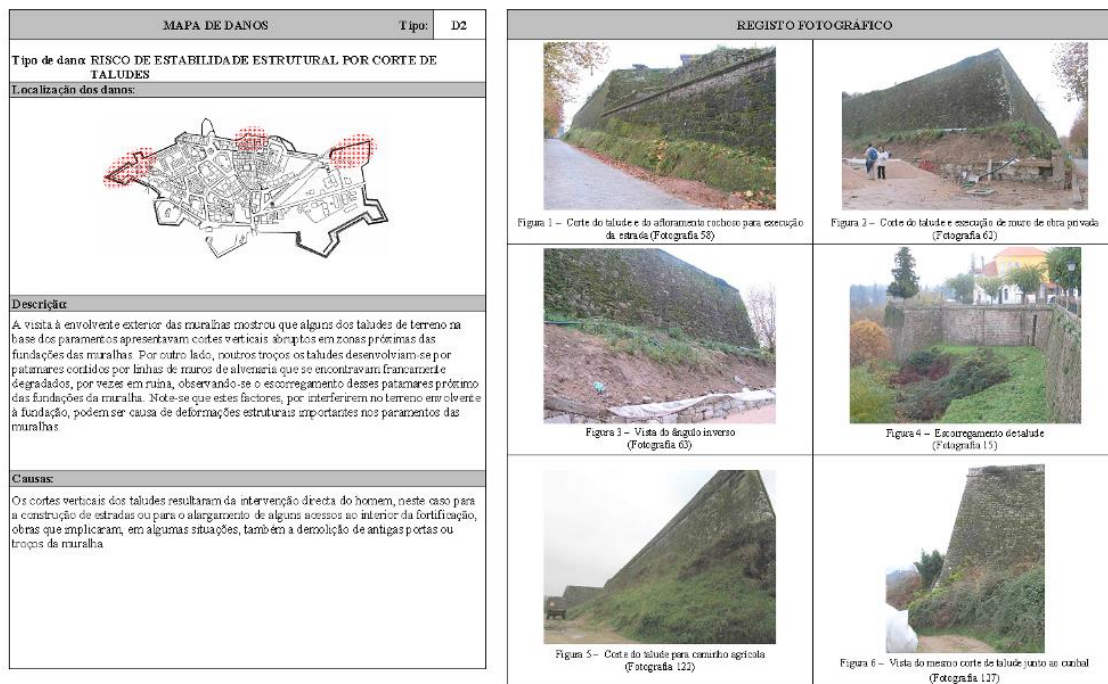
Fig. 13. Example of a damage form.

In these fortresses, characterized by several lines of defense developing along more or less high walls in granite, visual inspections with a structural scope were carried. For each fortress, after the identification and description of the load-carrying structure, those considered most relevant were recorded in damage forms (Costa, Guedes and Paupério, 2005). In these forms, Fig. 13, in addition to the in plan location of the damage, there is also a brief description associated with the identification of its probable cause. Also, the interconnection between different types of walls (crossing or extension of medieval walls with bastions) were identified and marked as additional and fundamental information to the inspection process.

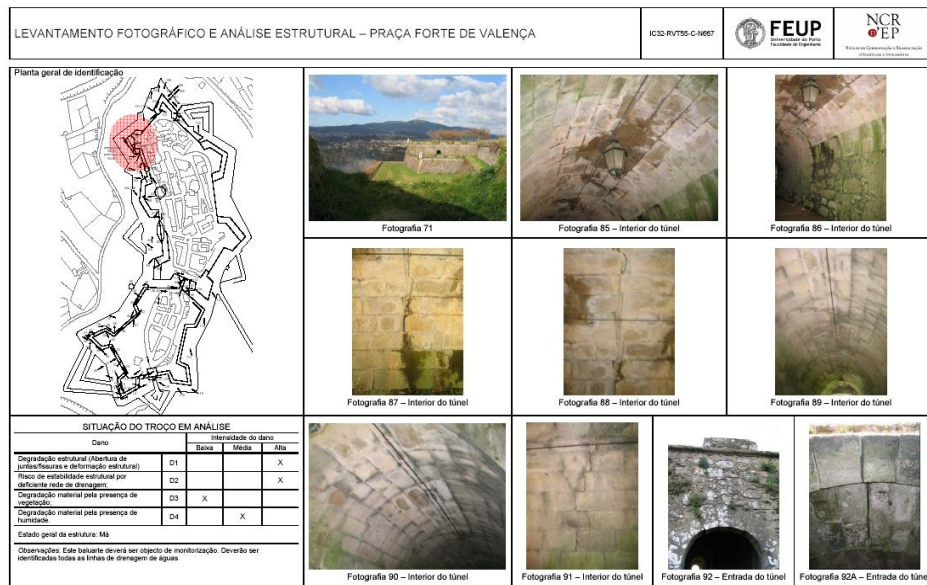
Fig. 14. Example of a photographic survey and structural analysis.

For larger structures, whether with high wall sections and/or at various levels, a photographic survey and a structural analysis were carried out by sections, Fig. 14. For each section under study, identified in a plan, in these forms it is shown a photographic record and a summary table that relates the damage recorded in the structure and its intensity of occurrence (low, medium, or high). In this way, in addition to the damage forms, a much more intuitive relationship is obtained between the damage, its intensity, and the place of occurrence, allowing for a more effective general identification of the state of conservation of the structure and the determination of critical points. It is noteworthy that, currently, the external slopes are not considered as an integral part of the structure and therefore, generally present a very poor maintenance. This situation is exacerbated by the indiscriminate cuts, resulting from the opening of streets or the execution of nearby constructions, this being a factor that enhances structural instability.

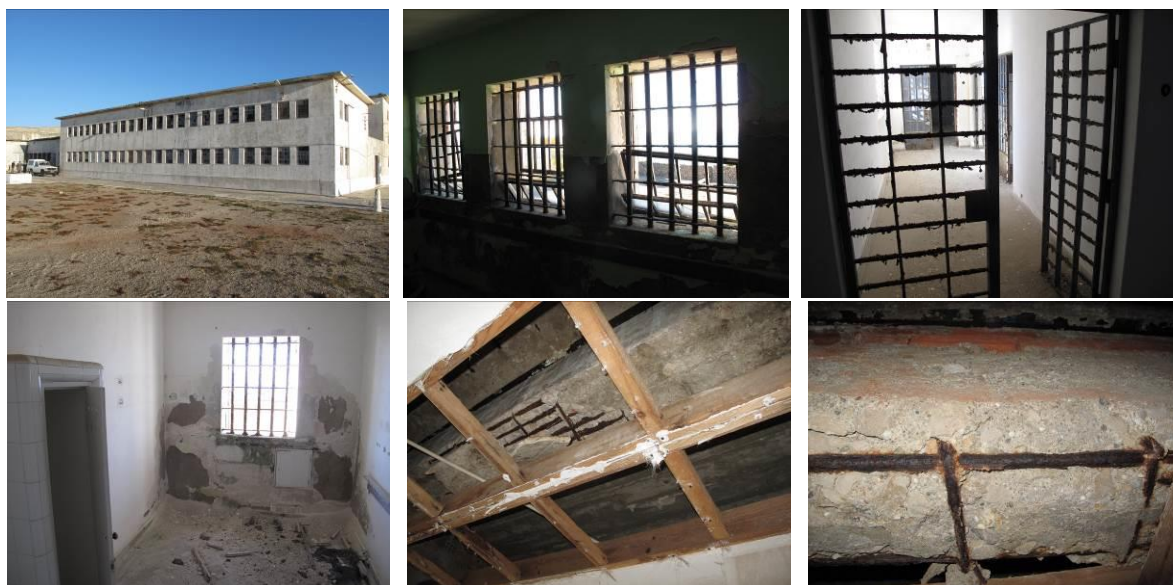
Fig. 20 – Former political prison buildings and their material/structural degradation
