# Spur gear teeth reconstruction via direct laser deposition

P. C. Romio<sup>1,2</sup> · P. M. T. Marques<sup>2</sup> · J. H. O. Seabra<sup>1,2</sup> · C. M. C. G. Fernandes<sup>1,2</sup> · J. Gil<sup>2</sup> · R. Cardoso<sup>2</sup> · M. F. Vieira<sup>1,2</sup> · J. M. Cruz<sup>3</sup>

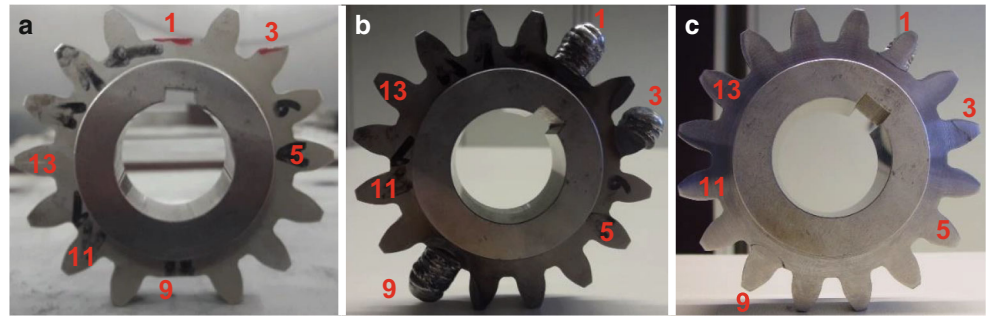
Teeth 1 and 9 were entirely removed from the pinion, while tooth 3 was partially cut over the pitch line to the tip tooth (Fig. 6a) using a conventional face milling process. Teeth 5, 11 and 13 were chosen for base material control and to establish the reference for the comparison between the as-built by conventional processes and DLD. The adopted strategy for the teeth reconstruction consisted of a combination of pure Inconel 625 (MetcoClad 625) for the tooth core and pure AISI 431 (Metco 42C) as a superficial coating. Table 2 presents the nominal weight percentage for the chemical composition of such materials.

Figure 6b presents the obtained result with the DLD process. Tooth 3 followed a similar DLD approach but only used three layers. The first layer combines Inconel 625 and AISI 413, while the last two were made only with AISI 413. The theoretical dimensions of the prism were 9 (width)  $\times$  14 (length)  $\times$  5.4 mm (height).

**Fig. 6** FZG-C, type C-GF Gear Sample. **a** Teeth removed, **b** DLD deposition and **c** Re-shape teeth profile

Finally, the tooth’s involute profile (Fig. 6c) was achieved by employing wire Electrical Discharge Machining (EDM), with the trajectory defined by digitizing one of the base material teeth. In this case, the tolerances were determined by the post-processing operation. The base tangent length over three gear teeth ( $W_k$ ) was used as a reference in the current evaluation. At all teeth positions, the measurements were inside the allowed tolerance (Table 1). Since only one reconstructed gear sample was available, a statistical study on the variability of the post-processing reconstruction was not performed.

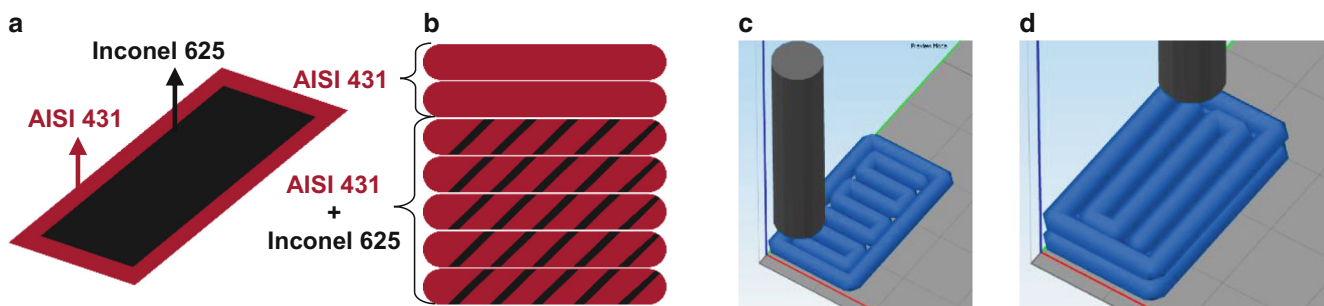
For teeth 1 and 9, seven layers were used. The DLD routine is illustrated in Fig. 7. As one can see, for five layers, an external perimeter of AISI 413 was initially deposited,

followed by filling the tooth core with Inconel 625. The last two layers used only AISI 413 for both perimeter and filling. The theoretical dimensions of the prism were 8.5 (width)  $\times$  14.5 (length)  $\times$  12 mm (height). The laser scanning pattern rotated 90° between layers, as shown in Fig. 7c and d, and the starting point of each layer was randomly chosen in order to better distribute the thermal delivery over the part—starting the deposit in the same position may lead to “slump” problems.

**Fig. 7** DLD strategy for gear tooth reconstruction. **a** materials distribution in a single layer, **b** material layer stacking sequence, **c** laser scanning pattern I and **d** laser scanning pattern II

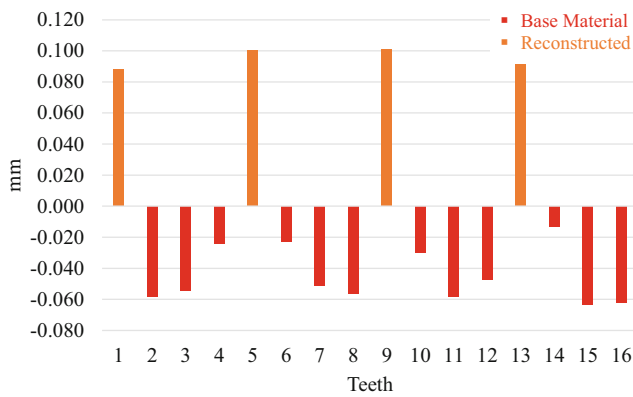
It is also worth highlighting that similar gears, produced by the same process, presented a gear quality grade of 12, according to DIN 3962. This analysis is illustrated in Fig. 8, where one can observe the Range of tooth thickness errors ( $R_s$ ) equal to 0.164 mm in an FZG-C Type C-GF pinion with four reconstructed teeth (1, 5, 9 and 13). This result is particularly significant since it illustrates how rebuilt teeth

can cause the gear quality grade to decrease. As an illustration, the gear quality grade would be equal to 6 ( $R_s = 0.012\text{ mm}$ ) if only the teeth away from the DLD (3, 7, 11, and 15) are considered. In addition, the average roughness of teeth flanks obtained with this approach was equal to  $0.9\mu\text{m}$  and the maximum pitch deviation from the reference value ( $p_n = 14.137\text{ mm}$ ) was  $0.117\text{ mm}$ .

**Fig. 8** Tooth thickness errors for a FZG-C Type C-GF pinion reconstructed with DLD

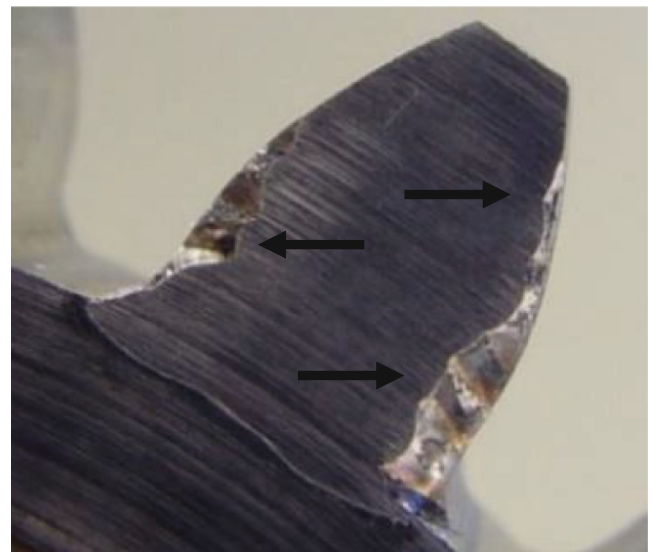
1. The turning post-processing to restore the teeth' face width produced a series of defects over the DLD teeth' edges, as illustrated in Fig. 11 by the black arrows. The intermittent shocks between the cutting tool and the gear led to inappropriate material removal.
2. A Liquid Penetrant Inspection revealed several crack defects on the DLD teeth prior to any test, probably related to the deposition process itself, as shown in Fig. 12a (pink marks in reconstructed tooth 1). On the other hand, the

**Fig. 11** Tooth 1 defect due to turning post-processing

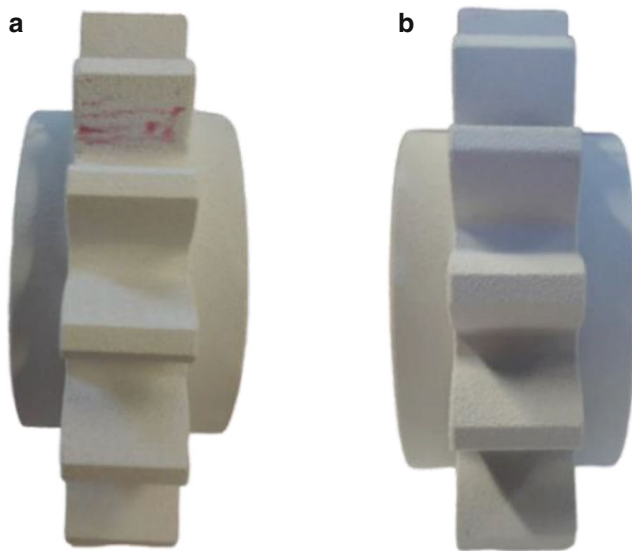
base material did not present a similar problem as demonstrated in Fig. 12b.

**Fig. 12** Liquid Penetrant Inspection for crack defects. **a** Reconstructed tooth 9 with cracks and **b** Material base teeth free of defects

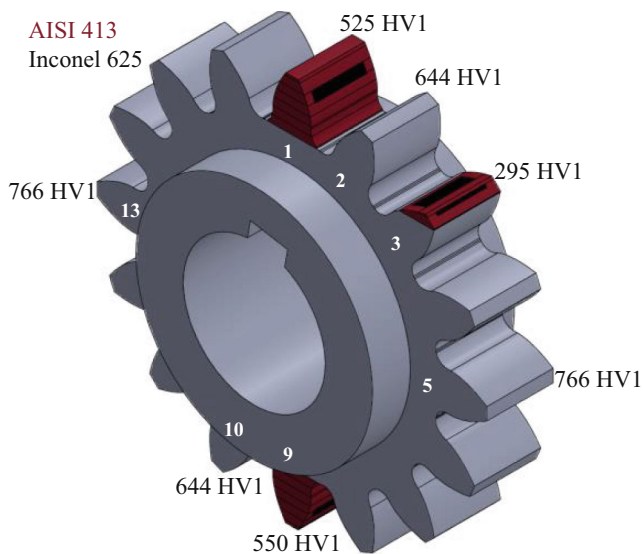
3. The dimensions of the DLD prism proved inappropriate for the EDM strategy employed in the geometric teeth restoration. As schematically represented in Fig. 13, part of the core was exposed after the wire cut, producing a material transition zone Inconel 625/AISI 413 over the teeth flanks.
4. A preliminary hardness assessment performed on the top of each tooth (over the tip diameter) disclosed a reduction in the reference value (766 HV1) for the teeth close to the DLD process, as one can see in Fig. 13. Still, teeth further away from the DLD process were not thermally affected and kept the original hardness. Finally, the deposited AISI 413 presented about 30% lower hardness than base material teeth, while the exposed Inconel 625 had a value of 295 HV1.

**Fig. 13** Material transition zone over the tooth flanks: AISI 413 in red and Inconel 625 in black. Hardness assessment after DLD

This exploratory work taught that caution is needed when planning the deposition prisms' dimensions to not compromise the teeth' flank capabilities. For this specific case, a miss calculation led to the mentioned Inconel 625/AISI 413 transition problem, and so a human error might be

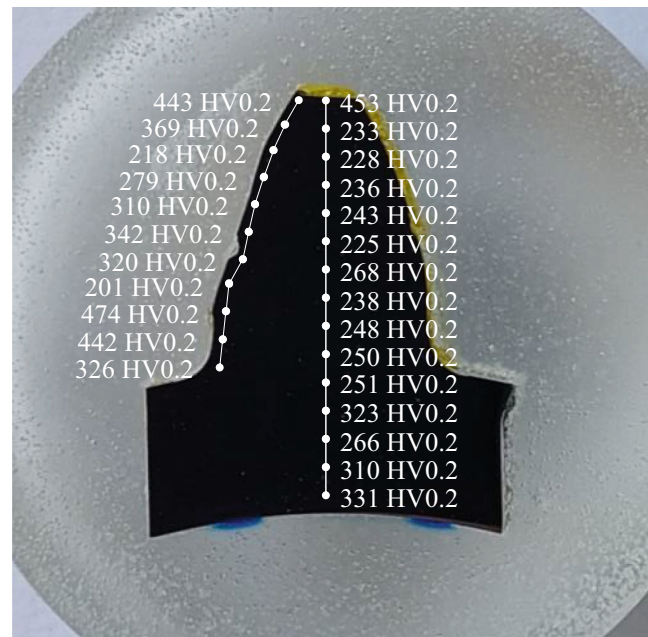
5. In order to confirm the material transition zone (item 3) and the results from the preliminary hardness evaluation (item 4), once the FZG test campaign was completed, the reconstructed tooth 9 was removed from the gear and cross-sectioned to allow an internal assessment of the DLD. The microhardness values, indicated in Fig. 14, were measured in a central line and along the involute profile of the active flank. The central line measurements showed three levels of hardness: a higher one at the top of the tooth, equal to 453 HV0.2, referring to AISI 413; a second region referring to Inconel 625, whose aver-

**Fig. 14** Tooth 9 cross-section microhardness (HV0.2)

age is 242 HV0.2; and the third area associated with the base material (16 MnCr 5), with an average value of 308 HV0.2. There is a slight difference between the hardness of Inconel 625 at the top of the tooth and the root of the tooth, with an increase in values for the depositions close to the base material. For the measurements along the involute profile, it is worth highlighting the evident change in hardness in the transition from AISI 413 to Inconel 625 (369 HV0.2—218 HV0.2) and back to AISI 413 (279 HV0.2—310 HV0.2), which corroborates with Inconel 625 core exposing hypotheses (item 3).

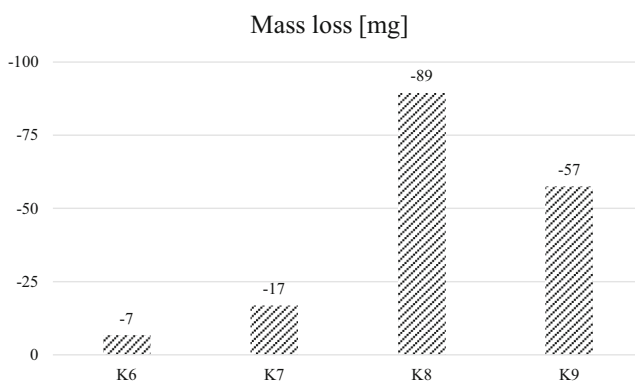
Figure 15 presents the mass loss throughout the FZG load stages used to evaluate the pinion performance. Between stages K1 and K5, no significant mass loss was detected. As one can see, the most significant mass change occurred in K8 (89mg), and a total of 170mg were removed from the pinion at the end of nine load stages. At this point, this first exploratory work did not replicate the same operating condition in a non-restored pinion in order to promote straightforward comparison. However, safeguarding the due differences in the FZG test conditions presented by [22], it can be said that the reconstructed pinion showed a more significant mass loss than pinions in only base material.

Fig. 15 Mass loss throughout load stages

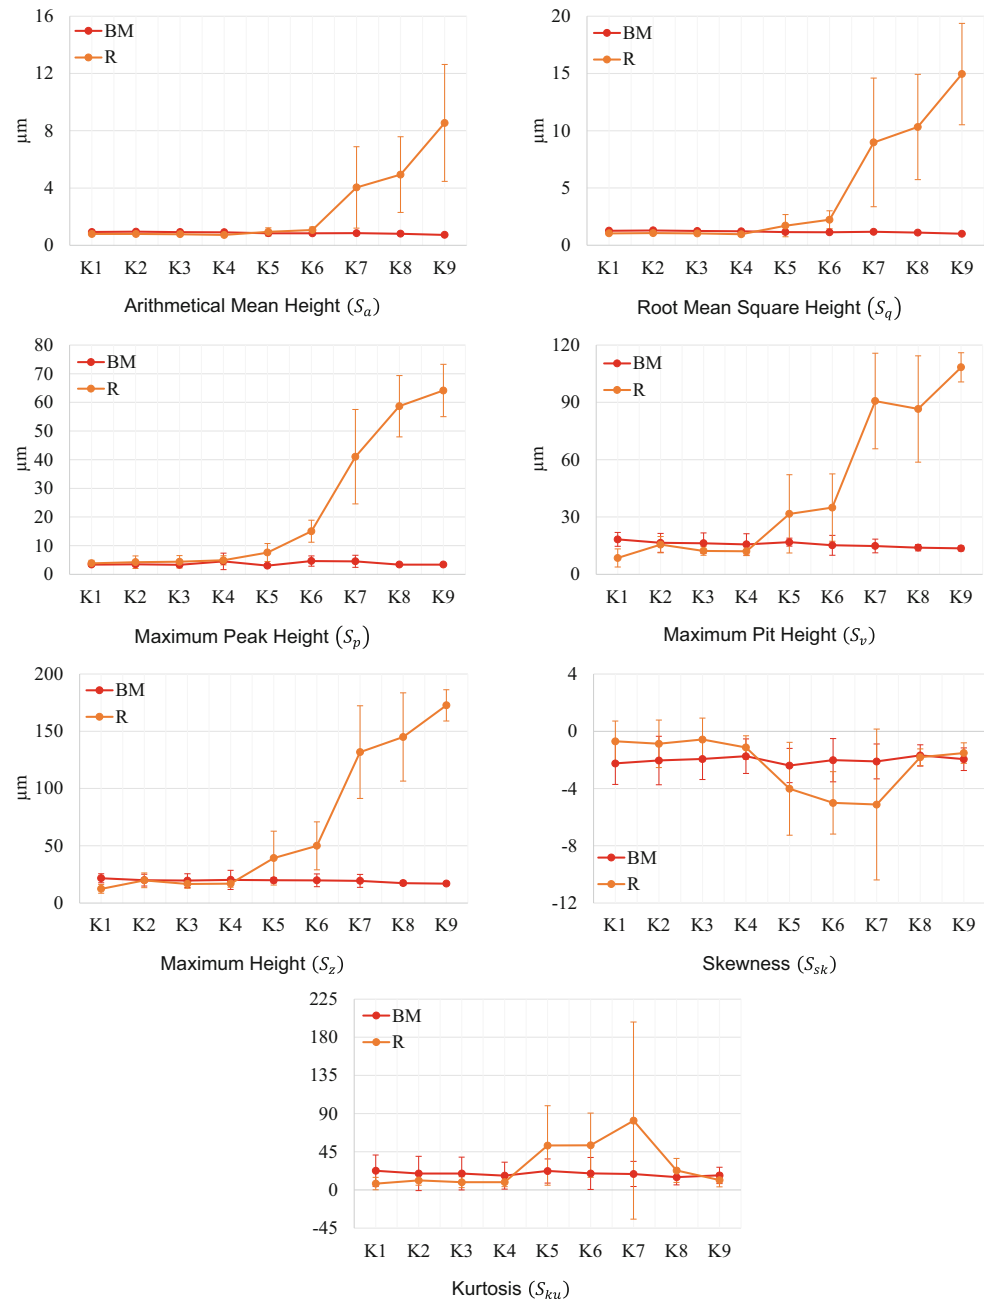
From the tooth flank roughness parameter perspective, which can be used to assess the surface condition, there is a clear difference between R and BM teeth development in the different load stages. While BM kept roughness parameters constant and stable, slightly decreasing along the tests, R presented significant changes, starting at the K5 load stage, leading to an increase in all roughness height parameters. Particularly  $S_p$ ,  $S_v$  and  $S_z$  proved to be sensitive tooth flank surface evolution and damage, with a more pronounced detachment of the curves BM and R.

Since  $S_p$  represents the highest peak in the measured area,  $S_v$  accounts for the absolute value of the lowest pit and  $S_z$  is defined as the sum of the previous two, it is possible to assume that changes in these parameters are directly related to failure occurrence on the flank teeth, and their increase is linked to the failure development. Also, one can mention that  $S_a$  and  $S_q$  also indicated changes in the teeth' surface condition, but these modifications manifested only in subsequent loading stages.

**Fig. 16** Roughness parameters throughout load stages. *BM* Base material, *R* Reconstructed

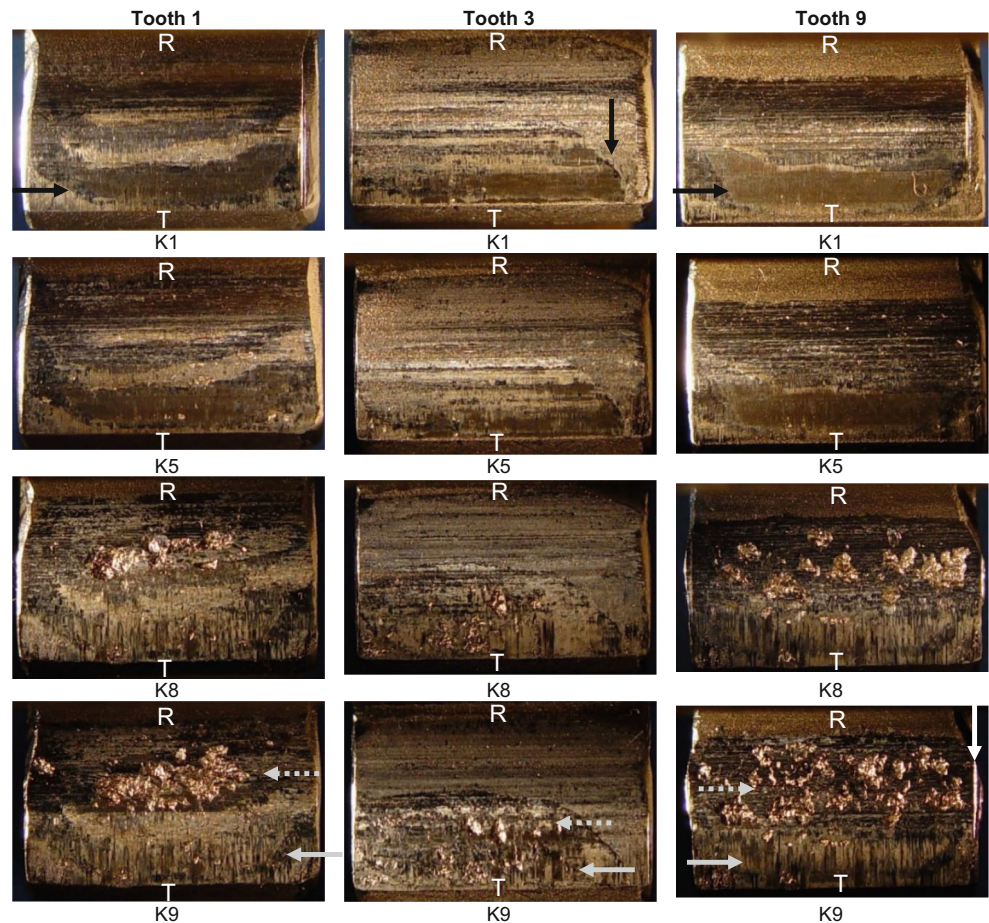
Figure 17 presents a collection of images for teeth 1, 3 and 9, where the evolution of the flank condition can be observed throughout the nine load stages. Similarly, Fig. 18 shows the development of the flanks of teeth 5, 11 and 13 for the base material.

The first point to observe is the already mentioned Inconel 625 core exposing after the wire cut, producing a material transition zone Inconel 625/AISI 413 over the teeth flanks, as indicated by the continuous black arrow in Fig. 17. Also, Fig. 17 puts in evidence the high level of degradation suffered by the reconstructed teeth throughout the nine loading stages, namely spalling (dashed grey arrow) and scuffing (continuous grey arrow). In addition, one can see in tooth 9 a severe plastic deformation (continuous white arrow), where its limits "broaden". A reasonable hypothesis for the mentioned problems resides in the fact that both DLD materials have lower hardness values than the base material teeth on the wheel. Although the reconstructed teeth allowed the gear to perform the proposed FZG gear tests, there is no doubt that they presented significant failure developments.

**Fig. 17** Reconstructed teeth evolution throughout load stages, *R* tooth root, *T* tooth tip

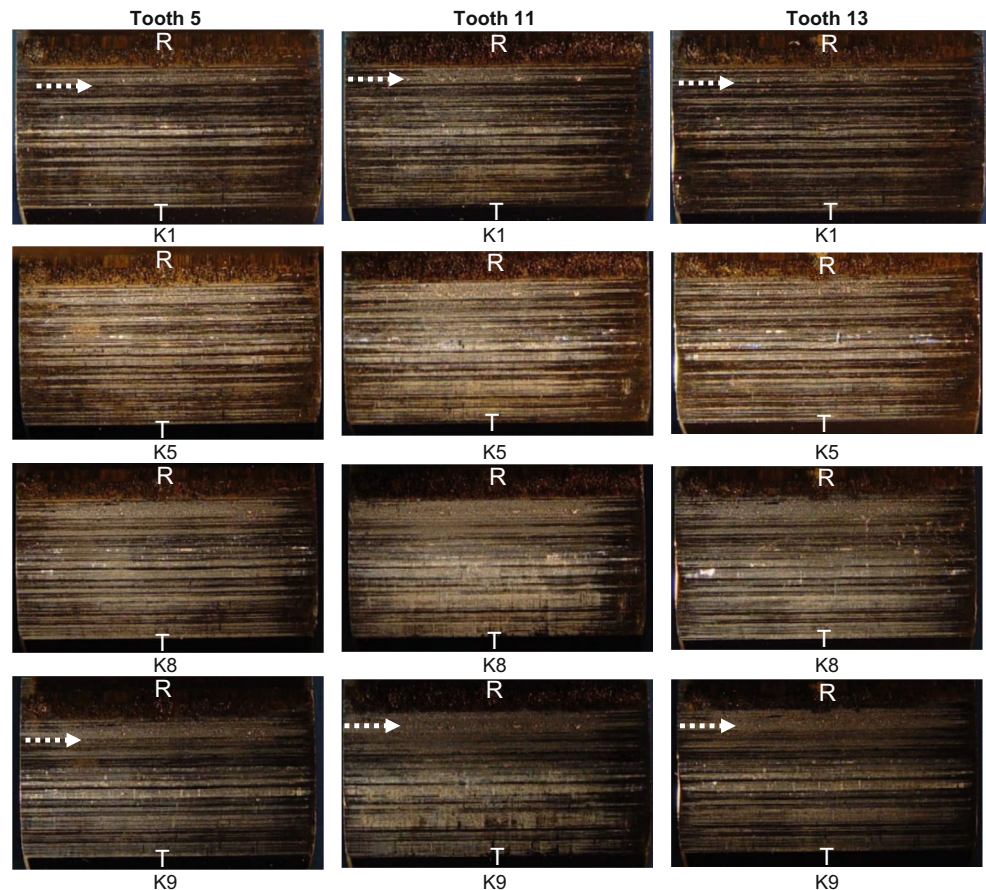
**Fig. 18** Base material teeth evolution throughout load stages, *R* tooth root, *T* tooth tip

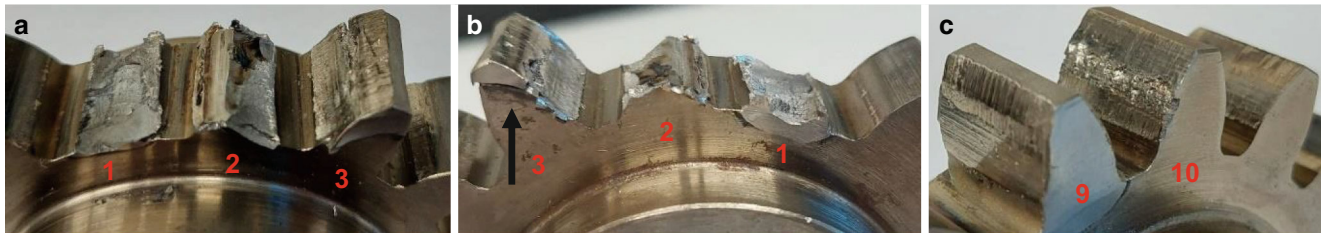
As shown in Fig. 19, DLD tooth 1 and base material tooth 2 fractured at the root. Considering the active flank, it can be assumed that the reconstructed tooth 1 was the first to fail, causing an overload on the base material tooth 2, leading to its rupture. Tooth 3, partially reconstructed, also showed severe damage and, in particular, loss of adhesion to the base material, as indicated by the black arrow in

Fig. 19b. Tooth 9 showed significant wear, namely scuffing at the tooth tip.

**Fig. 19** DLD reconstructed gear after the K14 load stage. **a** front view for teeth 1, 2 and 3; **b** back view for teeth 1, 2 and 3; **c** front view for teeth 9 and 10

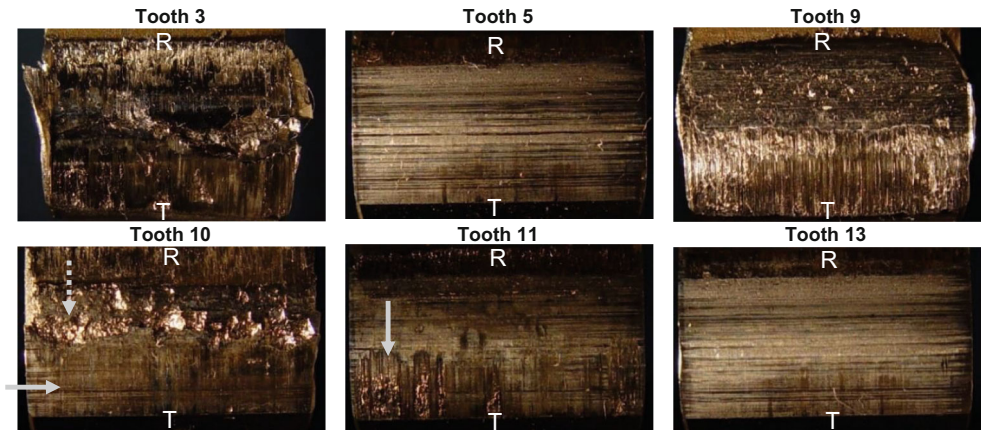
A highlight in this analysis is the degradation presented by teeth 10 and 11 after the K14 load stage. As illustrated in Fig. 20, the base material tooth 10 showed both spalling on its flank (dashed grey arrow) and scuffing (continuous grey arrow), similar to what was observed in tooth 9. Base material tooth 11 presented scuffing on its face, indicated by the grey arrow. It can be assumed that the hardness reduction due to the thermal effects of the DLD led to the weakening of these teeth, producing the results. This argument is corroborated by the better aspect presented by

**Fig. 20** Teeth aspect after load stage K14, *R* tooth root, *T* tooth tip

- Selection of a material for the coating of the tooth with better contact fatigue and wear capacity than AISI 413, that is, higher hardness levels. In this context, it is necessary to identify process parameters that guarantee the integrity of the coating and minimize cracks arising from the DLD, such as those observed with penetrating liquid;
- Perform a detailed analysis of the deposition geometry to not repeat the mistake in this first study, where Inconel 625 was exposed;
- Use other forms of machining in the post-processing of the deposited tooth, mitigating intermittent shocks with the cutting tool that could damage the reconstructed teeth (e.g., using milling instead of turning);
- Thermally protect the base material teeth close to the DLD zone to not weaken these adjacent teeth.
