# Preliminary seismic analysis and strengthening proposals of two churches in Azores

Aníbal Costa, António Arêde, Domingos Moreira & Nuno Neves  
*Faculty of Engineering at Porto University, Porto, Portugal*

**ABSTRACT:** This paper covers the seismic behaviour modelling and numerical analysis of two church structures on Pico Island, Azores, affected by the Faial earthquake on July 9, 1998. The observed damages are first described and some modelling options for the analysis are discussed, particularly in what concerns the way of including the roof as a means of bracing the bearing walls. Frequencies and vibration modes are analysed and discussed for the different types of modelling. Seismic calculations are performed considering the actually recorded accelerograms of that earthquake, and the obtained results are compared with the observed structural damages, in order to propose suitable strengthening techniques based on a better understanding of the structural aspects most directly responsible for the damages. In this context, analysis and discussion are included concerning the influence of modelling type on the peak principal stresses and their zones of occurrence. By comparing

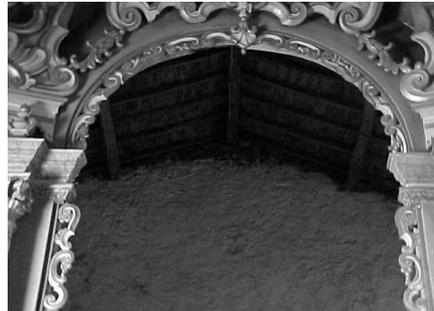
Behind the altar there is a small sacristy with an irregular plasterwork wall (see Fig. 4); in this zone the beams supporting the rafters are placed in a direction contrary to what is normally found in the island's roofs, for which it is presumable that there may exist a transversal wall connecting the longitudinal walls in the altar area.

Figure 4 Aspect of the roof over the sacristy behind the altar

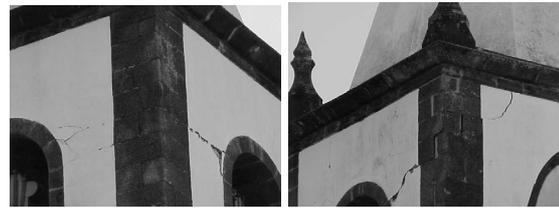
There is significant cracking in the towers. In the connection between the frontispiece and the tower, the above-mentioned crack extends to the right tower and runs around it, as shown in Figure 6a. The bell tower suffered great damage, with cracks running from the openings to the corners (as illustrated in Figure 6b) and substantial sliding between stones (Fig. 6c).

a) Cracks around the towers b) Cracks in corners

c) Sliding of stones  
Figure 4. Damages in the towers.

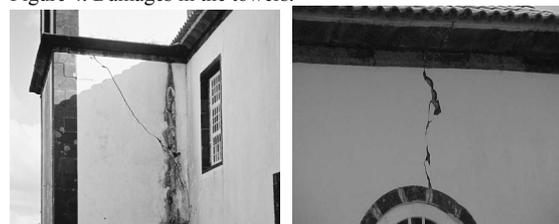
In the exterior, other cracks were detected, of which two particular examples may be seen in Figure 7, located in the towers' connection to the church body (Fig. 7a) and at the top of the right lateral external wall, between the windows and the coping (Fig. 7b). This last crack is also visible in the interior, as shown in Figure 8a; cracking was also found in the transition between the main body and the chancel (more specifically, next to the keystone of the triumphal arch) and in the area where the longitudinal walls connect to the upper choir and the towers. The arches providing access to the towers show evident signs of movements (Fig. 8b), with settlement in the area of the respective keystones. Finally, the ceiling lining above the upper choir was found ruptured, possibly caused by falling stones.

a) Cracking in the connection tower – lateral wall  
b) Crack in the lateral wall over the window  
Figure 5. Damages on the lateral wall.

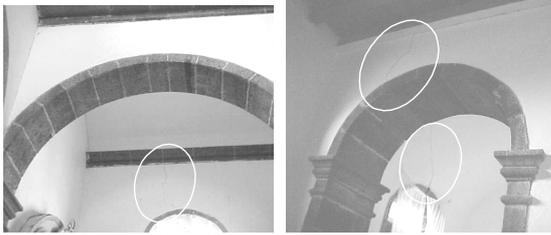
1. Some wall tiles fell from the towers and from the main facade, and the pinnacle also fell from the top of the right tower.
2. Substantial cracking in the exterior, in the body of the church's north end, and a vertical crack along the stone over the church's north side door.
3. Interior cracking in the upper choir area, specifically where the towers connect to the nave (Fig. 9a); the central nave's vaulted ceiling sagged slightly, causing the mortar to loosen, particularly next to the triumphal arch (Fig. 9b); loosening of stucco in various places on the ceiling of the naves (Fig. 9c).

a) Crack between the windows and the coping  
 b) Crack in the access arches  
 Figure 6. Examples of damages inside the church.

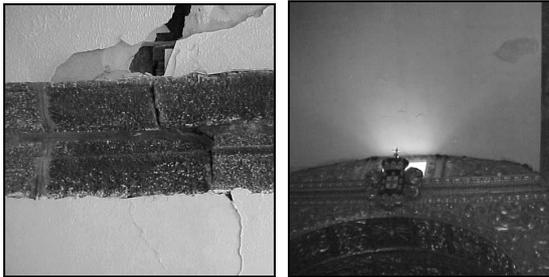
a) Cracking on the upper choir  
 b) Slight ceiling sag

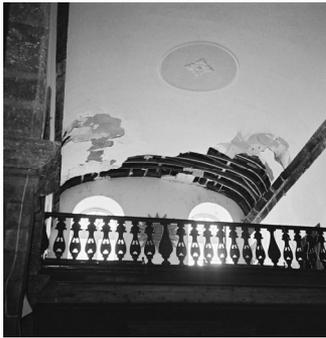
c) Stucco fell from the ceiling  
 Figure 7. Damages detected at the Madalena church.

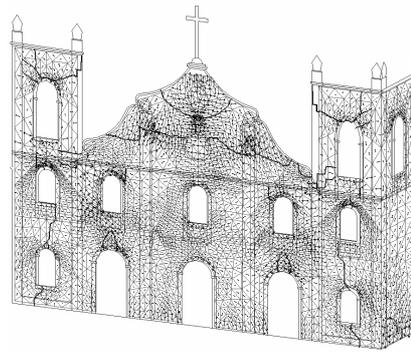
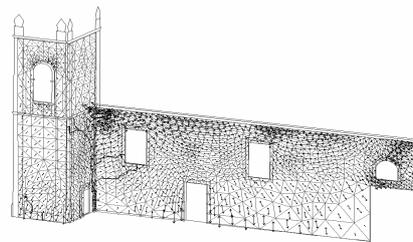
Figure 14. Principal tensile stresses directions (model A) and actually detected cracking pattern.

a) facades and towers

b) Right tower and right lateral wall

These results refer only to model A (without a roof) since, as already mentioned, it is closer to the real structure. The actually detected cracks in the structure were also plotted in the referred patterns, and it can be seen that the tensile stress vector distributions are denser in the zones surrounding those cracks. Figure 16a, in particular, shows the tension areas where the facade connects to the frontispiece (at the roof level) and in some of the tower and facade arches, whereas Figure 16b refers to cracking in the corner connection between the lateral wall and the tower.
