Seismic damage to churches: Observations from the 2011 Lorca (Spain) earthquake

SUMMARY:

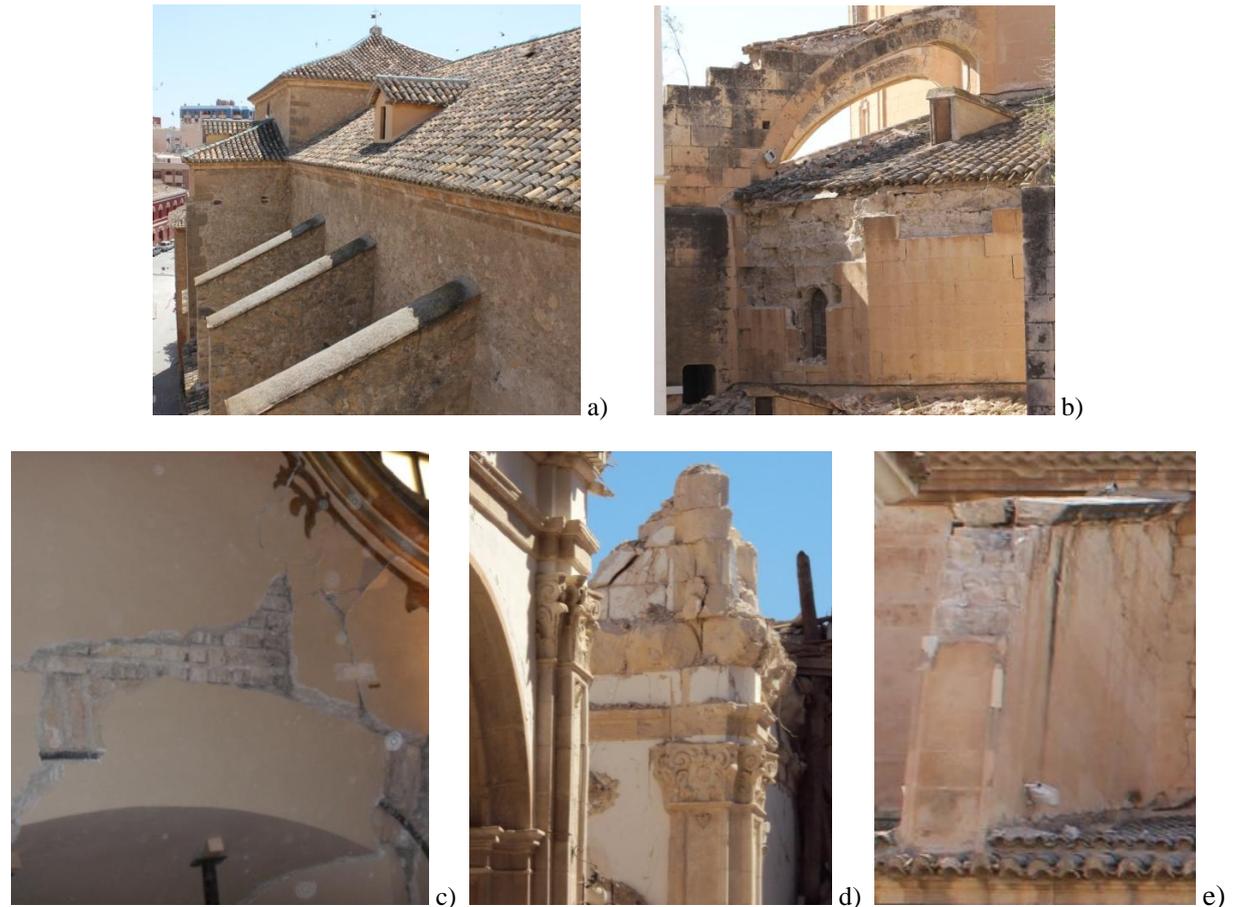
- Masonry type M1: Small and medium size irregular stones with mortar (Fig. 3a);
- Masonry type M2: Two-leaf wall with an outer leaf made of regular cut stone and an internal leaf made of small and medium size irregular stones with mortar (Fig. 3b);
- Masonry type M3: Brickwork (Fig. 3c);
- Masonry type M4: Regular cut stone (Fig. 3d);
- Masonry type M5: Three-leaf wall with regular cut stone leaves of similar thickness (Fig. 3e).

Figure 3. Masonry type M1 at the church of San Francisco (a), M2 at the cathedral of San Patricio (b), M3 at the chapel of N.^a Sr.^a do Rosário (c), M4 at the church of Santiago (d) and M5 at the cathedral of San Patricio (e).

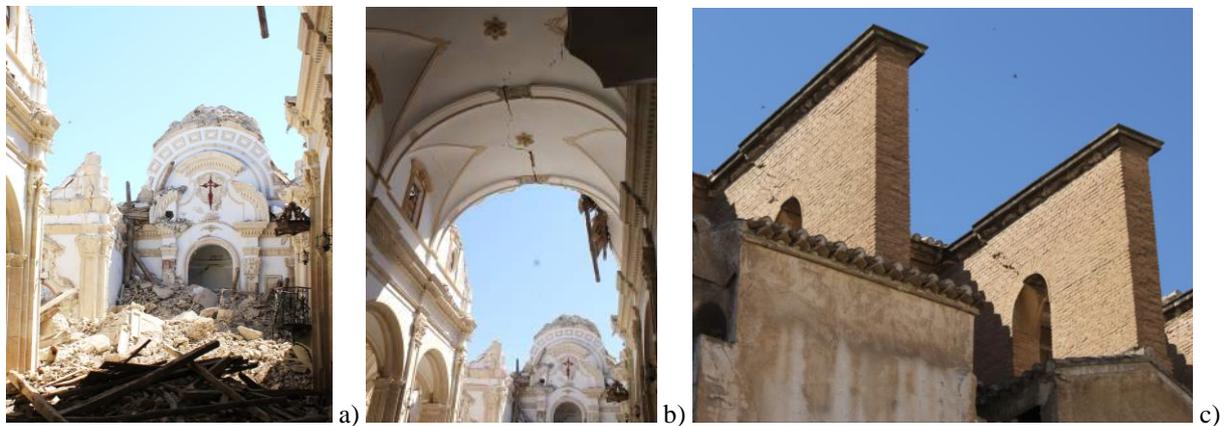
Figure 4. Damages to I2 after the collapse of the chancel and of the transept area, including the dome (a) and (b), and extensive cracking of the buttresses (c).

The most severely damaged church was seen to be I2, due to the collapse of the chancel and of the transept area, including the dome (Figs. 4a and 4b), but other significant damages were also observed such as the extensive cracking of the buttresses (Fig. 4c). The tower of this church was also severely affected due to the occurrence of extensive vertical cracking and loss of confinement of the keystones of the belfry arches. At the time of the visit, an emergency confinement with steel ties along the height of the tower was already in place. Since the construction system of church I1 was seen to be similar to that of I2, the level of damage observed in I1 was surprisingly low. The most relevant damages in I1 resulted of decorative elements of the roof and the façade that fell, namely some of them that fell over the roof of the apse. Other damages include displacements of the keystones of the arches of the first level of buttresses, as well as the detachment of the outer leaf of the exterior walls at some parts.

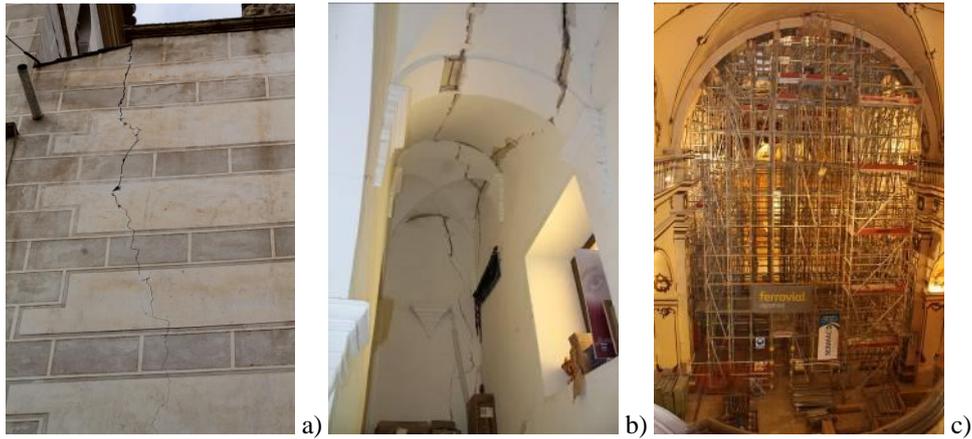
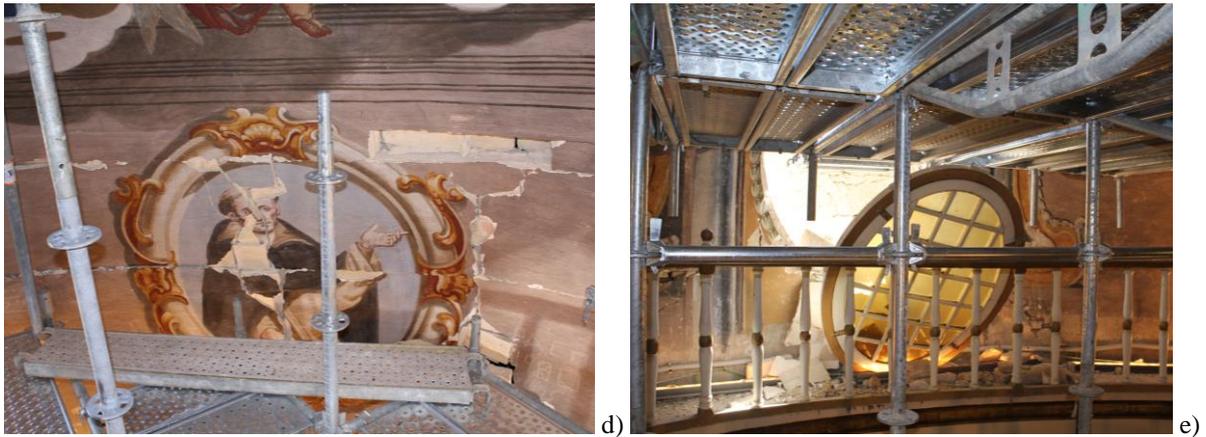
A surprising situation was also observed with respect to the very different damage levels found in churches I3 and I4, which are side-by-side. While church I3 was severely damaged and exhibited extensive cracking in the walls, arches, vaults and in the dome (Fig. 5), church I4 displayed almost no signs of damage, with the exception of some minor cracking on the back wall. Since the masonry type of these two churches is very similar, and assuming that the founding soils are also comparable, the difference between the damage levels of both churches is assumed to be largely caused by the previously referred vertical irregularity of church I3 which differs from the more regular shape of I4. Although the authors believe the damage differences are mainly due to this factor, other aspects can also influence the damage distribution, e.g. the churches might have different foundation types (an aspect for which there was no available information at the time of the visit).

Figure 5. Damages to I3 showing cracking in the façade (a) and in the interior walls and arches (b), emergency shoring of the dome (c), and damages to the dome (d) and (e).

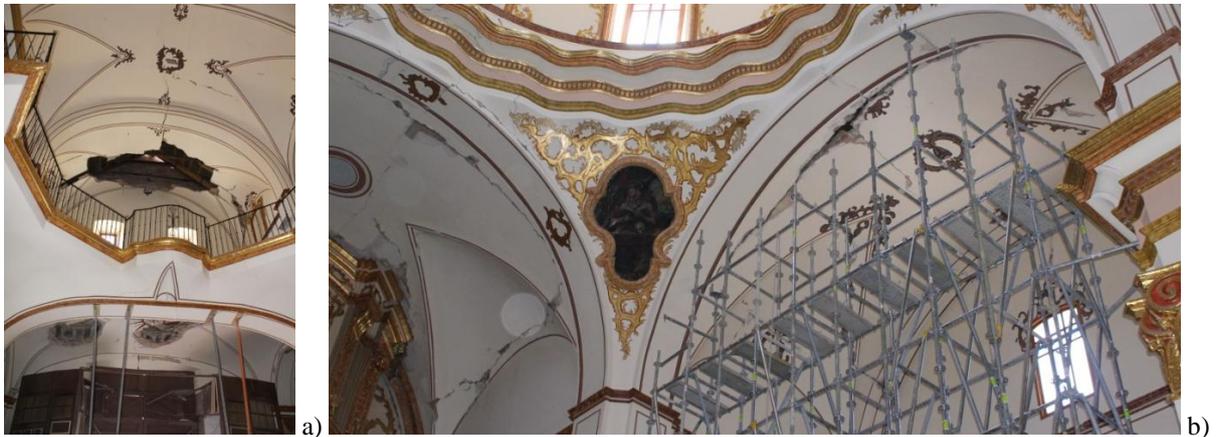
Figure 6. Damages to vaults of I6 from decorative elements that fell (a), detachment of vaults and arches (b).

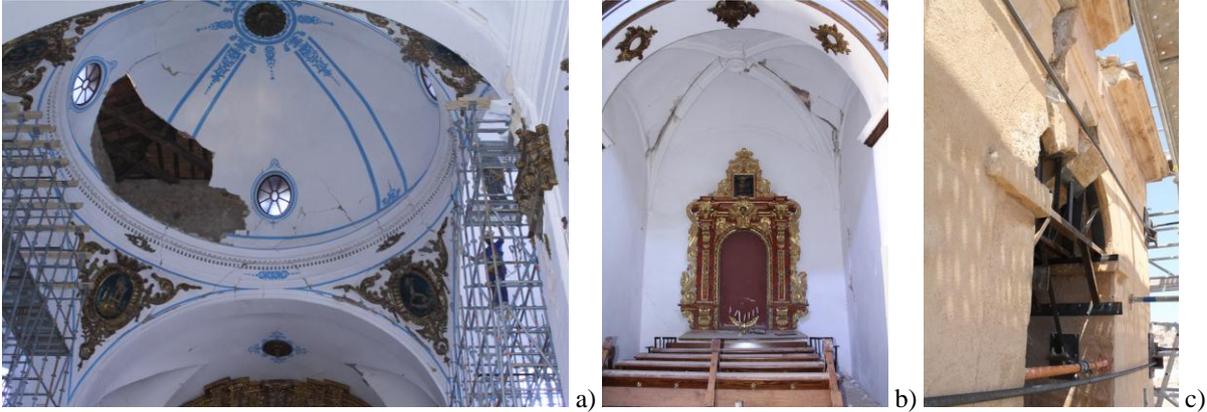
Church I5 was also extensively damaged, particularly the dome, the vaults and the arches of the transept area which were seen to be in a state of near collapse (Figs. 7a and 7b). At the time of the visit, several temporary shoring structures were in place to avoid further damage and the total collapse of these elements. The tower of I5 also showed significant levels of damage, namely deep vertical cracks in the lateral walls and large vertical displacements of the keystones of the belfry arches (Fig. 7c). At the time of the visit, an emergency confinement with steel ties over the height of the tower was also in place, along with shoring structures for the keystones of the belfry arches.

Figure 7. Damages to the dome (a) and lateral chapels (b) of I5, and vertical displacements of the keystone of one of the belfry arches of the tower (c).

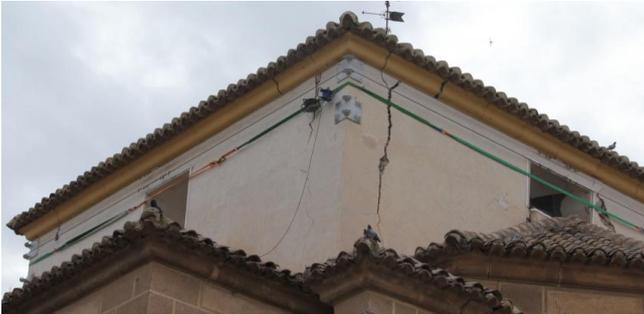
Figure 8. Damage and emergency confinement on the walls that surround the dome of I3.

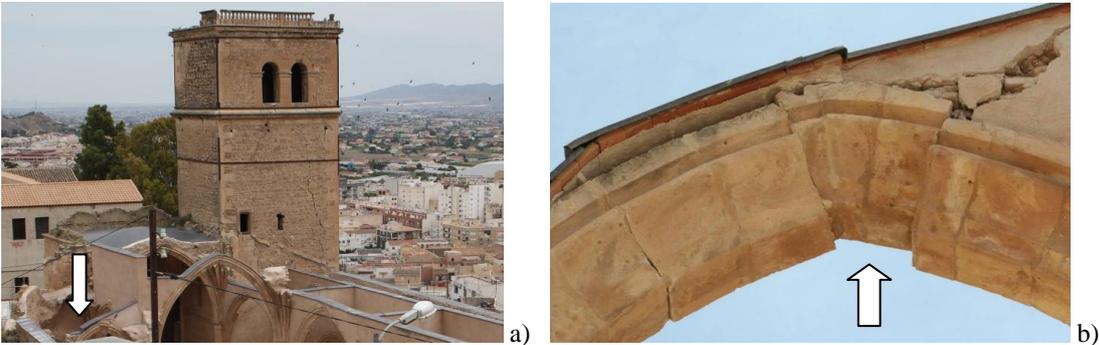
According to Lagomarsino (2012), these components are among the most vulnerable elements of a church and can be significantly damaged even for low intensity earthquakes due to the dynamic amplification of the ground motion as a result of the church characteristics. For example, the bell cell of church I3 was so extensively damaged that authorities decided that it would be best to demolish it. As referred in Table 2, churches I3, I5 and I7 have domes enclosed by lateral walls and topped by a hipped roof. This architectural feature can also be the source of additional damage to the domes if such walls are damaged by extensive cracking that may lead to their detachment, thus making them vulnerable to out-of-plane failure. Although such situation was not observed in churches I5 and I7, the damage on the walls that surround the dome of church I3 (Fig. 8) was seen to be significant and, at the time of the visit, an emergency confinement of such walls with steel ties was also in place. Finally, a reference is made to an uncommon damage found in the ruins of the church of Santa Maria (located north of I1). Although no other damages were apparently caused by the earthquake, the keystone of one of the arches (Fig. 9) seems to have been uplifted by the ground shaking.

Figure 9. Ruins of the church of Santa Maria (a) and damage detail showing the uplift of the keystone of one of the arches due to the earthquake (b).

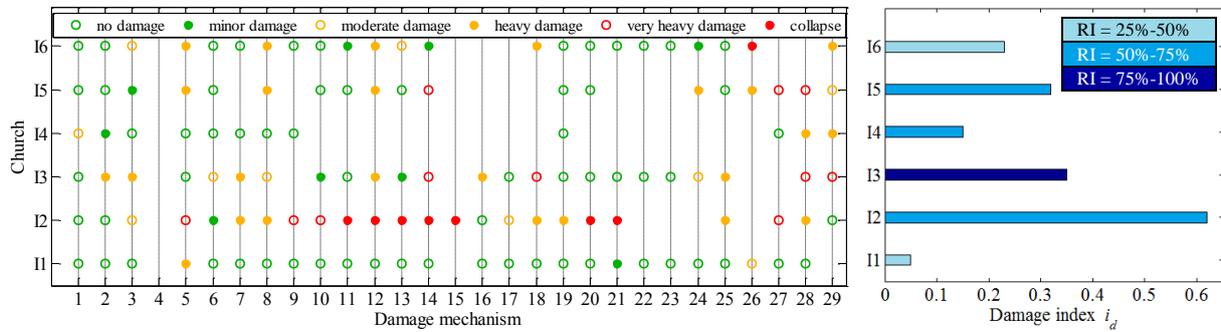
The damage grade and the i_d results obtained for churches I1 to I6 are presented in Fig. 10. The values of i_d are coloured according to their value of RI. The results of Fig. 10 indicate that, with the exception

of I2, the churches underwent only minor/moderate levels of damage in most mechanisms. Hence, the values of i_d are relatively small. Still, Lagomarsino (2012) indicates that when $i_d > 0.3$, churches are found unfit for use. According to Fig. 10, churches I2, I3 and I5 are also found unfit for use, a scenario which agrees with the decisions made by Spanish authorities. Although its i_d value is only 0.23, church I6 was also considered unfit for use by the Spanish authorities. Given the value of RI for I6, its value of i_d (< 0.3) could be seen as a consequence of its lower RI, thus emphasizing the importance of the information involved in RI and the need to consider such issue in a future review of the procedure.

Figure 10. Damage grade of each mechanism and global damage index i_d for churches I1 to I6.
