1 **Degradation induced by recycled Construction and Demolition Wastes**
2 **on the short-term tensile behaviour of two geosynthetics**

11 **ABSTRACT**

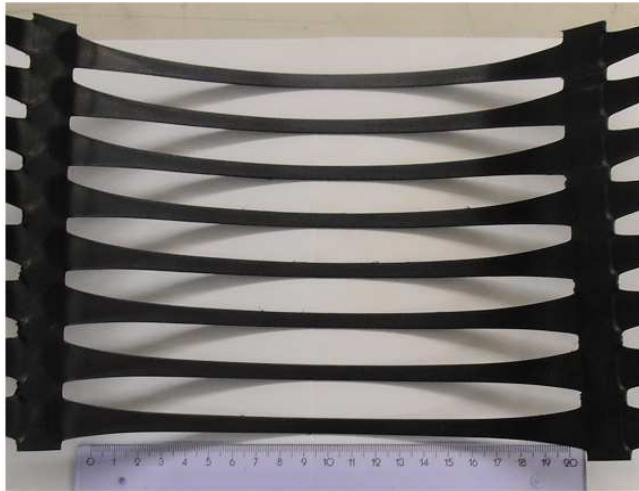
162 Two commercial available geosynthetics frequently used as reinforcement were used
163 in this study: an extruded uniaxial high density polyethylene (HDPE) geogrid (Figure
164 1a) and a high-strength composite geotextile consisting of polypropylene continuous-
165 filament needle-punched nonwoven and high-strength polyester yarns (unidirectional
166 geocomposite reinforcement) (Figure 1b). Table 1 summarizes the main properties of the
167 geosynthetics provided by the manufacturers.

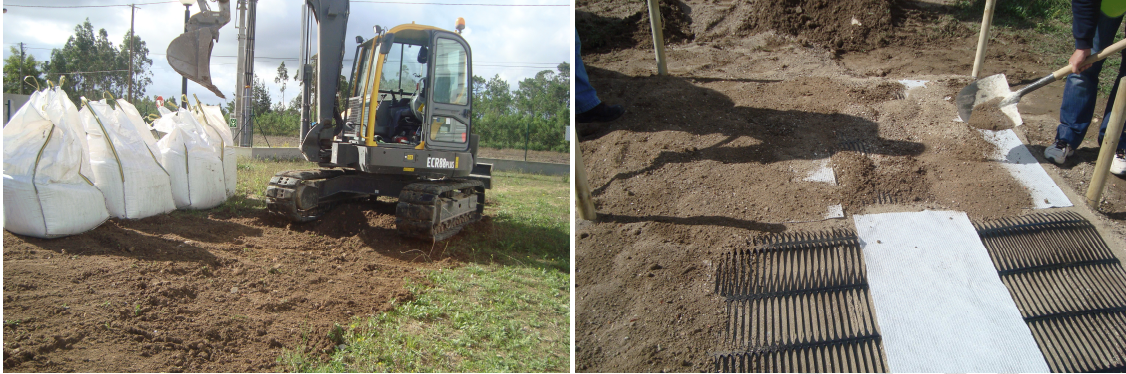
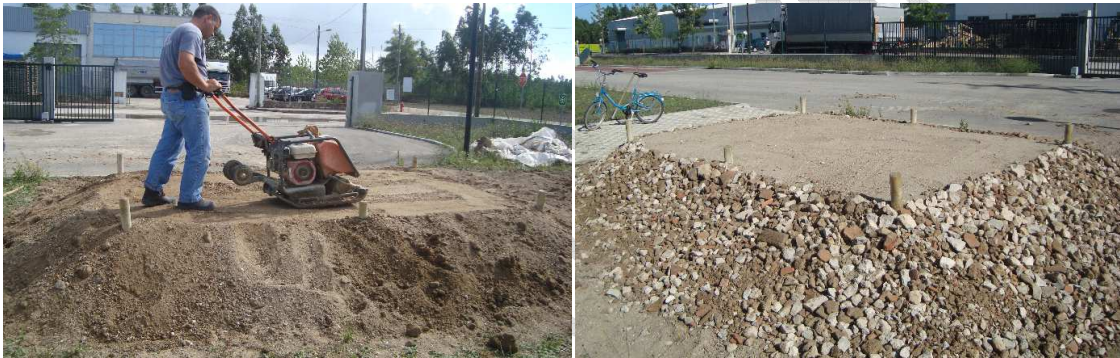
727 Figure 4 - Trial embankment construction: a) cleaning of the foundation; b) manual

228 After cleaning the foundation from the existing vegetation (Figure 4a), a 0.05m high
229 layer was placed and compacted. Eight geosynthetic samples (4 geogrid samples and 4
230 geocomposite samples) were carefully positioned without overlapping. Geosynthetic
231 samples were covered with a first layer of C&DW placed manually to prevent
232 mechanical damage (Figure 4b). Then additional quantities of C&DW were disposed,
233 evenly spread and compacted to reach a lift with final thickness of 0.20 m.

234 The compaction was performed with a forward compaction plate with weight of
235 94 kg, plate dimensions of 450 mm x 696 mm, static pressure of 382 kg/m² and
236 optimum vibration force of 16.5kN at 92Hz (Figure 4c).

240 The lateral slopes of the embankment were also compacted with the forward
241 compaction plate and aggregates from recycled C&DW were deposited to prevent
242 erosion by rain water (Figure 4d).

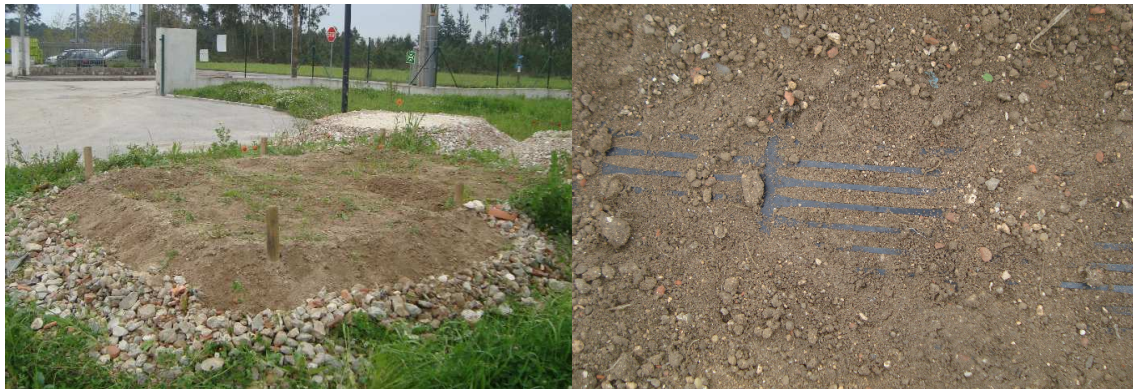
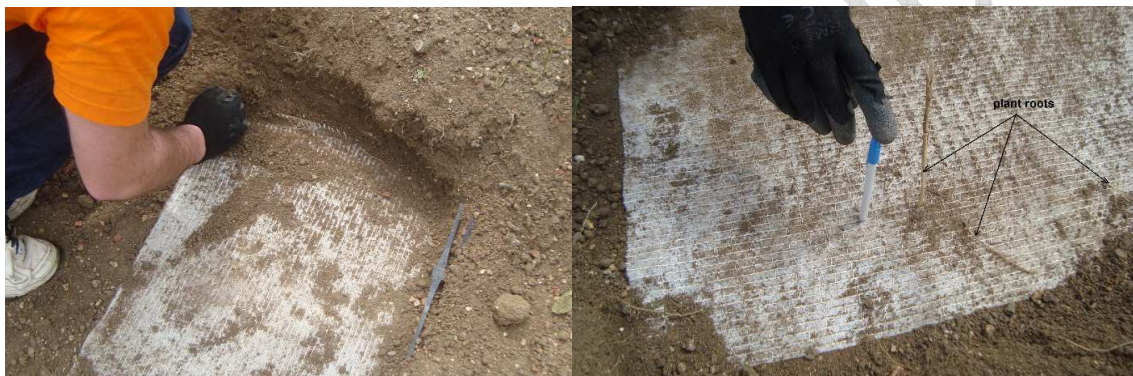
255 The exhumation began with the removal of the aggregates placed on the lateral
256 slopes of the embankment, as well as, the vegetation that grew up over the embankment
257 (Figure 5a). Then the fill material was manually removed with hoes and shovels until
258 reaching the geosynthetics (Figure 5b), being the material just above the geosynthetics
259 removed carefully with the hands (Figure 5c).

260 From the visual inspection, the geogrid did not show significant damages (visible to
261 the naked eye). Geocomposite samples were damaged by plant roots that crossed the
262 geotextile, some of them with a few millimetres in diameter (Figure 5d). The exhumed

380 The unchanged tensile stiffness modulus observed on the geocomposite suggests that
381 after 6 months of exposure the damage induced in the polyester yarns could be
382 neglected, even if some damaged was observed in the base geotextile (Figure 5d and
383 Figure 7d).

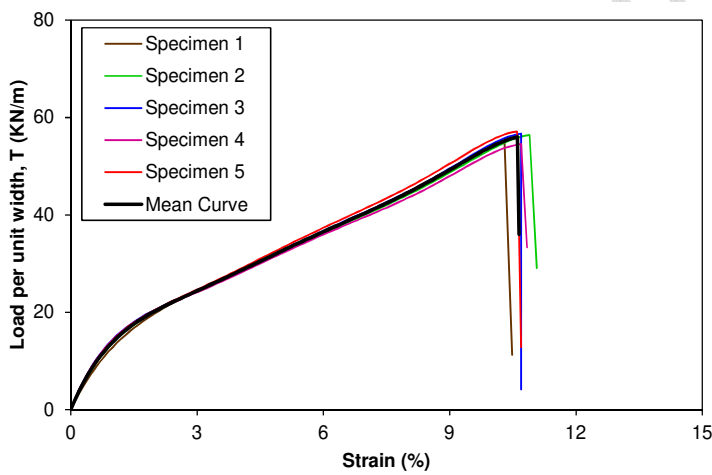
781 b) exhumed geogrid specimens.

296 Figure 8 presents load-strain curves of intact geogrid and exhumed geogrid
297 specimens subjected to tensile tests carried out according to EN ISO 10319 (2008). It
298 would be expected that the variability of the results for exhumed specimens would be
299 greater than that of intact specimens, due to the different mechanisms that could
300 contribute to the geosynthetics damage. However the results presented in Figure 8 and
301 summarised in Table 4 and Table 5 contradict this assumption. In fact tensile tests
302 carried out with intact geogrid specimens have shown great variability, even so the
303 coefficient of variation for the tensile strength was smaller than 4.2%. This variability is
304 usual and it might be attributed to the production process.
