Formal and functional analysis of contemporary interventions in multifamily housing buildings from the mid-twentieth century. The case of the Cerco housing complex (Porto)

L. Rocha & R.F. Póvoas

University of Porto - Faculty of Architecture: Centre for Studies in Architecture and Urbanism (CEAU-FAUP), Porto, Portugal

R. Amoêda, S. Lira and C. Pinheiro (eds.). *HERITAGE 2020*

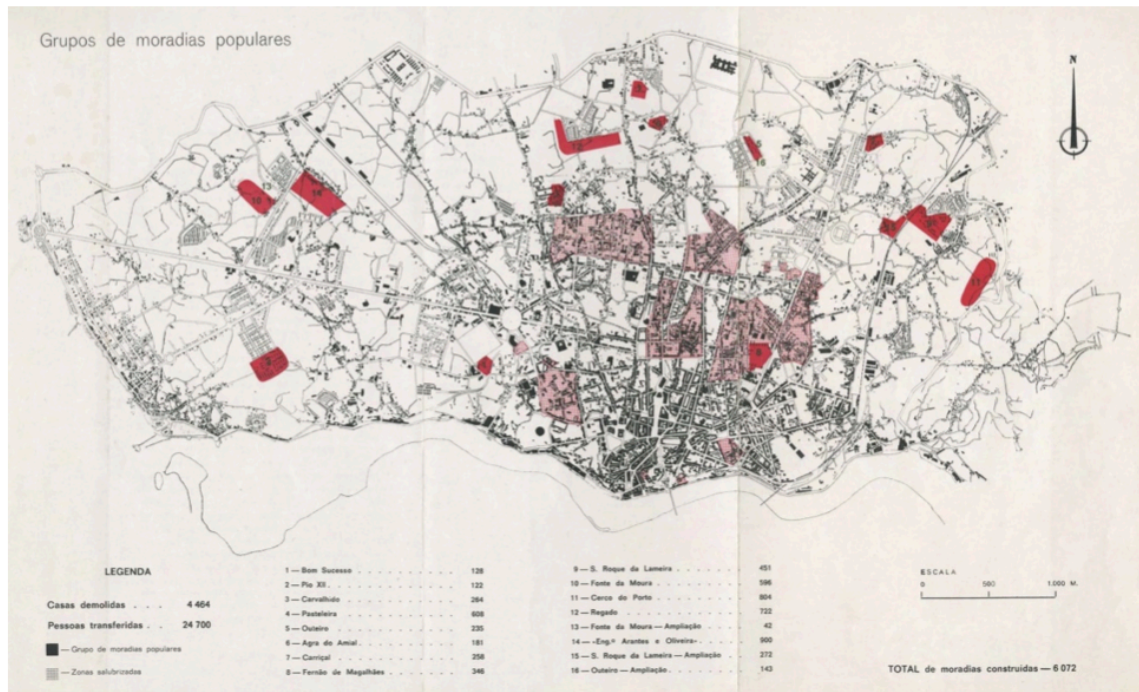
Fig. 1. 'Improvement Plan' for the city of Porto. Location of housing complexes (CMP, 1966:17)

The ‘Improvement Plan’ for the city of Porto (*Plano de Melhoramentos: CMP, 1966*)¹ (Fig. 1), developed by engineer José Albino Machado Vaz and approved in 1956 by Decree-Law N° 40616 of 28 May (MOP, 1956), arose as a possible response to the city’s housing problem and marked the beginning of a new phase in its urban development (Queirós, 2016:41).

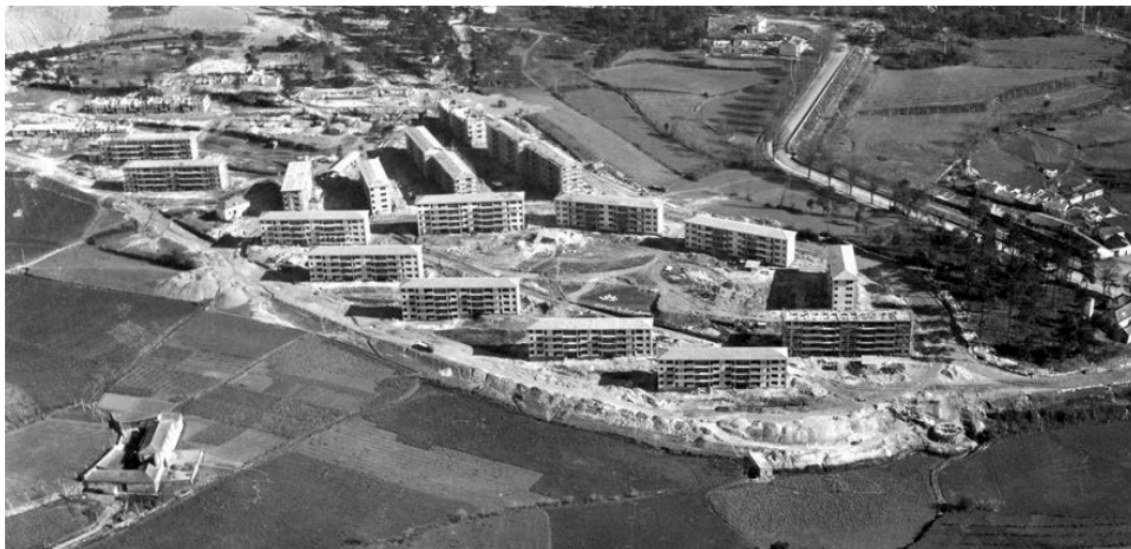
Fig. 2. Cerco housing complex. Construction phase, 1961 (Arquivo Histórico Municipal do Porto)

The construction system reflects a transitional period of the mid-twentieth century characterised by the combined use of structural stone and wood, with an increasing use of reinforced concrete and other industrial constructive elements (Vale & Abrantes, 2012). In the specific case of the *Cerco* housing complex, the buildings displayed simple exterior walls of structural stone ma-

sonry, solid concrete slabs and interior partitioning in the form of brick masonry walls. The sloping roofs were covered in ceramic tiles, consisting of a wooden support structure, with possible brick masonry bracing.

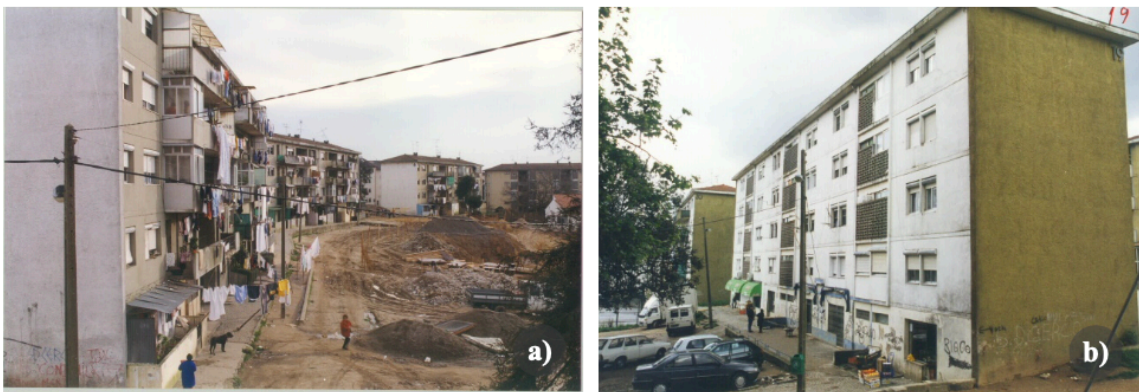
Fig. 3. The neighbourhood before the intervention (Domus Social E.M.)

The diagnostic report produced by the architect Virgínio Moutinho prior to the first intervention, in 1996, describes the main negative and positive factors that informed the first design project. These points identify the main problems and/or potentialities that existed at that time in relation to this housing ensemble, which had already been in place for more than three decades (Fig. 3). The main difficulties highlighted by the architect were the evident degradation of the buildings and the inadequacy of their functional programmes, as well as the disruption that had been caused to the surrounding public space, without any hierarchical structure or public support equipment. Such issues are usually associated with the population that is faced with significant social and economic problems (Moutinho, 1996:1).

The same diagnosis underlined the significant dimension of this public space, stressing the quality and variety of the green spaces and wooded areas, as well as the structure of its road system (Moutinho, 1996:1), which seemed to provide an adequate response to the needs of the housing complex. The report also focused on the community spirit and the esteem that the inhabitants felt for their neighbourhood, as shown by the treatment that was given to some common spaces, such as the gardens (Moutinho, 1996:1). These considerations formed the basis for the first phase of interventions.

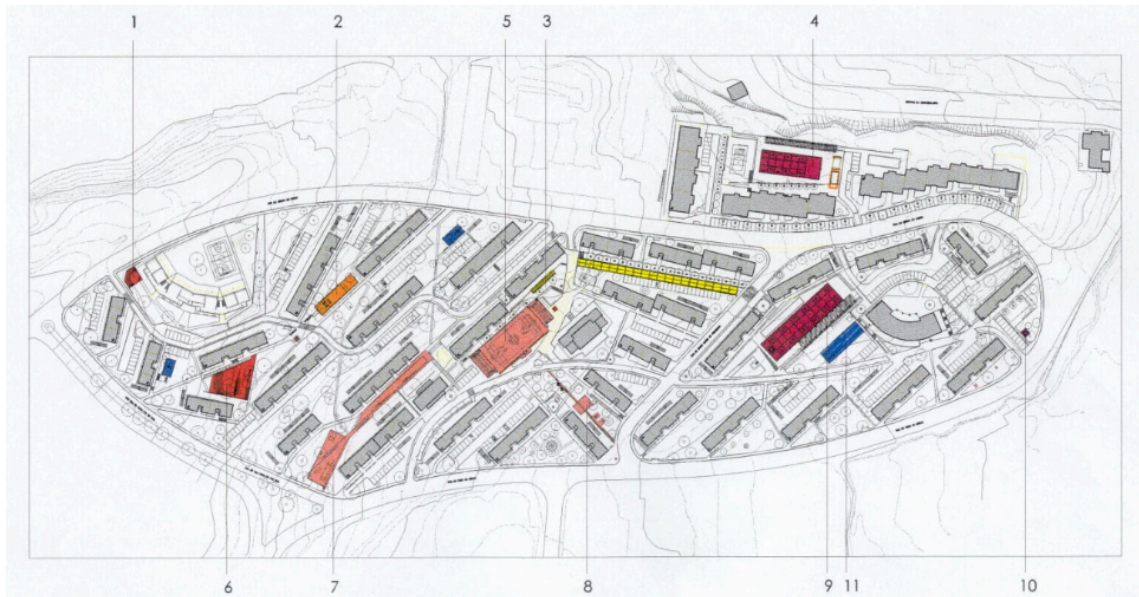
Fig. 4. General plan of the first intervention (Domus Social E.M.)
[1. School; 2. Activity Centre; 3. Market; 4. Square; 5. Sports complex; 6. Open-air amphitheatre; 7. Extreme sports area; 8. Climbing wall; 9. Plaza – Coffee and pergola; 10. Kiosk; 11. Children's playground]

The first intervention on the *Cerco* housing complex, undertaken by the architect Virgínio Moutinho (Fig. 4), was based on three essential aspects: the regeneration of the public space; the inclusion of neighbourhood equipment; and the general rehabilitation of the buildings. This general intervention thus sought to address the main problems of the neighbourhood, such as the advanced state of degradation of the buildings and the adjacent exterior areas and the lack of available spaces for collective use, as explained previously. The interventions that focused on the exterior spaces were designed to revitalise the neighbourhood and, simultaneously, enhance its relationship with the city (Moutinho, 1996:1-2).

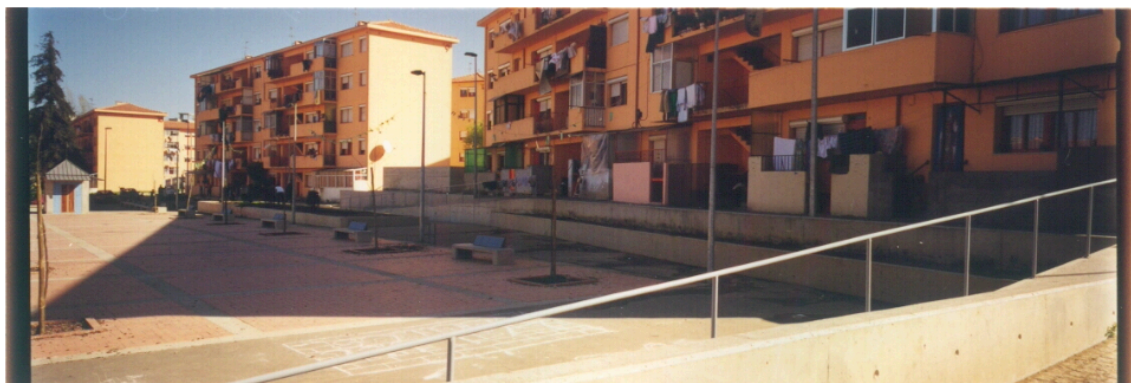
Fig. 5. First intervention. General view (Domus Social E.M.)

The intervention on the buildings focused mainly on the external envelope, which included the treatment of façades with reinforced plaster, the repair of roofs, the replacement of window frames (aluminium), the enclosure of certain areas, such as the laundry rooms and access to the building

and the integration of standardised awning solutions (Fig. 5). This intervention was notable for its use of bright colours, both in the painting of the façades, as well as in the tiles that were placed in the laundry rooms and the decorative panels of handmade tiles that were placed on the buildings' gables. According to the architect, this different treatment was designed to break away from the previous solutions and, mainly, to guarantee that each building had its own separate identity (Moutinho, 1996:4-5).

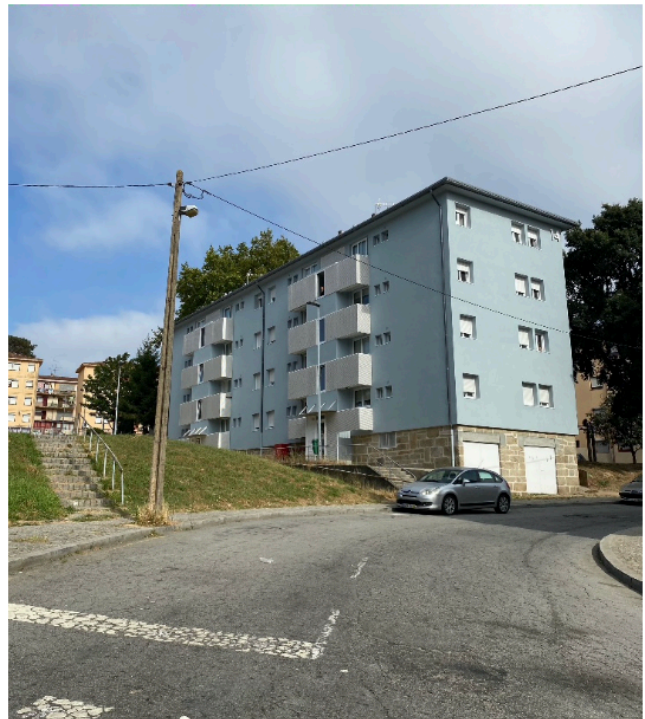
Fig. 8. Intervention by Virgínio Moutinho (Luciana Rocha, 2020)

Other significant actions involved the replacement of the exterior window frames with lacquered aluminium, with thermal shutters, a built-in ventilation system and the enclosure of the balconies and laundry rooms with aluminium frames and ventilation grilles, which also serve to hide the drying racks. These grilles, which are composed of a tubular structure and lacquered aluminium shutters, are a notable feature of the composition of the new elevations (Fig. 8).

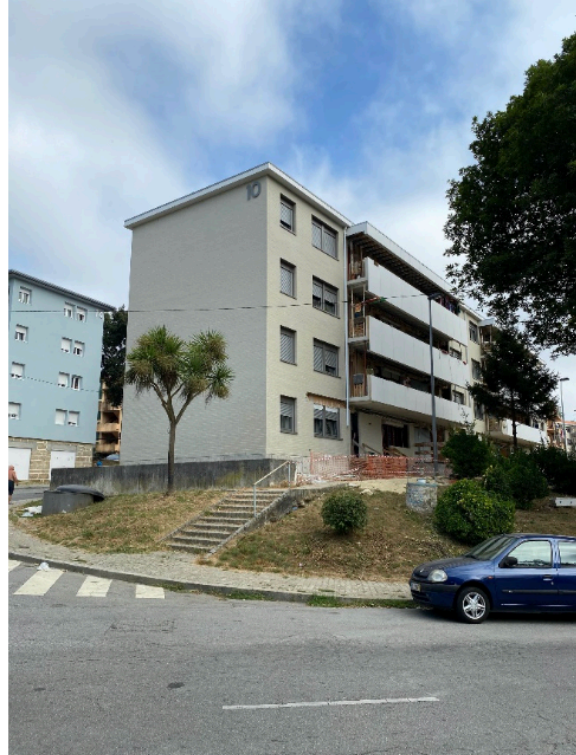
Fig. 11. Intervention by José Gigante. Block 10 (under construction). (Luciana Rocha, 2020)

The remaining interventions on the external envelope include the replacement of the original wooden window frames (already damaged or illegally altered) with double-glazed aluminium window frames, aluminium blinds with polyurethane insulation and ventilation grilles. The project also provides the application of metallic structures in the laundry room windows to support the drying area (Fig. 11).

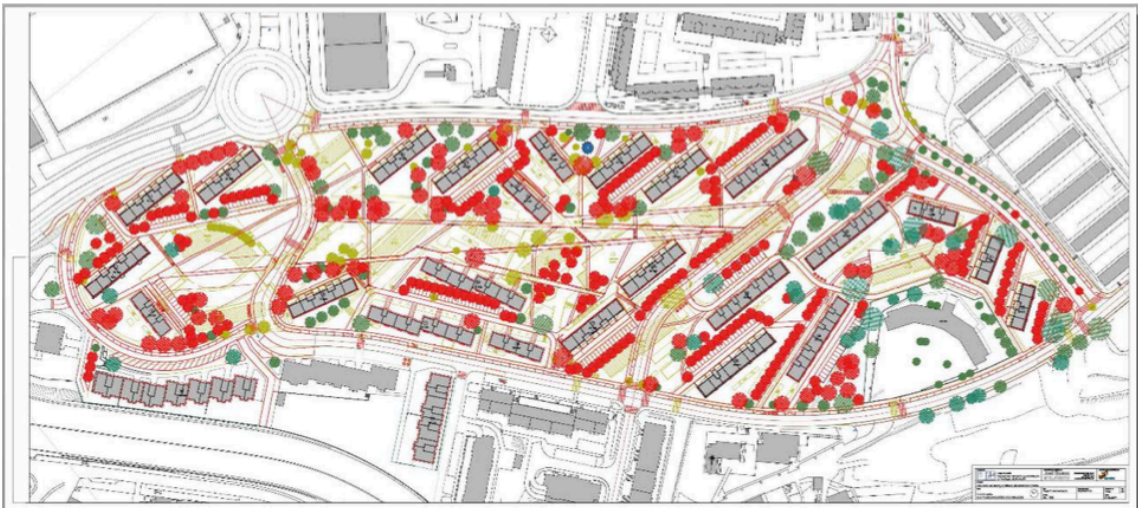
Fig. 12. Intervention by José Manuel Soares. General plan with alterations ©Domus Social E.M. [Red: to build; Yellow: to demolish]

The project thus includes a series of interventions that are mainly related with the definition of the pavement surfaces (circulation areas in tarmac, parking areas in granite cubes and kerbs in prefabricated concrete), the increase in the number of parking spaces, the resolution of the slopes in the circulation areas and access points, and the implementation of urban furniture (billboards, bus stops, recycling areas and waste disposal bins) and special elements (benches, walls, stairs, among others). One of the main functions of this intervention consists in adapting the neighbourhood, insofar as possible, to the legislation governing accessibility and the fire safety regulations (Fig. 12 & Fig. 13).

The implementation of this project would, however, result in the demolition of eight buildings (with a total of 200 dwellings), as well as obsolete or degraded social facilities (the headquarters of a sports association, small constructions, an indoor football pitch and benches). As an alternative, the project envisages the future construction of a new building with 81 one-bedroom apartments for senior citizens with day care services, a cafeteria, laundry and parking.
