# **DETERIORATION OF CORK STOPPERS IN VINTAGE PORT WINE BOTTLES**

**MARIA JOÃO CARVALHO MOURA MAGALHÃES DE SOUSA**  
DISSERTAÇÃO DE MESTRADO APRESENTADA  
À FACULDADE DE ENGENHARIA DA UNIVERSIDADE DO PORTO EM  
ENGENHARIA QUÍMICA

**Symington Family Estates**

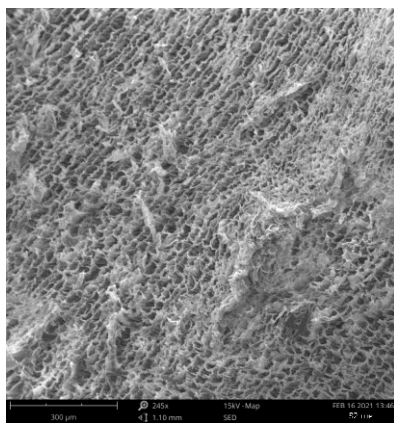
The analysis of the top section of the ten stoppers revealed no differences in terms of their microstructure (see APPENDIX B). Also, observing the images taken from samples S2 and S4 (Figure 11 and Figure 12), respectively the ones with highest extraction force and highest density, there seems to be no difference between them and the other bottled stoppers.

Figure 11 - SEM image of sample S2 at the top.
