# Root causes analysis of pitting corrosion in copper heat exchangers used in gas water heaters

Engineering Physics  
Department of Physics and Astronomy  
2022

Eng. Daniel Alfredo Mota, Senior Manager, Bosch Thermotechnology, S.A – Aveiro

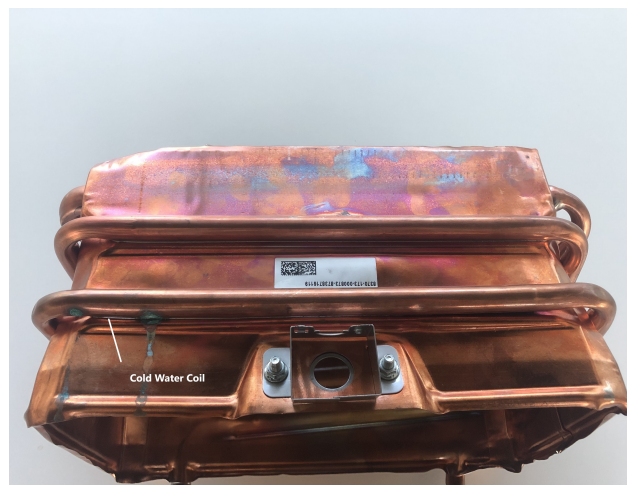
FIGURE 1.1: Illustration of the coil of the heat exchanger where 78% of the failures occur.

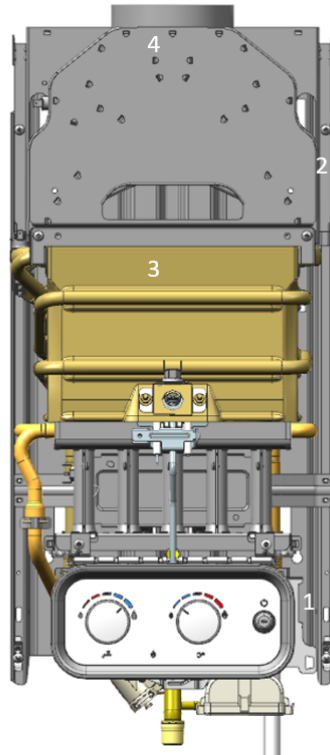
A gas water heater is an appliance powered by gas intended to perform the instantaneous heating of sanitary water. The common and usual structural composition of a gas water heater is divided into four large groups as shown in the following figure: (1) gas/water valve, (2) safety sensors, (3) heat exchanger and (4) draught diverter.

FIGURE 1.2: Structural composition of a gas water heater.

The heat exchanger represented by point 3 is responsible for heating the water in the circuit and is composed by the following components: skirt, cold water coil, hot water coil, U pipes and Fins. The skirt has a rectangular geometry and is helically wrapped by a cold water coil and a hot water coil. The helical shape of the pipes aims to cool the walls of the heat exchanger (skirt) avoiding phenomena such as thermal fatigue. In the upper region of the heat exchanger is the region where the most of heat energy is transferred from the burned gases to water.

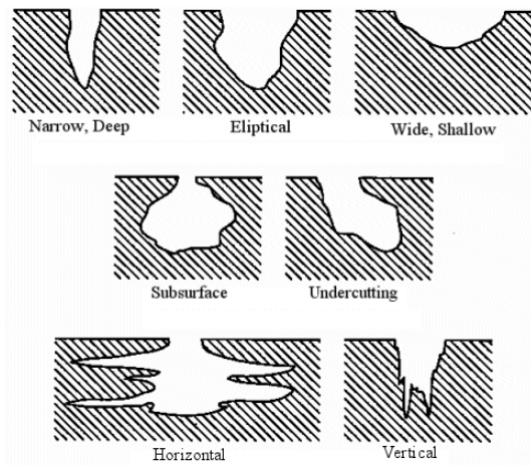
Pitting Corrosion is a form of localized corrosion that leads to the creation of small holes in the material [5]. Pitting Corrosion is widely known as one of the most dangerous types of corrosion because it is difficult to predict and detect (pits are often covered by corrosion products). In addition, it is difficult to measure quantitatively and compare the extent because of the number of depths and number of pits that occur in identical conditions [6]. According to ASTM G46-21 Standard [10], pits can have different morphologies depending on the metallurgy and chemistry of the environment and are sketched in figure 2.3. Pits can be narrow, elliptical, wide, subsurface, undercutting, horizontal or vertical.

FIGURE 2.3: Variations in cross sectional of pits. Adapted from ASTM G46-21 Standard [10].

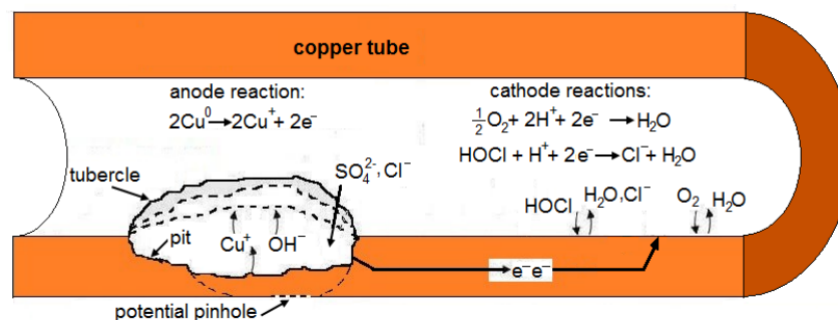
After initiation, propagation can be increased by differential concentration cell, due to changes that occur in a small region. According to Sarver, the pit water becomes very acidic due to Lewis acidity of released  $Cu^{+1}$  and  $Cu^{+2}$  ions, and salty due to the increasing anion (e.g.,  $Cl^-$  and  $SO_4^{2-}$ ) concentrations drawn into the pit to maintain electro-neutrality as illustrated by figure 2.5.

FIGURE 2.5: Simplified depiction of pitting corrosion of a copper tube. Electrons produced at the anode are consumed at the remote cathode. Adapted from [13].

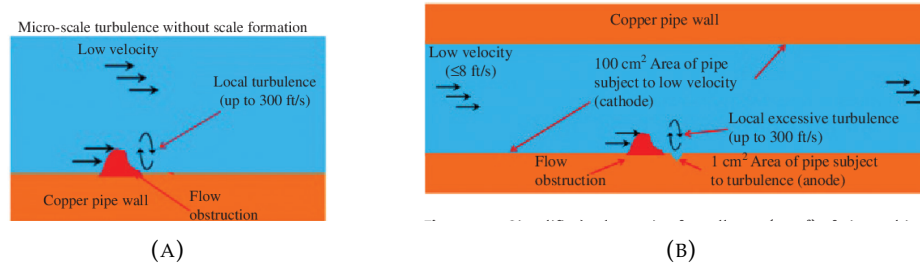
layer of copper oxides present on the inner surface of copper pipes as shown by figure 2.9. Variation of copper oxide layer specifications of smoothness, adhesion and stability has effects on copper corrosion resistance in running water environment.

FIGURE 2.9: (A) Schematic of localized high velocity and turbulence, which may form downstream from an obstruction. (B) Simplified schematic of a small area ( $1\text{cm}^2$ ) of pipe subject to turbulence and a large area ( $100\text{cm}^2$ ) of pipe subject to low velocity. Adapted from [29].

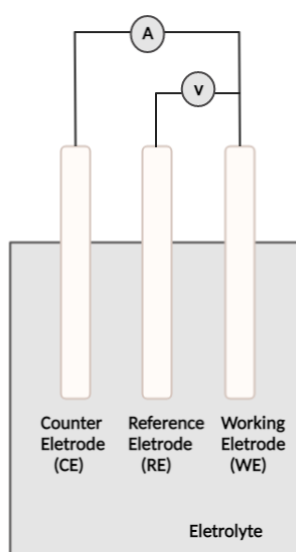
To obtain a potentiodynamic polarization curve, a potentiostat is required (more detailed information regarding the operation of the electronic circuit of the potentiostat can be found in Appendix A). A potentiostat is an electronic instrument that controls the voltage between a working electrode (WE) and a reference electrode (RE). The potentiostat implements this control by injecting current through a counter electrode (CE). The device controls the current between the working electrode (WE) and the counter electrode (CE) to maintain the potential difference between the working electrode (ET) and the reference electrode (ER) as shown in figure 2.10.

FIGURE 2.10: Schematic of three electrode setup.

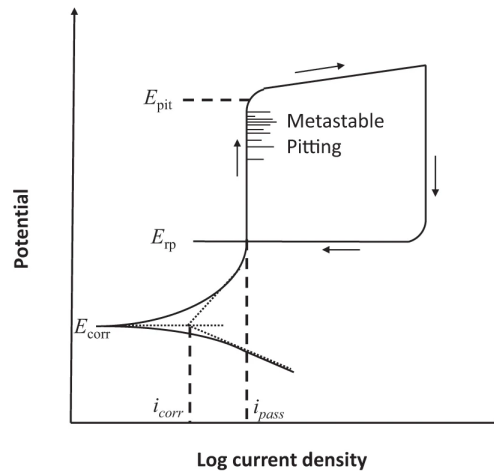
figure 2.11. The pitting resistance can be compared and predicted based on the magnitude of the values and the relative position of the pitting potential compared to the corrosion potential. If the value of the pitting potential is positive compared to the corrosion potential, the pitting resistance of the material is high [33].

FIGURE 2.11: Illustration of a polarization curve. Adapted from [33].

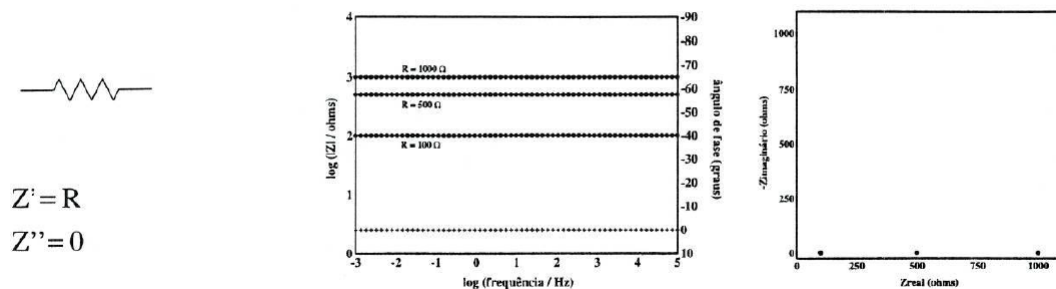
Using as examples R, L and C for simple electric circuits. The first equivalent element represented in table 2.2 is a resistor and impedance is a result of no phase shift ( $\phi = 0$ ) corresponding to R. There is visible in the Bode plot a constant parallel to abscissa as represented by figure 2.13 for resistances with  $R = 100 \Omega$ ,  $500 \Omega$  and  $1000 \Omega$ .

FIGURE 2.13: Bode and Nyquist Diagram for resistances  $R = 100 \Omega$ ,  $500 \Omega$  and  $1000 \Omega$ . Adapted from [36].

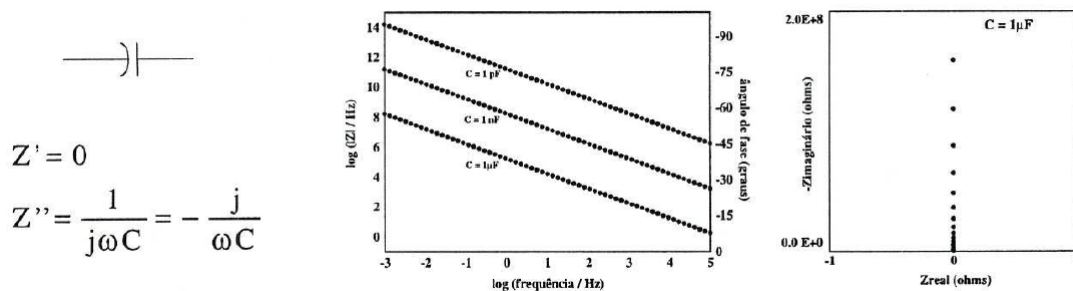
The second equivalent circuit represented in the table above is capacitance and is related to the double electric layer. Capacitance has the capacity to store charge. It is visible in the Bode plot represented by figure 2.14 capacitances with capacities of  $C = 1 \text{ pF}$ ,  $1 \text{ nF}$  and  $1 \mu\text{F}$ .

FIGURE 2.14: Bode for capacities  $C = 100 \text{ pF}$ ,  $1 \text{ nF}$  and  $1 \mu\text{F}$  (left) and Nyquist Diagram with  $C = 1 \mu\text{F}$  (right). Adapted from [36].

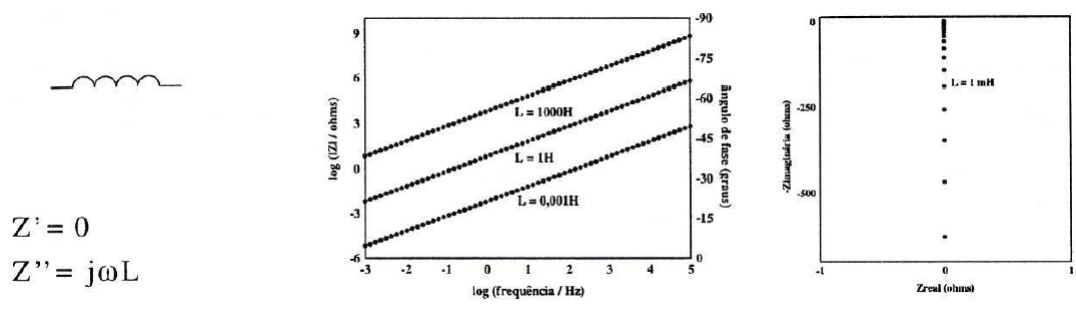
The third equivalent circuit represented in the table is inductance. Inductance has only an imaginary component and impedance is a result of phase shift ( $\phi = 90^\circ$ ) with respect to the voltage corresponding to  $j\omega L$  and is related to charge absorption. Figures 2.15 show different inductances for  $L = 1000 \text{ H}$ ,  $1 \text{ H}$  and  $0.01 \text{ H}$  (left).

FIGURE 2.15: Bode for inductances  $L= 1000\text{ H}$ ,  $1\text{ H}$  and  $0.01\text{ H}$  (left) and Nyquist Diagram with  $L = 1\text{ mH}$  (right). Adapted from [36].

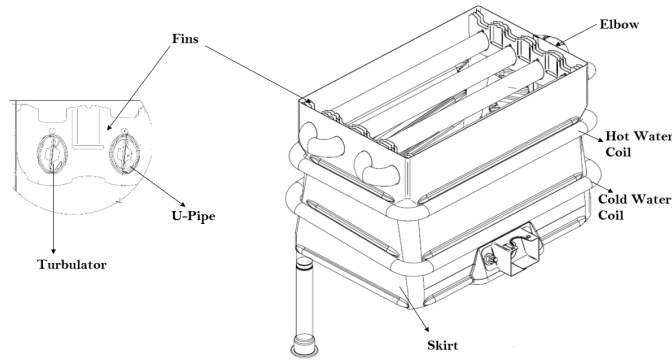
Structurally, a heat exchanger is made up of seven important components: skirt, cold water coil, hot water coil, fins, U-pipes, turbulator and elbows as illustrated by figure 3.1. The raw material of choice for heat exchanger manufacturing is copper, given its high thermal conductivity and high plastic conformability.

FIGURE 3.1: Structural composition of a heat exchanger used in gas water heaters.

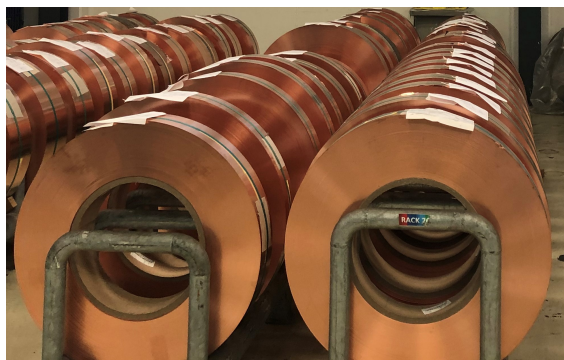
Copper, as shown in figure 3.2, is produced in a roller, which is formed and cut in a press, creating a "patina" (name assigned in the production section). The sheet is then folded and then opened to give the apron the desired shape. The joining of the sheet is done by a process called "stitching". In this process, the ends of the sheets are bent to intertwine them together.

FIGURE 3.2: Raw material used for skirt manufacturing.

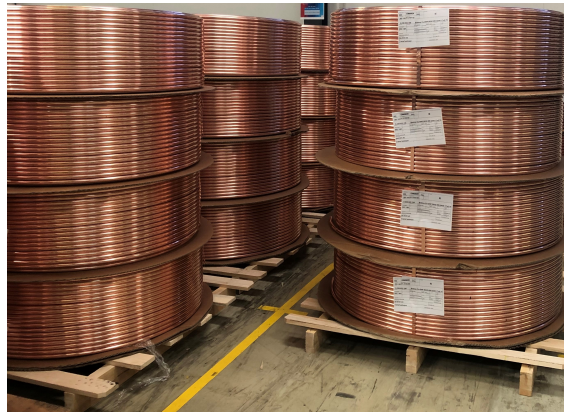
The raw material arrives at the production section in coils as shown in figure 3.3. The dimensions of the external diameter and thickness of the coils are  $13.00 \times 0.60$  mm, respectively.

FIGURE 3.3: Raw material used for coils manufacturing.

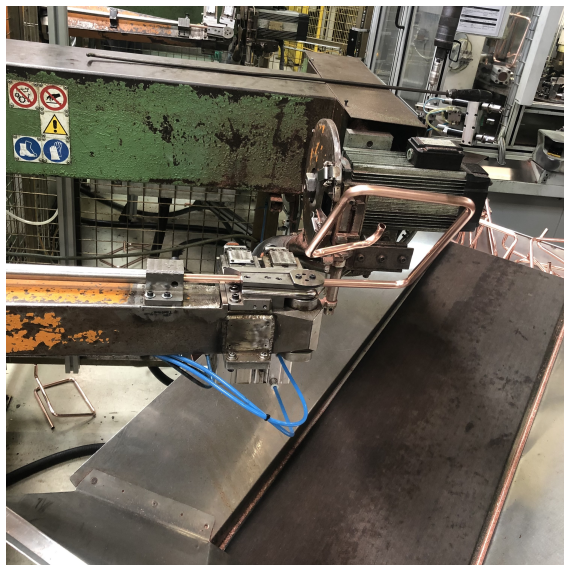
The coil is introduced by the employee in the corresponding coil production machine to carry out the desired design. The manufacture of hot and cold water coils is carried out in two similar machines, one of the machines designing the cold water coils and the other one for hot water represented in the figure 3.4. The machines mentioned above are based on a Computerized Numerical Control (CNC) that works in three axes: translation in x (the x value gives the value of each of the straight sections of the coil), rotation in y (the y value indicates the value of the angle that each of the straight sections makes with the fixed reference) and rotation in z (the value of z gives the angle that two straight sections give to each other) represented in figure 3.4.

FIGURE 3.4: Machine used for coils manufacturing.

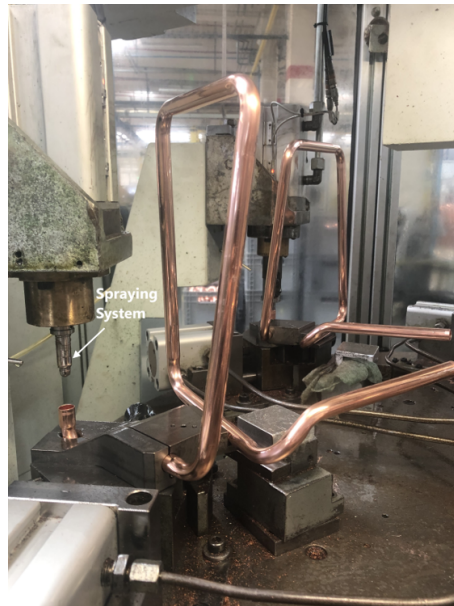
Next, the end of the cold water coil is squashed to allow it to fit into the upper region of the heat exchanger. The oil used for the conformation of the end of the cold water coil is Lubsec (the datasheet of oil is attached in appendix B). The application is made using a spraying system as shown in figure 3.5.

FIGURE 3.5: Cold water coil: flare formation.

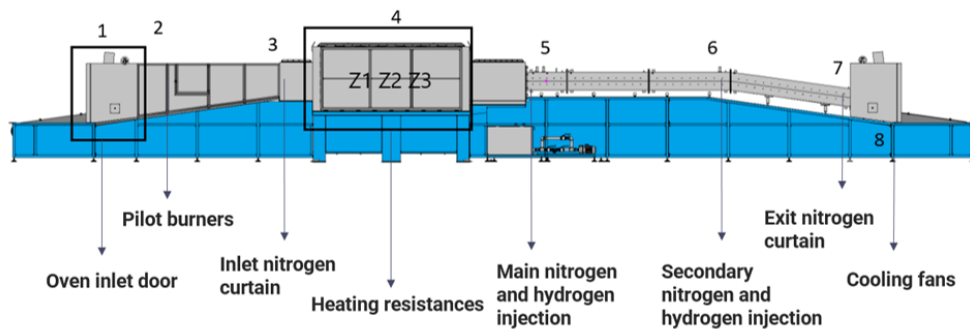
FIGURE 3.6: Schematic representation of oven used in the production section of Bosch Thermotechnology.

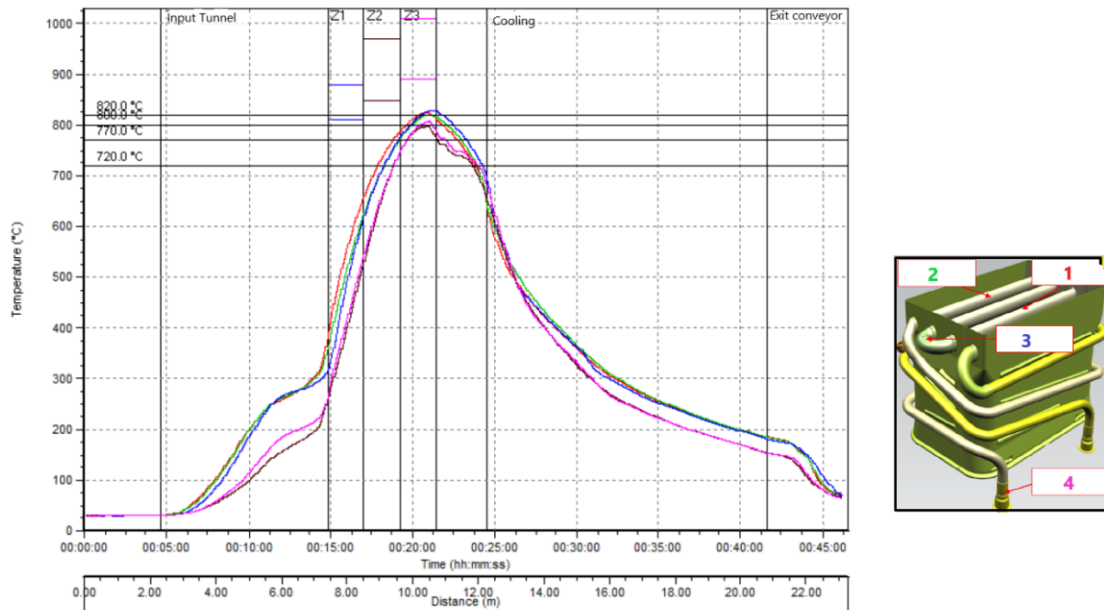
Point of application	Temperature (°C)
1	824.3
2	820.4
3	828.8
4	798.7

FIGURE 3.7: Schematic representation of temperature profile of oven used in production section and point of application of temperature sensors in the heat exchanger.

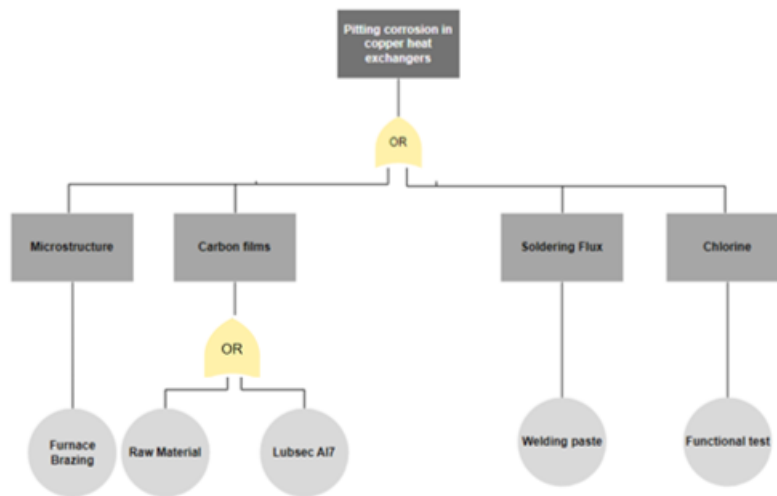
FIGURE 3.9: Fault tree analysis of manufacturing process: possible causes for pitting corrosion in copper heat exchangers.

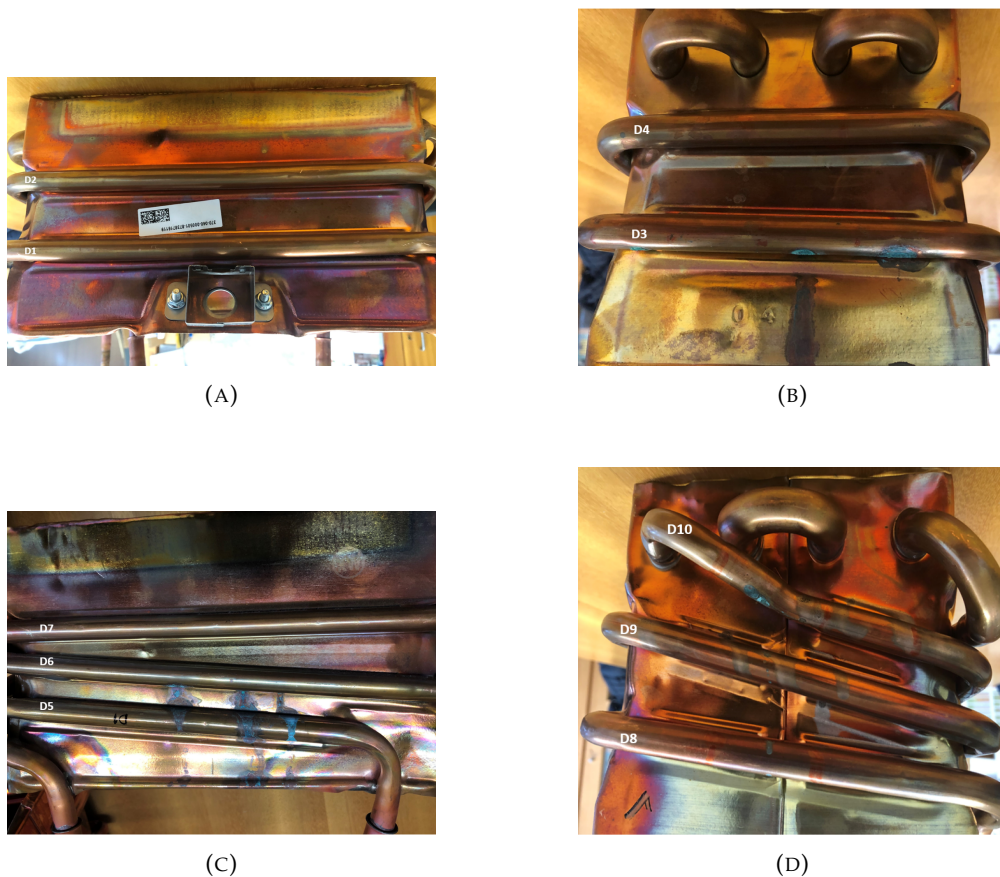
FIGURE 4.2: Different view of heat exchanger (A) Front view: sections identified as D1 and D2. (B) Lateral view: sections identified as D3 and D4. (C) Back view: sections identified as D5, D6 and D7. (D) Lateral view: sections identified as D8, D9 and D10.

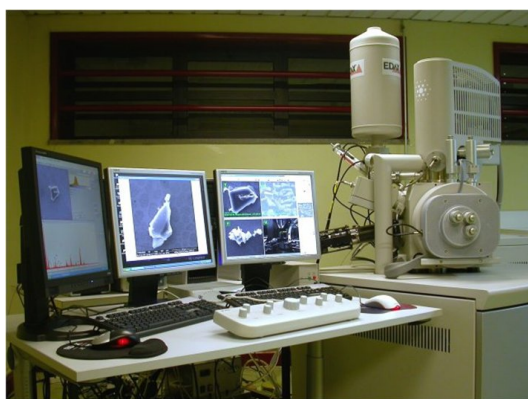
In order to study the morphology of the copper pits present in the internal surface of copper coils of a heat exchanger that was in operation SEM/EDS analysis was performed to observe the pits. The SEM is an equipment that uses highly energized electrons to scan the surface of the sample under study. Due to the interaction between the electrons and the sample, a variety of signals are generated, revealing the external morphology, chemical composition, crystal structure and orientation of the materials constituting the sample. Analysis of pits were carried out using SEM/EDS at Materials Centre of University of Porto (CEMUP), at the Imaging, Microstructure and Microanalysis Unit Laboratory (IMICROS). SEM/EDS analysis was performed on a high-resolution scanning electron microscope (Schottky) with X-ray microanalysis and backscattered electron analysis, using the FEI Quanta 400 FEG represented in figure 4.4.

FIGURE 4.4: CEMUP/IMICROS Scanning electron microscope. Adapted from [40].

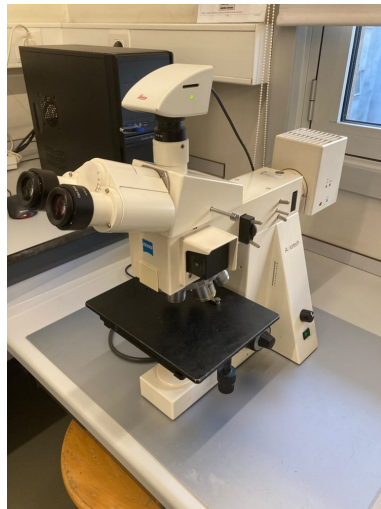
After chemical etching copper samples were observed by optical microscopy using optical microscope ZEISS Axiotech illustrated in figure 4.6. Photomicrographs of the samples were obtained with an image acquisition program Leica Application Suite (LAS) using CCD camera system coupled to the microscope. Observations and acquisition were carried out at the Department of Metallurgical and Materials Engineering of the University of Porto. Due to the impossibility of using the grain expert tool, which allows automatic identification of the grains, was used a manual image processing program, namely Image J.

FIGURE 4.6: Optical Microscope ZEISS Axiotech used to record different microstructures of copper samples.

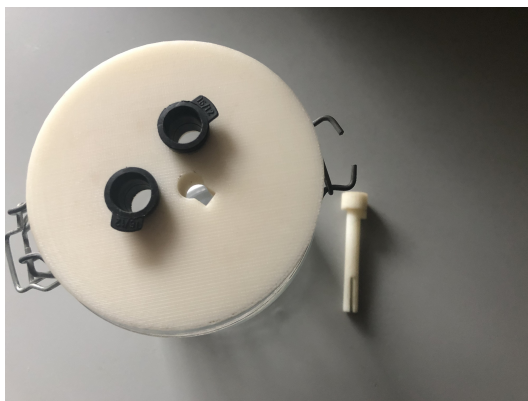
To carry out the electrochemical experiments, it was necessary to size the electrochemical cell and the sample holder represented in figure 4.9, given the morphology of the copper samples. The electrochemical cell was drawn ensuring that the distance between the electrodes is constant and that are relatively close together, the dimensions are in Appendix D.

FIGURE 4.9: Electrochemical cell and sample holder drawn for electrochemical experiments using as print material ABS P340.

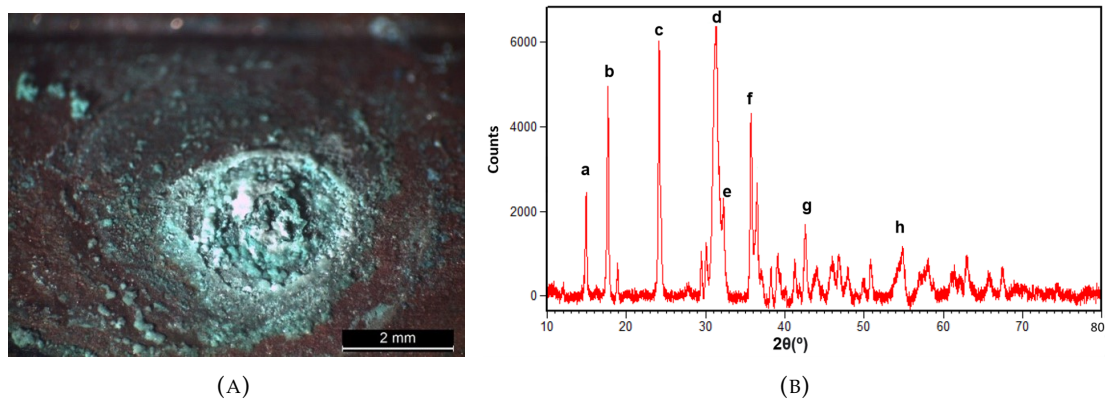
FIGURE 5.1: (A) Image of stereoscopic magnifier of corrosion products present on the external surface of heat exchanger (pit of section identified as D3). (B) The XRD spectra of green layer present on the external surface of heat exchanger corresponding to malachite ( $Cu_2CO_3(OH)_2$ )

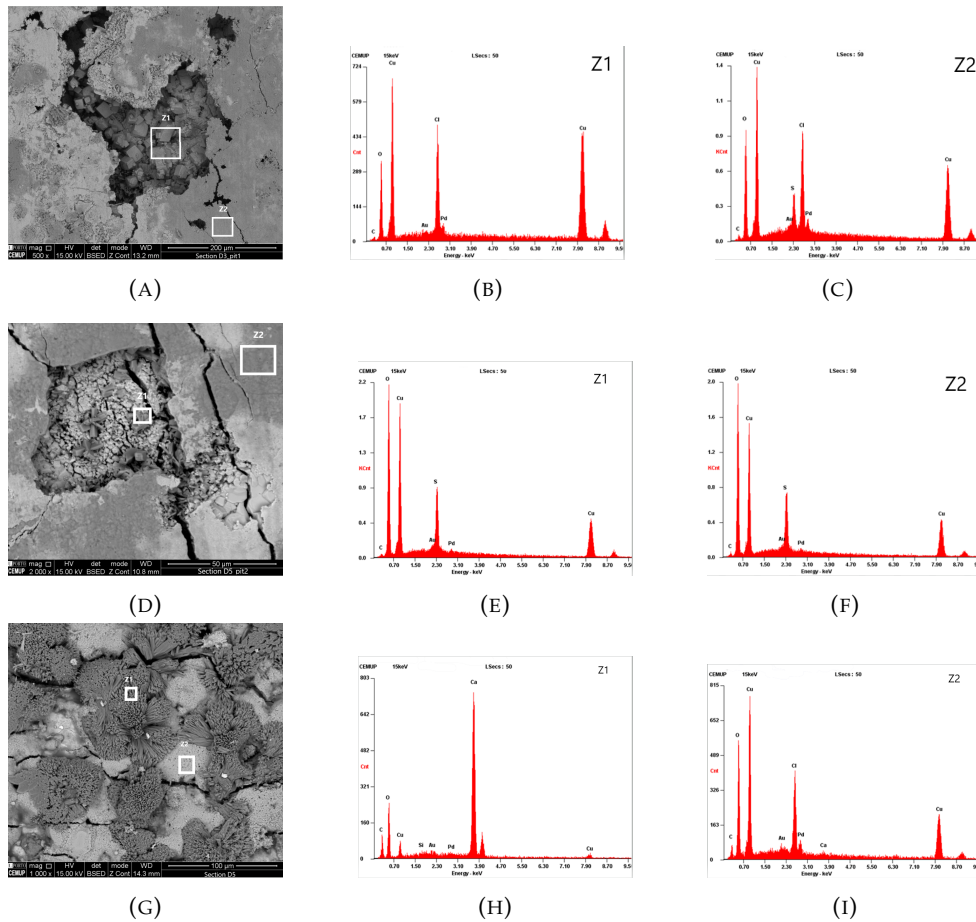
FIGURE 5.2: (A) SEM micrograph showing the region with pit from section D3 (cold water coil). (B) EDS spectra at the surface of pit. (Z1) confirming the presence of chlorine. (C) EDS spectra at the surface of pit (Z1) alongside pit. (D) SEM micrograph showing the region with pit from section D5 (hot water coil). (G) SEM micrograph showing the region without pit from section D5 (hot water coil).

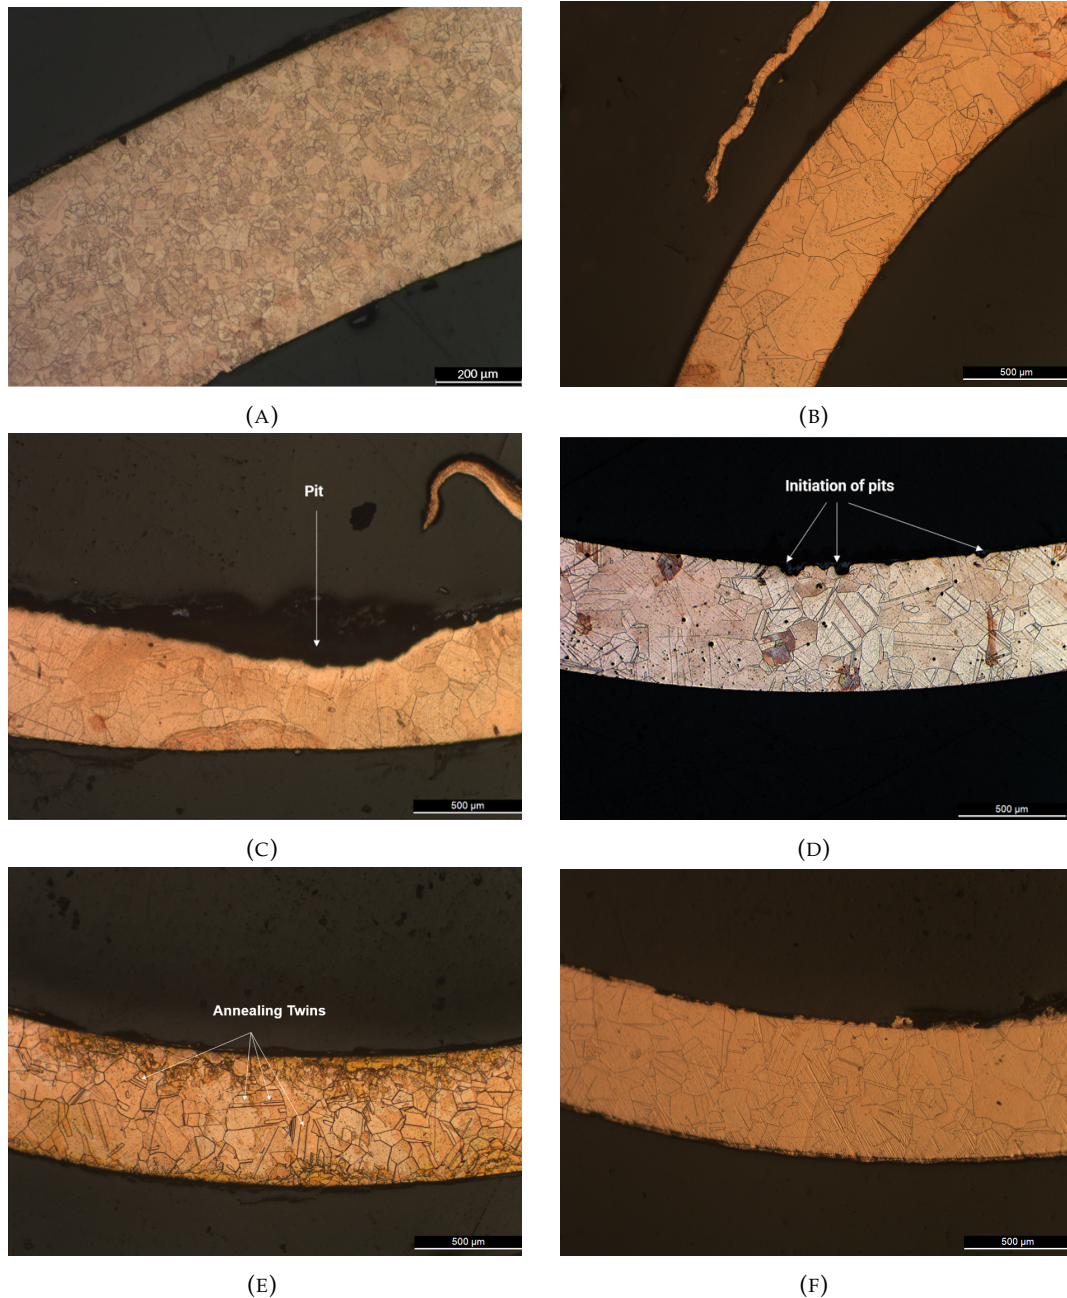
FIGURE 5.3: Microstructure of Sample (A) Cu\_Raw Material (before oven inlet) (B) Cu\_Furnace Brazing (after oven outlet) (C) Cu\_Operation\_pit1 (region of pit)(D) Cu\_Operation\_pit2 (region of pit initiation) (E) Cu\_Operation \_without pit1(region without pit) (F) Cu\_Operation \_without pit2 (region without pit).

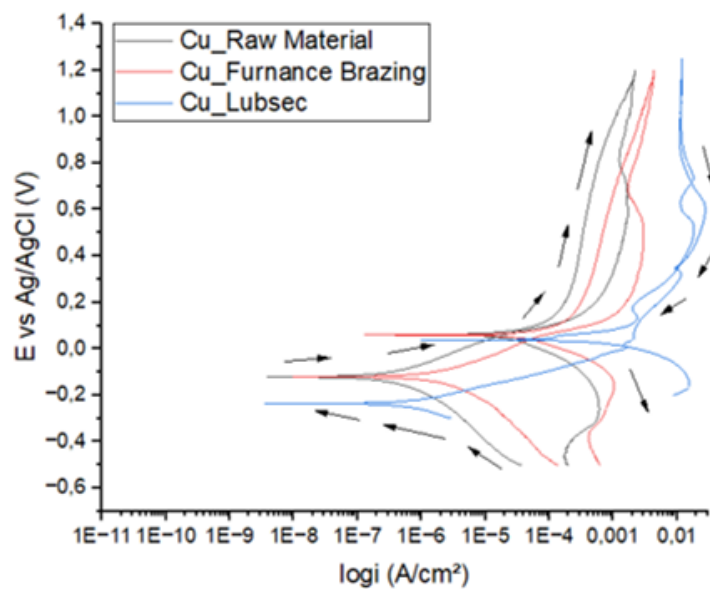
FIGURE 5.5: Graphic representation of polarization curve for sodium chloride (NaCl) for different samples: Cu.Raw Material, Cu.Lubsec and Cu.Furnace Brazing.

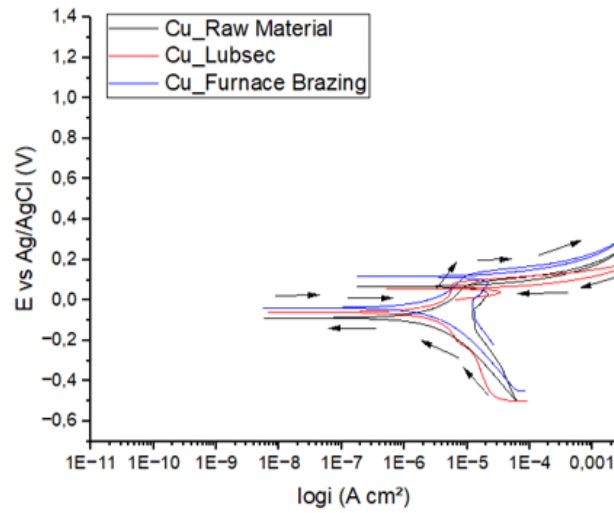
FIGURE 5.6: Graphic representation of polarization curve for 0.1 M of sodium sulfate ( $Na_2SO_4$ ) for different samples: Cu\_Raw Material, Cu\_Lubsec and Cu\_Furnace Brazing.

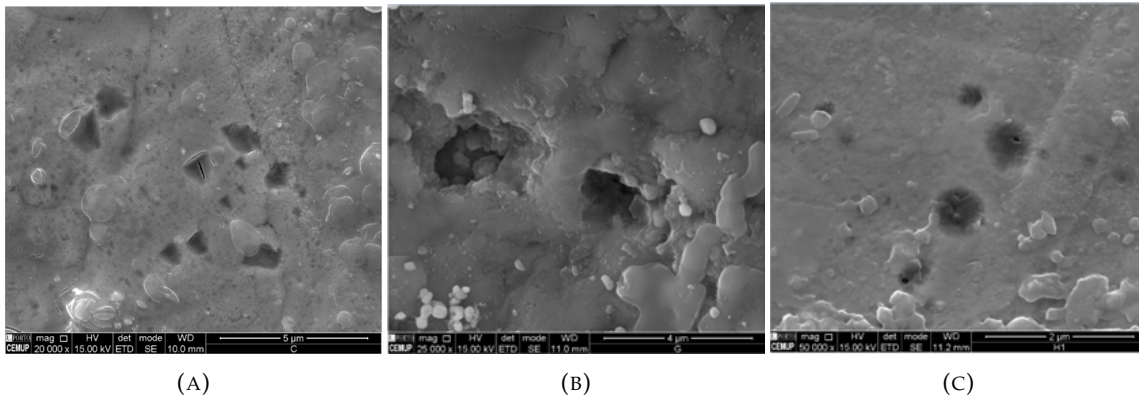
FIGURE 5.7: Copper samples after electrochemical experiments corresponding to (A) Cu\_Raw Material. (B) Cu\_Furnace Brazing. (C) Cu\_Lubsec.

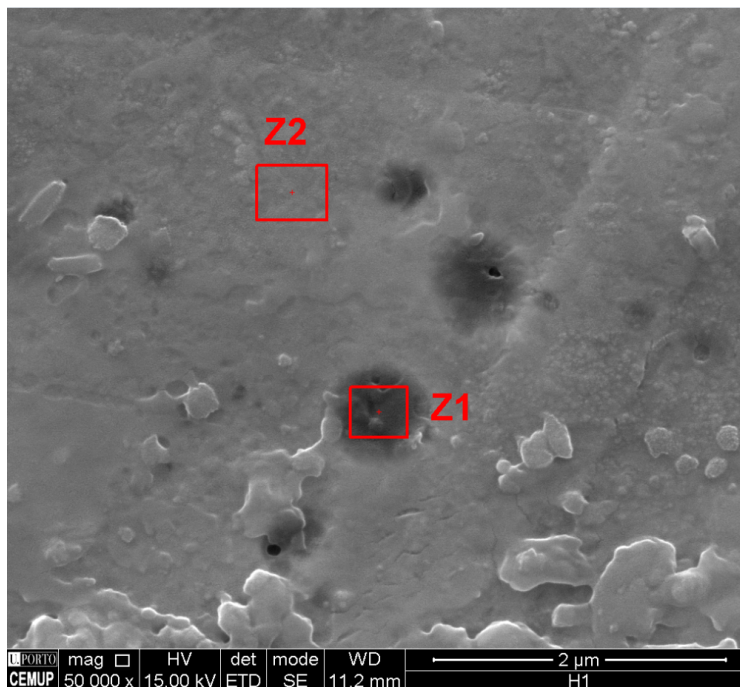
FIGURE 5.8: SEM micrograph corresponding to copper sample with 1 mL of Lubsec showing several pits.

In summary, was possible to identify root causes with this work and make suggestions at the level of the manufacturing process of the heat exchangers. It was suggested to wash the pipes to remove the residues of the lubsec oil and the improvement of water used in the functional tests.

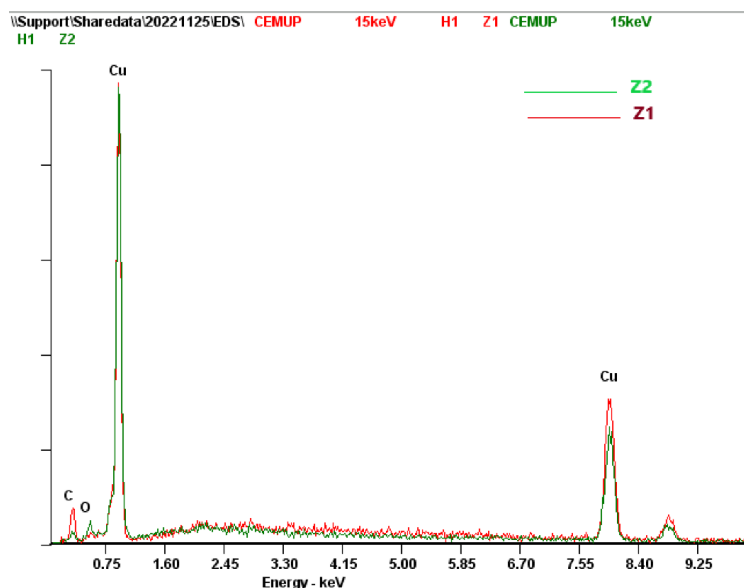
FIGURE 5.9: EDS spectra showing a higher amount of carbon in region Z1 (location of pit initiation) in comparison with region Z2 (region without pit).

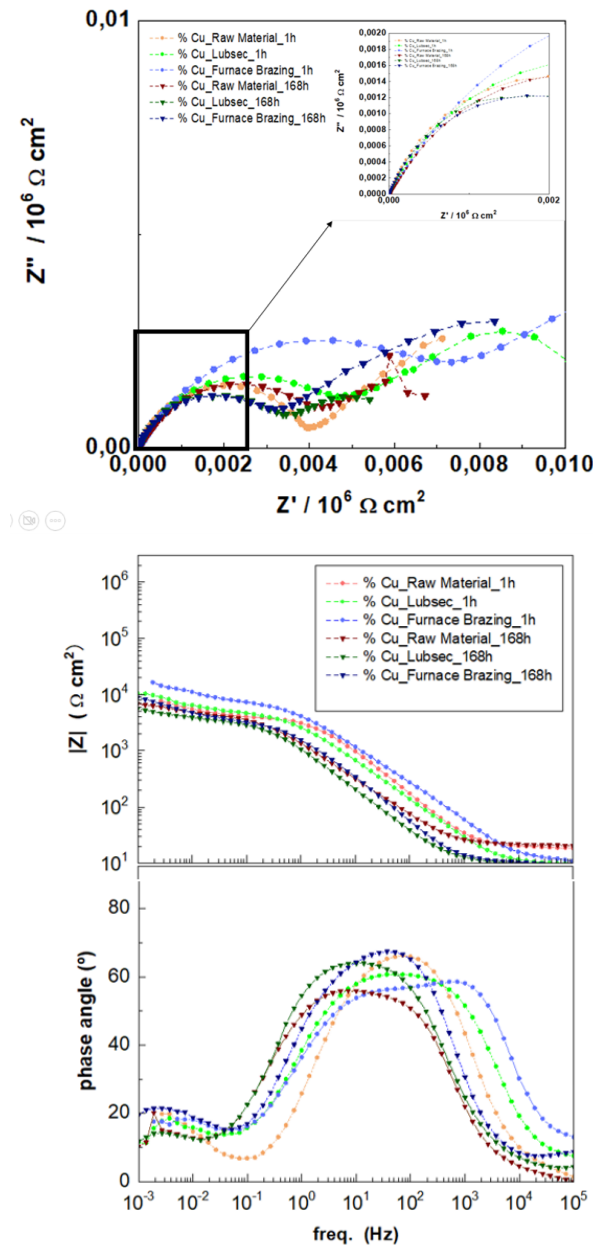
FIGURE 5.10: (A) Graphic representation of Nyquist Diagram for 0.6M of sodium chloride (NaCl). (B) Graphic representation of Bode Diagram for 0.6M of sodium chloride (NaCl).

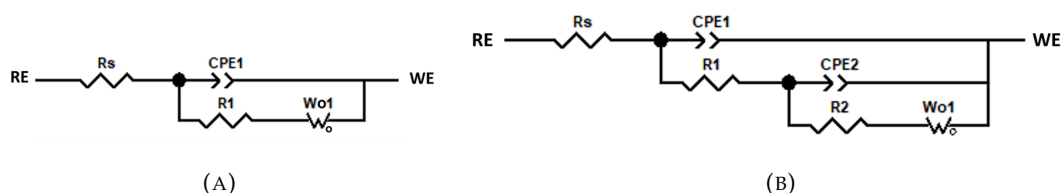
FIGURE 5.12: (A) Electric circuit used to fit experimental data in NaCl solution. (B) Electric circuit used to fit experimental data in NaCl and  $Na_2SO_4$  solution.

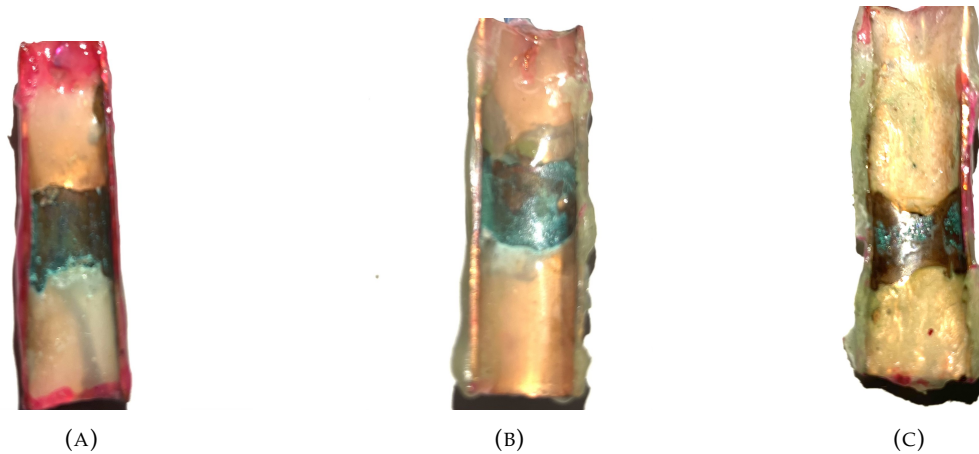
FIGURE 5.13: Copper samples after 168h of immersion in solution of 0.6M NaCl corresponding to Cu.Raw Material (B) Cu.Lubsec (C) Cu.Furnace Brazing

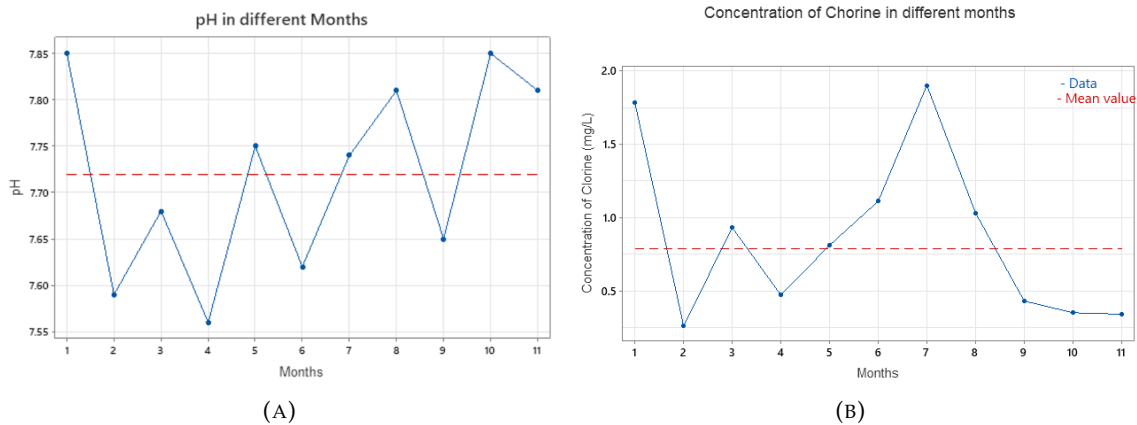
FIGURE 5.14: (A) Analysis of pH of water used in functional tests. (B) Analysis of free chloride ( $Cl_2$ ) concentration of water used in functional tests.

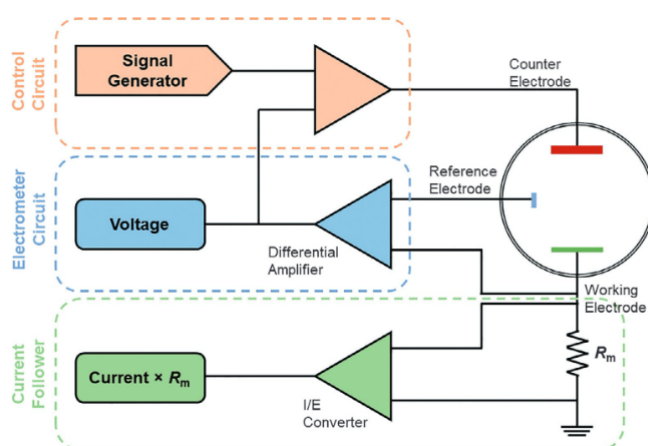
FIGURE A.1: Simplified electric circuit of a typical potentiostat: control circuit, electrometer and a current follower. Adapted from [51].

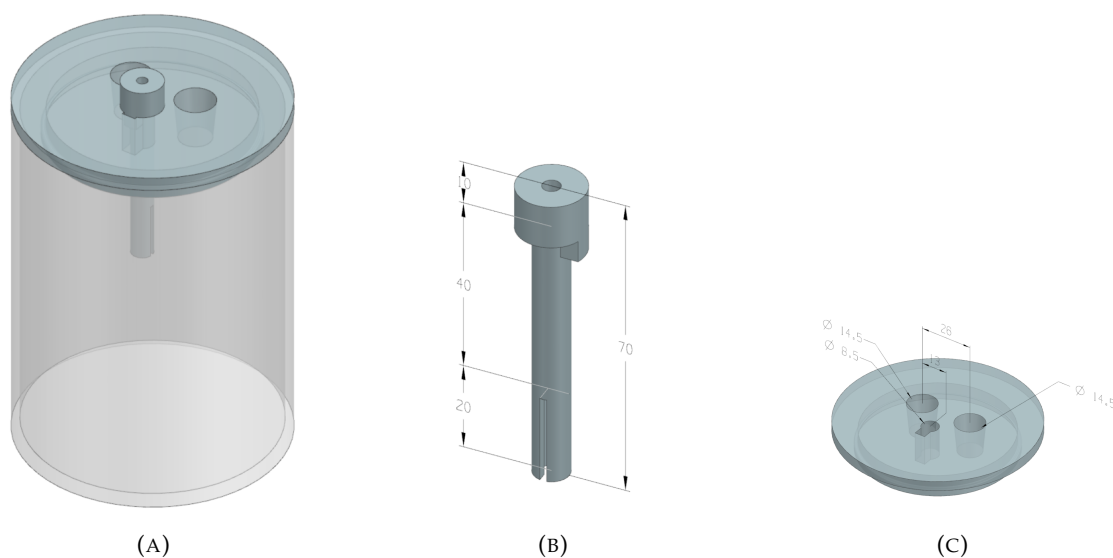
FIGURE D.1: (A) Electrochemical cell. (B) Dimensions of sample holder. (C) Dimensions of the upper region of the electrochemical cell.

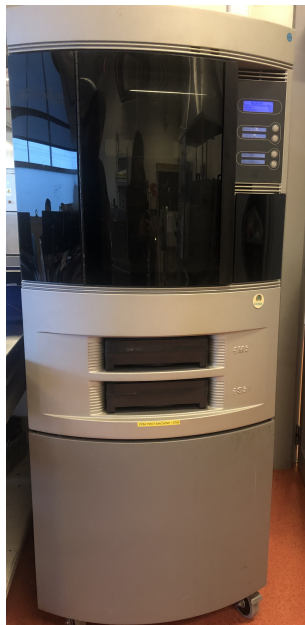
A Stratasys dimension elite 3D Printer represented in the figure D.2 was used to print the electrochemical cell and printing was carried out at Bosch Thermotechnology, S.A - Aveiro.

FIGURE D.2: The 3D printer Stratasys dimension elite used to design the morphology of the electrochemical cell, whose operations is based on FDM (Fused Deposition Modeling) technology. The impression material used was ABS P340 amorphous polymer (Stratasys).
