# **A Lean Approach to the Inefficiency of Natural Cork Stopper Sorting Processes**

**Master Dissertation**

**Master's in Industrial Engineering and Management**

This thesis reflects a study that aims to improve the efficiency of the sorting processes for natural cork stoppers at SOCORI, an industrial unit of the Amorim Group, through Lean Thinking focused on continuous improvement.

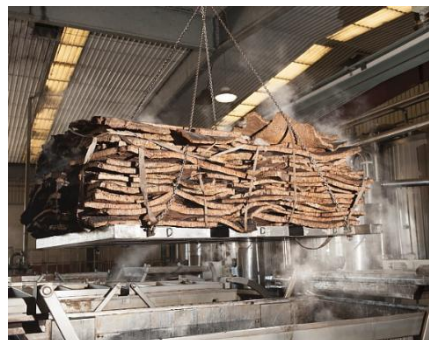
After choosing the planks, the next step is boiling. The planks are boiled in closed, filtered stainless steel tanks, as shown in figure 3.2. The process cleans the cork, eliminates organic particles from the ports and increases the thickness by fully submerging the planks in clean boiling water. This technique also enhances the flexibility of the cork and enables it to reach the optimal level of humidity required to produce cork stoppers. The duration should be a minimum of one hour at a temperature near 100°C. As the volume of the board increases, it becomes more regular and simpler to handle, making thickness a crucial aspect.

Figure 3.2: Boiling Process (Amorim, 2022d)

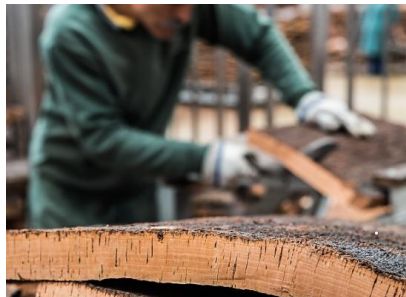
Figure 3.3: Trimming Process (Amorim, 2022d)

After undergoing the process of boiling, the cork needs to stabilize at least one day, but never more than three. Once the planks have been stabilized, the edges are prepped and the corners are trimmed, as presented in Figure 3.3. The cork, then, is categorized, based on specific features such as their look, thickness and porosity, into the same groups that were mentioned in the previous process (reception of the raw cork). At this stage, there is a sub-categorization of the *cheio* class, making it possible to distinguish, within the planks that continue into production, those that are of higher or lower quality. In this phase is very important to identify a crucial defect, “*bicho*” (hole in the cork). Due to its highly visual and subjective nature, it is crucial the expertise of the workers during the process.

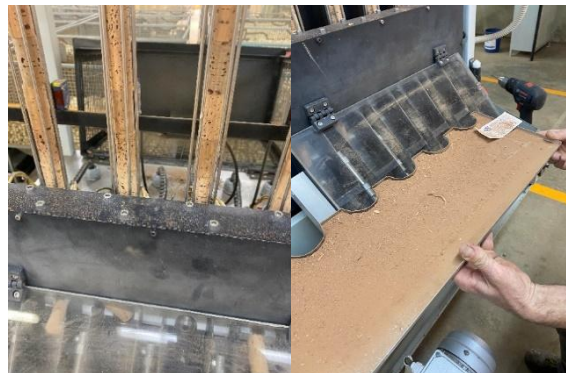
Figure 3.7: Examples of dust accumulation on CIP

Due to its entire mechanical system relying on various parts, the machine is very sensitive to dust and dirt. Any cork fragment or particle has the potential to interrupt the sensor or enter one of the channels, causing the machine to interrupt its operation in some channels and deform cork stoppers.

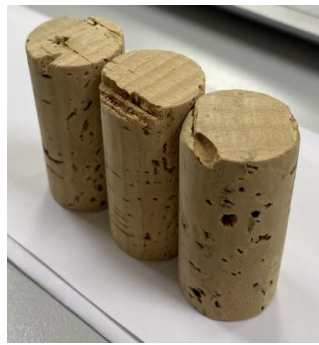
After examining the Table 3.4, it can be concluded that the predominant flaw observed in the stoppers that undergo the sorting procedures was the *repass*. In addition, among all the defects, *repass* is the only one that can be repurposed for cork stoppers of different sizes, resulting in a greater profit. In contrast, cork stoppers with *bicho* can only be grinded or used for colmation and have no other viable use. Given that the proportion of *repass* is greater in the 2nd EE, the study focuses only in this specific process. The figure 3.9, below represented, displays cork stoppers that are classified as *repass* in the 2nd EE, exhibiting damaged top surfaces.

Figure 3.9: Cork stoppers with *repass*

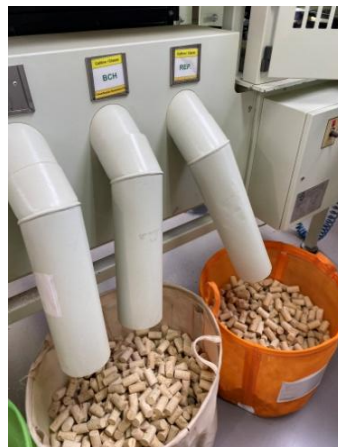
The 2nd EE is a crucial stage in the sorting process, where the stopper obtains its most accurate commercial grade. This phase uses a machine equipped with 3D visualization, enabling more efficient elimination of defects. The section has six machines, which, in addition to producing various outputs for different grades as described in subchapter 3.1, also include two dedicated output channels for *repass* and *bicho*, illustrated in Figure 3.10. Each machine consists of a 3D lens and a 2D lens that examine the surface, tops and size of the cork stopper based on a set of parameters particular to each program matching to each type of stopper.

Figure 3.10: Output channels for *bicho* and *repass* (2nd EE)

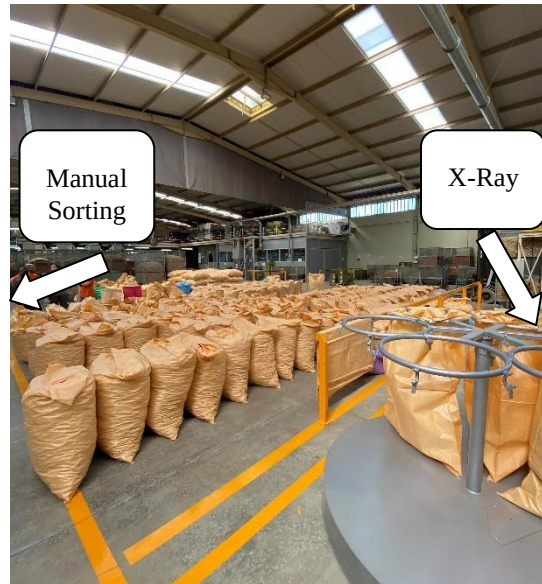
Figure 3.12: Waiting bag area in SOCORI II

The fact that bags or containers produced via the Manual Sorting and X-Ray processes share the same waiting area is the first obvious visual defect. As illustrated in Figure 3.12, it is difficult to visually distinguish between the bags or containers that have been processed by the Manual Sorting and are going to the X-Ray, and those that have already undergone the X-Ray process and are prepared for placement on the pallet. Multiple bags or containers are present in close proximity.

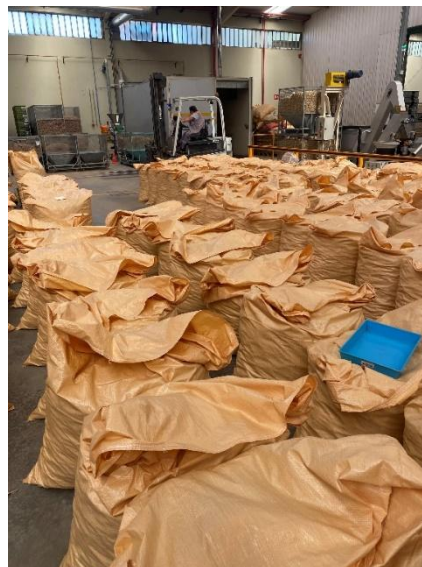
Figure 3.13: Waiting bags without quality control identification

Another significant issue at this particular location is the challenge of not only differentiating between bags, but also being unable to determine which bags have already been controlled after X-Ray process and what the outcome of the inspection was. As represented in Figure 3.14. below illustrated, the bags lack clear indication that determine whether they have undergone quality control or if the corresponding batch is validated to be placed on the pallet.

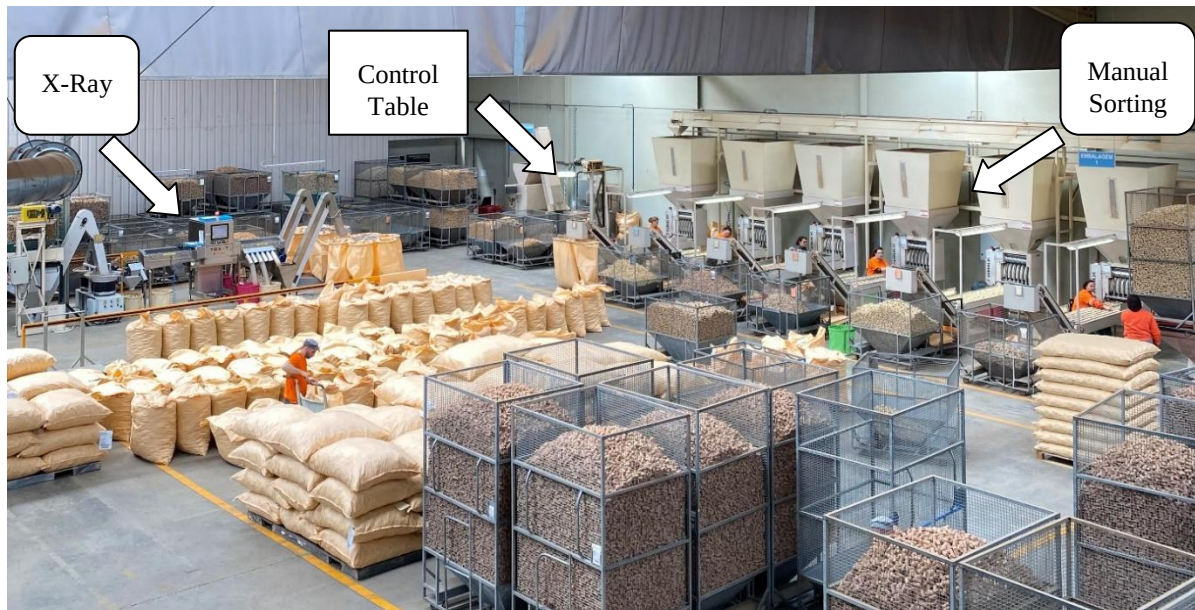
Figure 3.14: Overview layout of SOCORI II (X-Ray and Manual Sorting sections)

The last problem identified in the context of visual management in this section relates to the fact that the final control table, where the samples of the bags from the x-rayed batches are analyzed, is relatively far and hidden from the bag waiting area, as Figure 3.15 illustrates.

When taking a wider perspective on Figure 3.15, it becomes apparent that there is a deficiency in visual identification and a unclear layout. Besides the distance between control point and waiting area, the standards used for comparison with the samples are not located at the control point due to the small size of the table. Whenever the worker wants a standard, which is a sample used as a reference to validate or invalidate another, they must ascend to the top floor of this section, resulting in a big loss of productive working time. These factors may have an adverse effect on the section's performance and production.

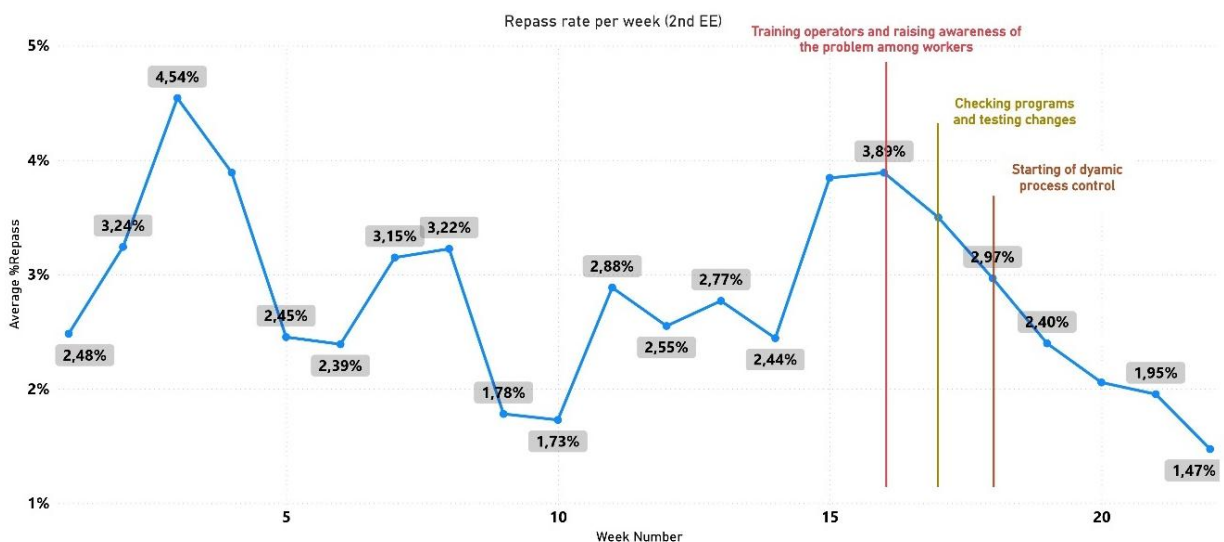
Figure 4.3: Average weekly *repass* rate across all 2nd EE Machines (Considering all the study period)

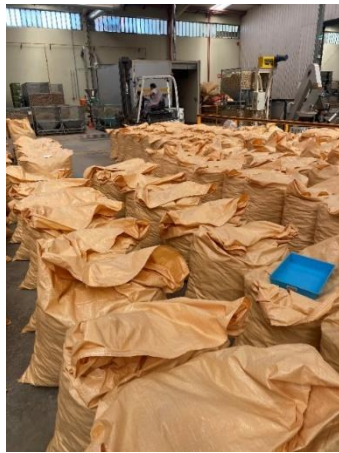
((a)) Before

The creation of laminated cards has enhanced the determination of whether a bag that has undergone X-Ray and final control, has achieved a satisfactory outcome in terms of that quality control, i.e., whether it has been approved or not. The card consists of two pages, a front page in green and a rear page in red, as depicted in Appendix N. The information provided includes the article and final customer, the quantity of bags in the order, the date of the control, and the individual responsible for conducting the quality inspection. If an order batch is approved, the card will be oriented with the green side facing upwards. Conversely, if the batch is rejected, the card will display the red side along with the explanation for the rejection. An order may contain many bags, therefore, a card is placed at the start of a queue and another card is placed when the bags in that order are completed. The bags that don't have a card are because they haven't been through quality control yet. With this implementation, every person in the section is now aware of the outcome of the final inspection and the bags that have or have not undergone quality control. Prior to the implementation, the bags lacked any form of quality control identification, as seen in Figure 4.4(a) On the other hand, Figure 4.4(b), clearly demonstrates the visual enhancement achieved by implementing cards on the bags.

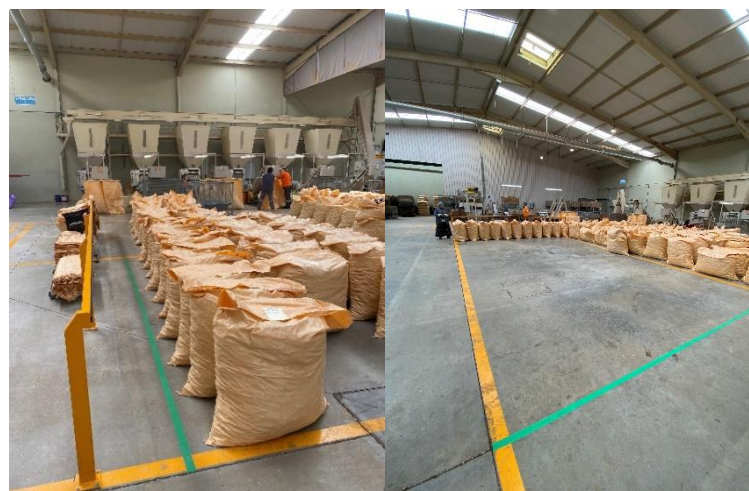
Figure 4.5: Green tape marking the tested area for bag that undergone X-Ray

During a visit to one of Amorim Cork's industrial units, it was noted that there were designated waiting places for bags, complete with a floor mat, as depicted in Appendix O. These floor mats enhance the food safety of the cork stoppers by preventing the bag that is delivered to the customer from touching the floor. Additionally, they facilitate improvements in visual management. It is crucial to note that containers are unable to move over these floor mats as they have the potential to crush them. To mark the area exclusively for bags coming out of the X-Ray, green tape was set on the floor, as depicted in Figure 4.5.

An experiment was conducted over several weeks to evaluate the best size of the area to be selected, considering the daily production and its variability. After a few weeks, the decision was to proceed with the investment and purchase the floor mat only for the designated waiting area where bags are placed after undergoing X-Ray Machine.

Figure 4.6 illustrates the final decision regarding the area's final dimensions and the new layout organization. This revised layout only considers improvements in organization and visual management. After observing Figure 4.6, it becomes evident that the floor mat will only be present in the waiting area that follows the X-Ray. This decision ensures clear visual identification and differentiation between bags that have passed through the X-Ray process and those that have gone through Manual Sorting. Furthermore, it enhances food safety by preventing the bags that are delivered to the consumer from making direct touch with the floor. Although the cork itself is not food, it is in contact with the wine that is going to be consumed. The floor mat has a price of approximately 2525€, for the chosen area. Unfortunately, the order did not arrive in time for the project's conclusion, so there are no pictures to show the scene once the floor mat was in place. Essentially, the floor type illustrated in Appendix O will be put inside the boundaries marked by the green tapes illustrated in Figure 4.5.

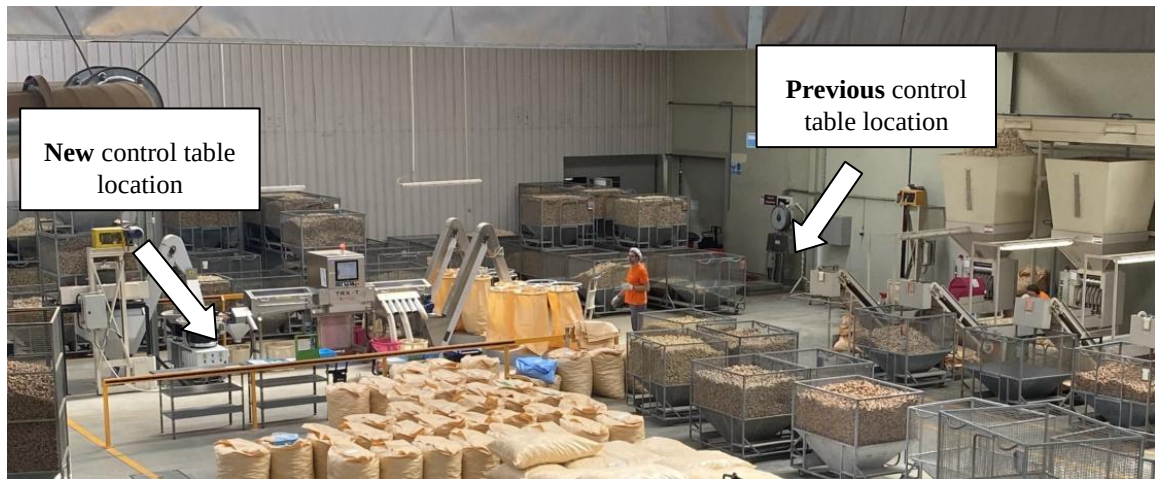
In order to address this issue, it was necessary to purchase two additional control tables, which incurred a cost of around 550€, and expand the area close to the X-Ray machine. The tables were positioned near the waiting area and the X-Ray, allowing for more efficient control of the bags, as depicted in Figure 4.7.

Figure 4.7: Changes in quality control workplace

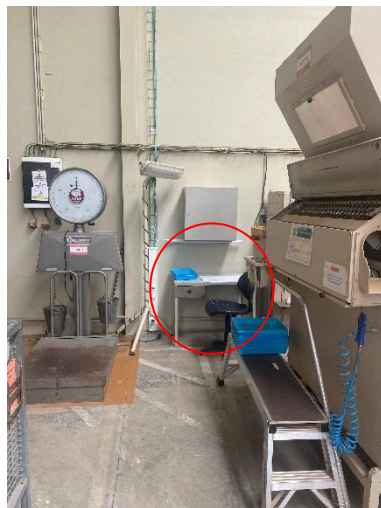
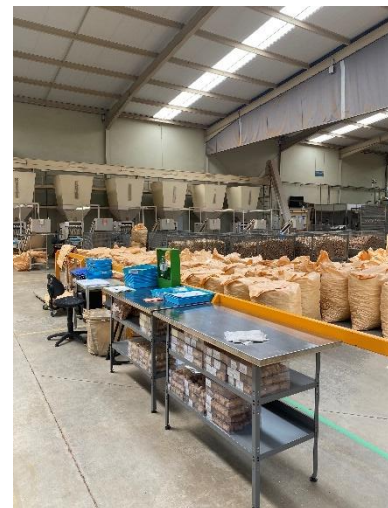
Figure 4.8: Changes in the table use for quality inspection

Additionally, by acquiring the new tables, it was able to place the standards near the shop floor. Figure 4.8(a) shows the appearance of the quality control supervisor's former workplace. The introduction of the new tables has resulted in considerable differences in terms of working space, proximity to the bag area, working environment and convenience as depicted in Figure 4.8(b).

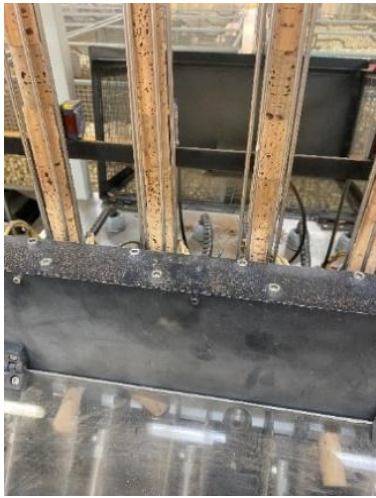
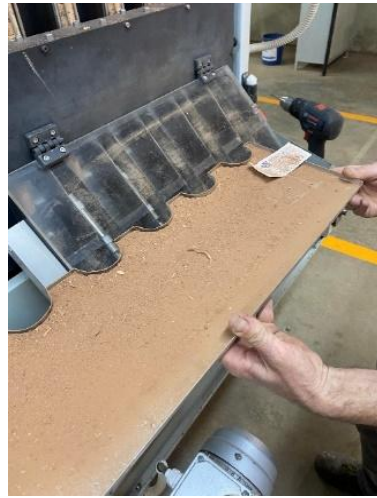
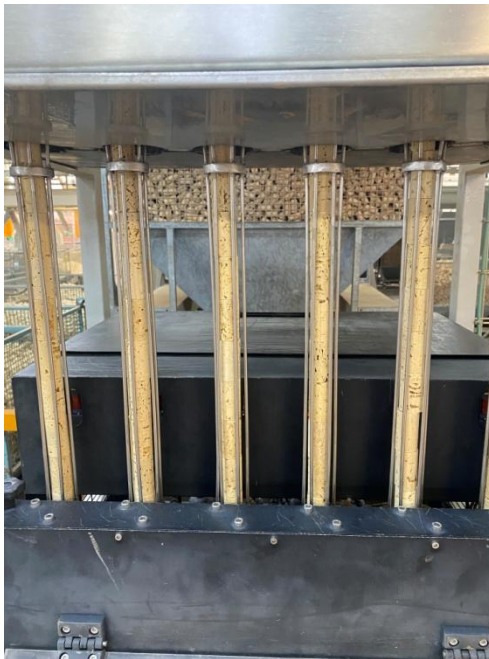
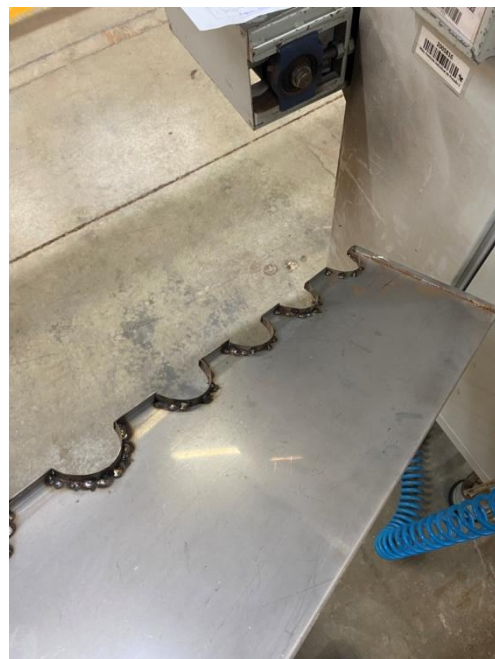
## Appendix F: Differences in CIP's Parts Before and After SW Implementation

**BEFORE** Cleaning Standard Work

**AFTER** Cleaning Standard Work
