**FACULDADE DE ENGENHARIA DA UNIVERSIDADE DO PORTO**

# **Application of Toyota Production System Principles to Improve Process Flow, Safety and Efficiency in Automotive Final Assembly**

Mestrado em Engenharia Mecânica

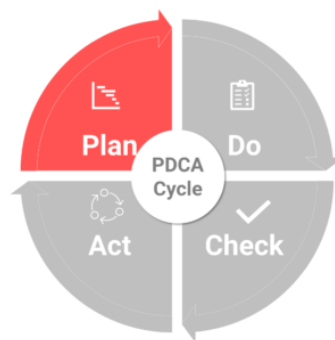
Figure 2.2: PDCA Cycle

Problem solving in the Toyota Production System (TPS) is built around a robust and standardized methodology known as the Eight-Step Problem Solving Process, also referred to as Toyota Business Practices (TBP) or Practical Problem Solving. This approach emphasizes structured thinking, clarity of problem definition, and root cause analysis based on the PDCA (Plan–Do–Check–Act) cycle (Figure 2.2) [9, 16].

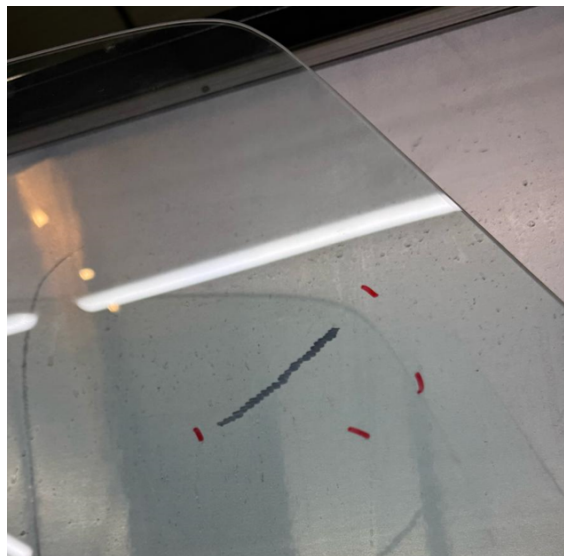
Figure 4.9: Window Rejected - Markings from station "P"

The specific non-conformity addressed in this project was the presence of **surface scratches** on the **outer face of the front side windows** (Figure 4.9). These scratches were considered defects when they could be felt with a fingernail, according to the established quality criteria. Their classification as non-conformities led to the **rejection and replacement** of the glass, generating internal cost and operational disruption.

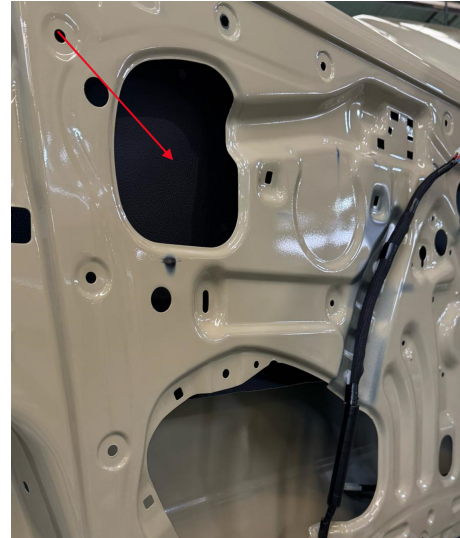
Figure 4.19: Fabric layer, prototype, 2

A fabric layer was positioned inside the door to create a buffer between the glass and the metal, with magnets used to fix the protection to the outer door panel, as shown in Figures 4.18 and 4.19.

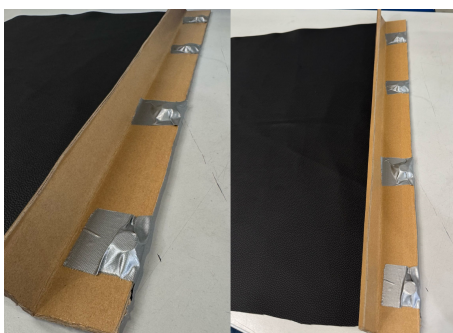
Figure 4.20: Magnet reinforcement

To improve the fixation and ease of use, a second version of the protection was developed. **The two were replaced by four stronger magnets** to ensure a more stable attachment to the door frame and the lighter side of the fabric was positioned inward, improving visibility during the window installation (Figures 4.20 and 4.21). To be noted that each magnet was wrapped in **protective tape** to avoid damaging the paint.

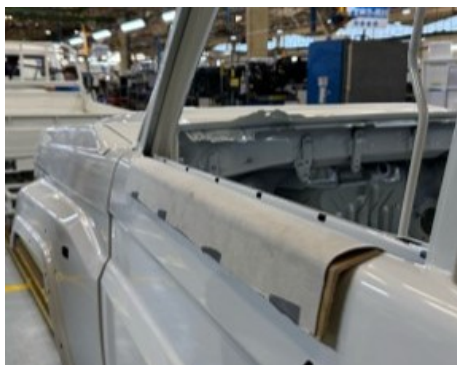
Figure 4.22: Protection testing

In the final stage of development, after proving its functionality and effectiveness, the protection was further **refined to improve handling and integration into the operator's routine**, adding a handle to one end of the cover, allowing for faster and easier manipulation, as shown in Figure 4.22 and 4.23. This also made it possible to store the protection on the dolly when not in use, avoiding unnecessary floor contact or misplacement.

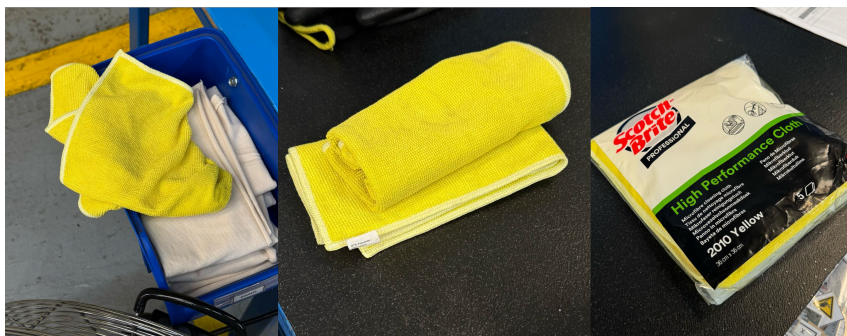
Figure 4.24: Cloths (in use, used, and new ones)

To ensure that cleaning cloths used during glass handling remained clean and effective, a clear maintenance plan was introduced (Figure 4.24), defining the quantity, usage cycle, and cleaning frequency of cloths at station P, removing the informal and inconsistent practices previously in place.

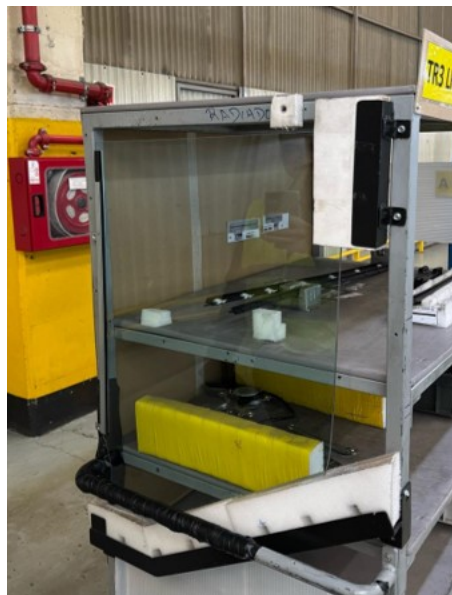
Figure 4.25: Dolly, before

An inspection was conducted on all four dollies used for transporting the front side windows, revealing that the **two LH dollies**, where a significantly higher number of scratch occurrences had been recorded, did not have any protective barrier between the stored glass and the adjacent components placed inside the dolly (Figure 4.25). This meant that, during part handling or placement, there was a **real risk of unintended contact** with the exposed surface of the window.

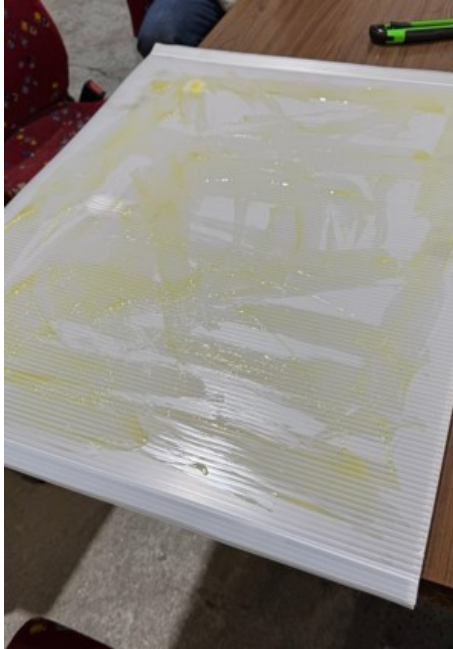
Figure 4.26: Creating protections

To address this problem, custom protective panels were created and installed in both dollies, as shown in Figure 4.26 and 4.27. The solution was developed using **repurposed/residual materials**

**available on-site**, including scraps of polypropylene sheets and foam padding, effectively creating an impact-absorbing surface between the window and any stored parts.

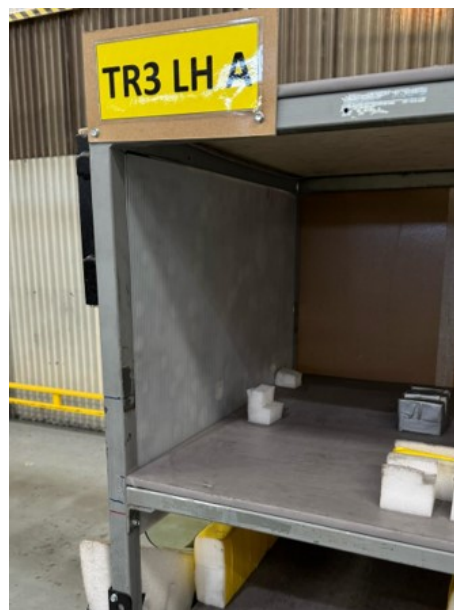
Figure 4.28: Dolly, after - with protection

The intervention was simple but highly effective, bringing the dolly condition in line with process requirements and significantly reducing the risk of incidental damage to the glass during transport or parts handling. The final state of the dolly with the protections can be seen in Figure 4.28.

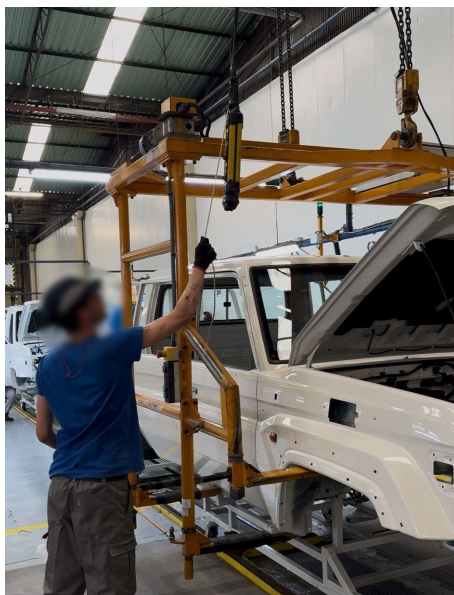
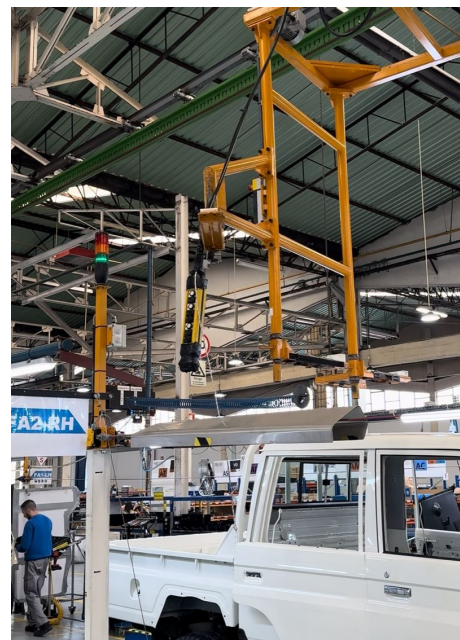
Finally, operational testing was carried out in real working conditions with the production team and the tests demonstrated that the controller remained high enough to avoid collisions and that its handling remained smooth and easy for the operator (Figure 4.34 and 4.35).

Figure 4.34: New system in use by the operator

Figure 4.35: No interference with most critical obstacle

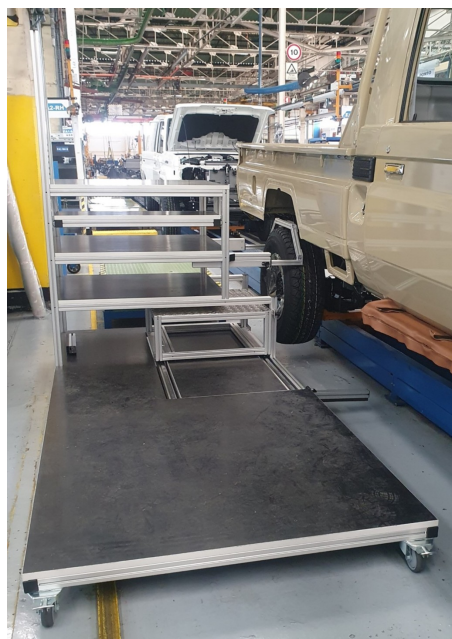
Figure 4.36: Dolly FA3 design

In this context, a new solution was developed: **a mobile support dolly** designed to ensure safe and ergonomic working conditions while maintaining compatibility with the line's moving conveyor (Figure 4.36). To be noted that implementing fixed steps or auxiliary supports was not viable, as the vehicle is constantly in motion along the conveyor and any static elevation device would create a significant safety risk, particularly in terms of balance and potential falls. Therefore, a new approach was required to improve operator access without compromising safety or disrupting the production flow.

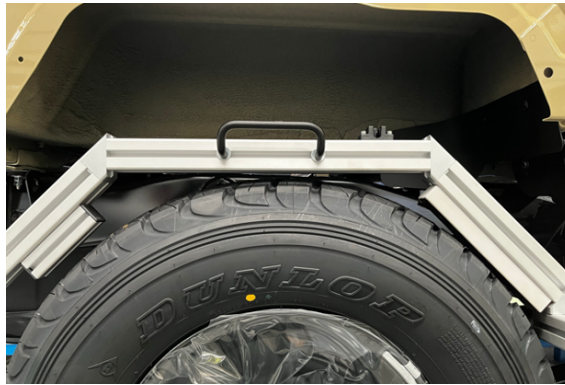
Figure 4.37: Final coupling mechanism design

The attachment system between the dolly and the vehicle's rear wheel was modified to facilitate easier engagement and disengagement, and prevent the system to contact the vehicle's surface (Figure 4.37).

A buffer was also added to eliminate the gap between the wheel and the coupling area and to absorb potential shocks.

Additionally, a **locking pin** was installed to secure the dolly support during reverse movement, preventing unintended rotation or contact with the vehicle during the return path to the start of the station (shown in Appendix C, Figures C.22 to C.26, comparing the before and after improvements).

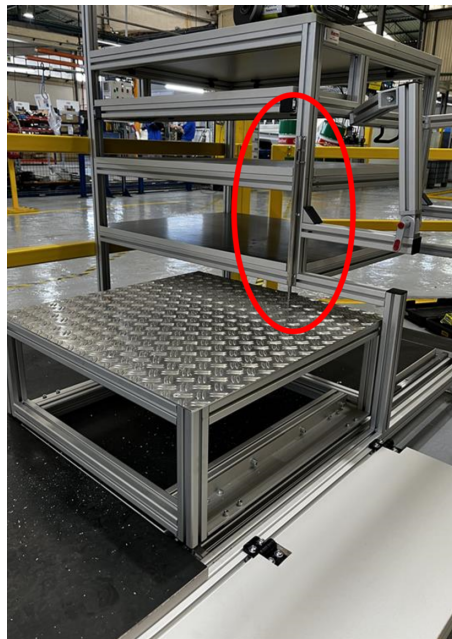
Figure 4.38: New lock mechanism for step (open position)

The original lock mechanism for the dolly step was difficult to reach and operate (shown in Appendix C, Figure C.27). It was replaced with a simplified pin system that is both accessible and secure in the open and closed positions (Figure 4.38).

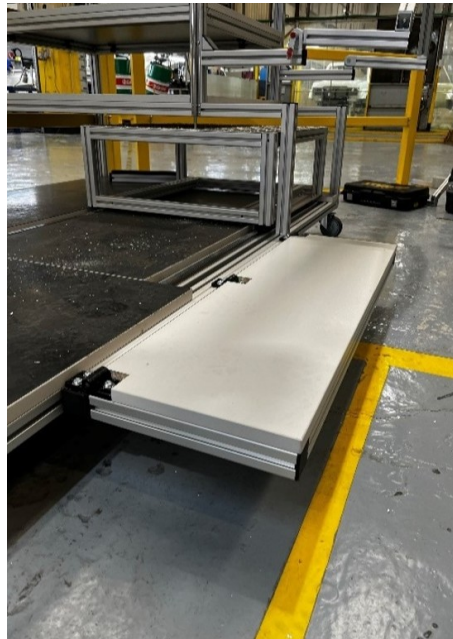
Figure 4.39: Side step installed in the Dolly

A side step was added to enable the operator to stand closer to the vehicle during critical operations (Figure 4.39). To address flexing issues caused by span length, a central support wheel was introduced to stabilise the platform during use. (shown in Appendix C, Figures C.29 and C.28)

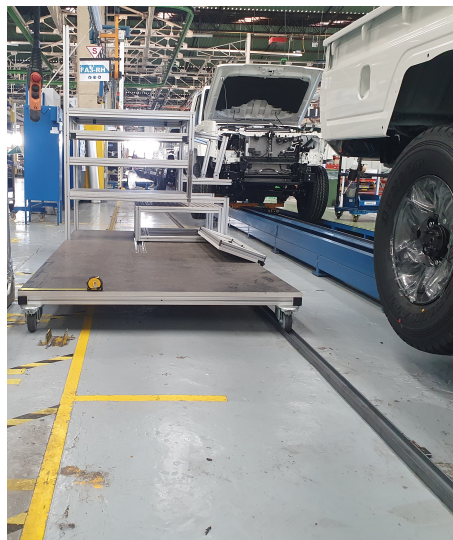
Figure 4.40: Guiding rail – testing

To ensure precise alignment and stable linear motion along the station, a **guiding rail** was designed and installed on the floor, preventing lateral deviation of the dolly as it moves in sync with the vehicle, especially important during transitions at the beginning and end of the station (Figure 4.40).

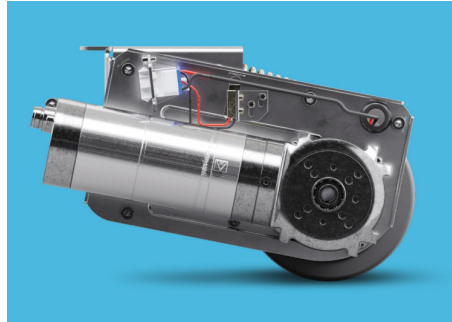
Figure 4.41: Motorised wheel, for dolly FA3

As a potential future enhancement, the implementation of a **motorised wheel system** on the dolly is currently under technical evaluation (Figure 4.41). This feature would allow automatic return of the dolly to its initial position after decoupling, eliminating the need for manual repositioning by the operator and further improving process fluidity, safety, and ergonomics.

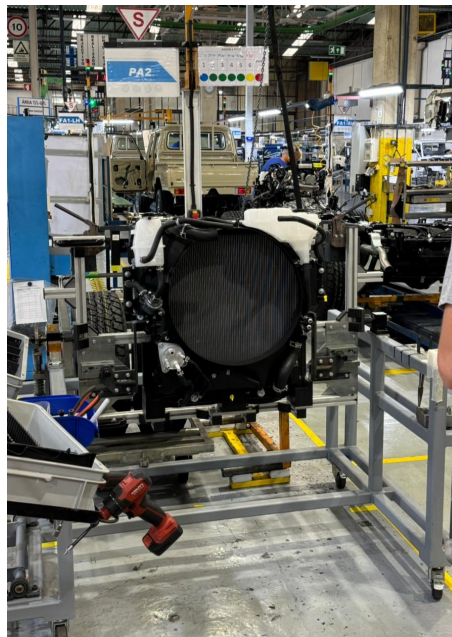
Figure 4.42: Radiator pre-assembly station

As part of the broader objective to improve efficiency and eliminate waste across production processes, a study was carried out on the **pre-assembly station of the radiator system**, since it was needed to update its operations times (WSS). This station is responsible for preparing the radiator pre-assembly prior to its integration into the vehicle structure further down the line (Figure 4.42).

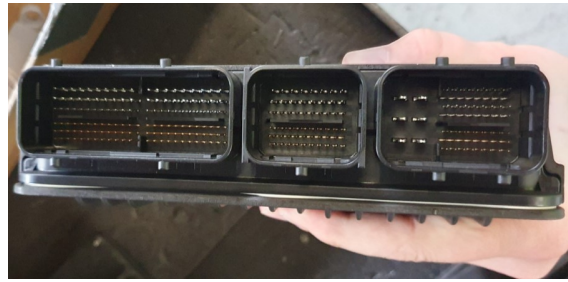
Figure 4.43: ECU stored with no protections

During a recent internal assessment to the Final Assembly area, a specific issue was raised regarding the **handling and protection of electronic control units (ECU's)** before installation in the vehicle. The exposed pins of these components presented a risk of damage during handling and logistics operations (Figure 4.43).

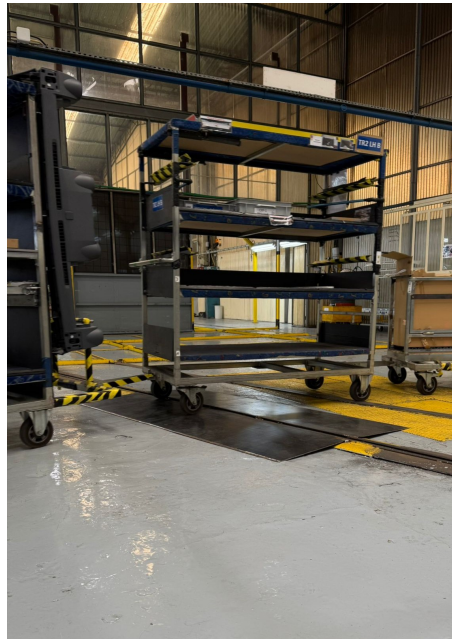
Figure 4.46: New ramp installed - smoother dolly transition

To address the issue, a **custom steel ramp** was designed and welded directly onto the existing metal track (technical drawing is shown in Appendix C, Figure C.30). This ramp reduced the angle of approach and enabled a smoother, more gradual transition, significantly improving wheel stability during passage. The solution eliminated the bouncing effect, reduced noise, and improved the protection of in-process components (Figure 4.46).

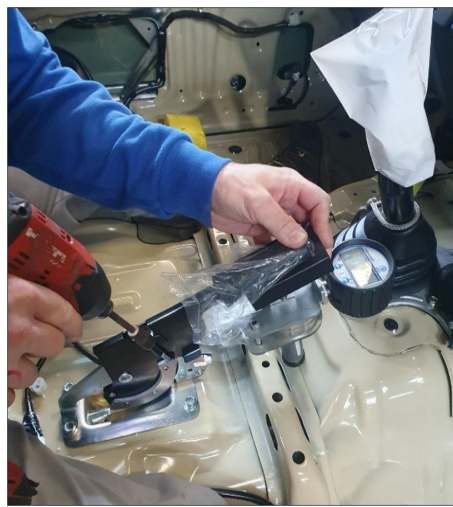
Figure 4.48: Handbrake assembly with measuring instrument in use

- Measuring the diameter of the load cell's contact surface to calculate the area;
- Converting the target force (192 N) to pressure using the equation  $P=F/A$ , resulting in a target reading range of approximately 0.200–0.210 MPa;
- Testing the device directly in the assembly process to validate usability and accuracy (Figure 4.48).

Once validated, this measurement method was integrated into the **standard operating documentation (EWS – Element Work Sheet)** for the handbrake assembly process. Operators now follow a defined procedure that includes using the gauge to ensure consistent application of the required force, eliminating reliance on subjective feedback (clicks) and ensuring alignment with OEM specifications (EWS is shown in Appendix C, Figure C.8).

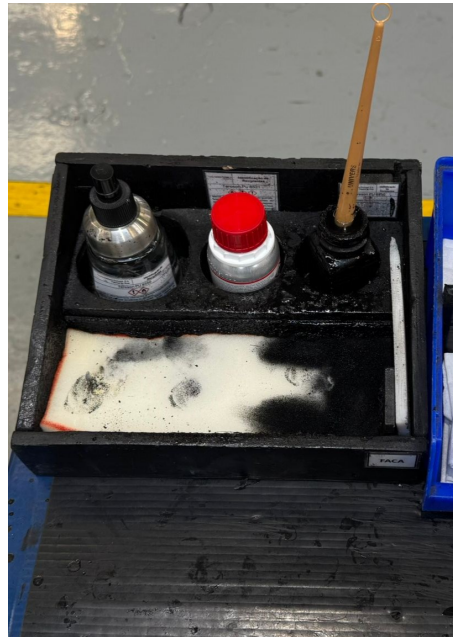
Figure 4.49: Primer stored, before kaizen

The process involved two different types of primer products, each stored in a **similar-looking bottle but serving different purposes**. Previously, there was no visual aid to distinguish between

the two beyond the cap color, which could create a risk of confusion when replenishing the bottles on the workstation, as shown in Figure 4.49.

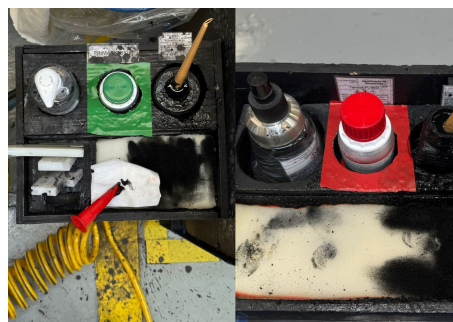
Figure 4.50: Primer stored, after Kaizen

To address this issue, a quick kaizen was implemented: **a colored visual aid matching the bottle cap** was applied around each bottle's insertion point (Figure 4.50). This ensured instant identification of which bottle belonged to which position, simplifying replenishment and **minimising errors**.

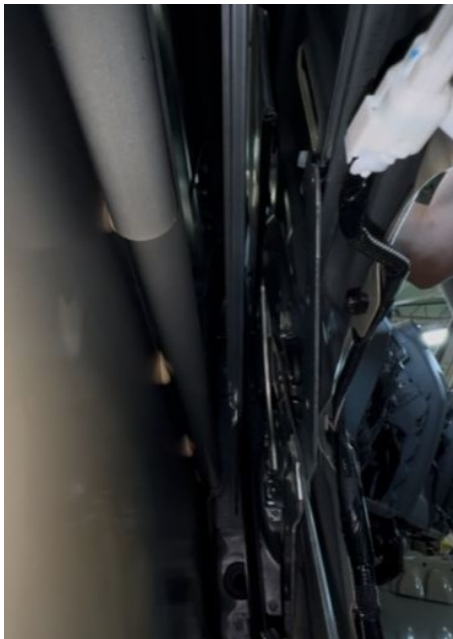
Figure B.21: Components inside door frame during window installation

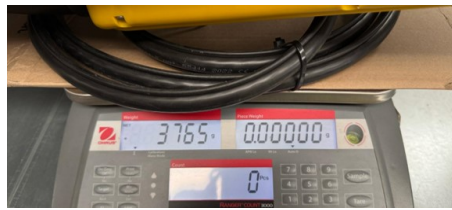
Figure C.15: Controller and cable weight

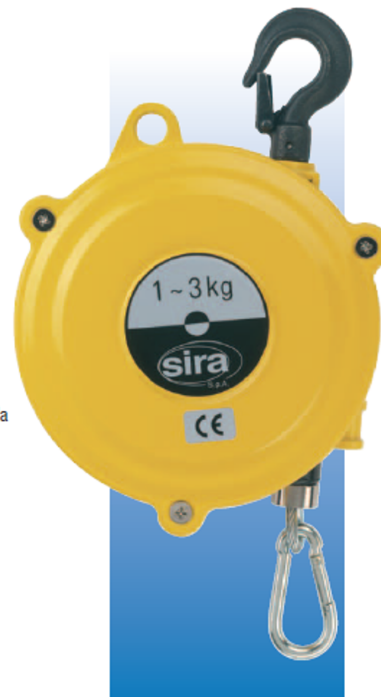
- Scocca in metallo
- 13 modelli per coprire un campo di carico tra 1 e 120 kg
- Carico della molla regolabile
- Corsa del cavo regolabile
- Cavo in acciaio
- Dispositivo di sicurezza contro la rottura della molla
- Conforme alle normative CE

Figure C.17: Balancer, flex type c

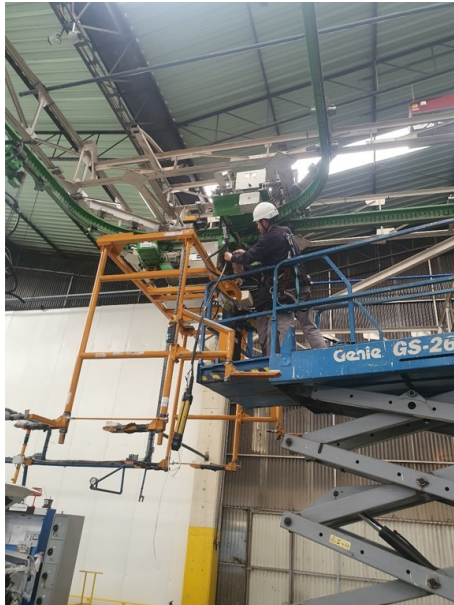
Figure C.18: Balancer System installation

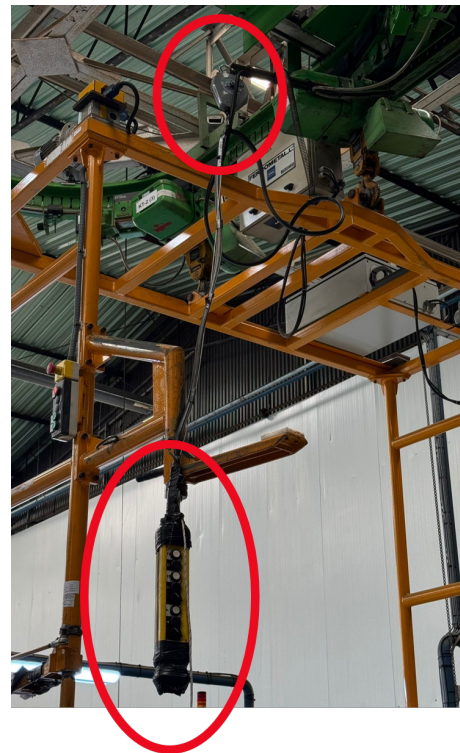
Figure C.19: Spring Balancer System installed

- Removal of a recurrent safety hazard caused by low-hanging controller movement;
- Improved ergonomics, allowing easier and safer controller access;
- Low-cost, quick implementation with direct replication in a second hangar (Yokoten).

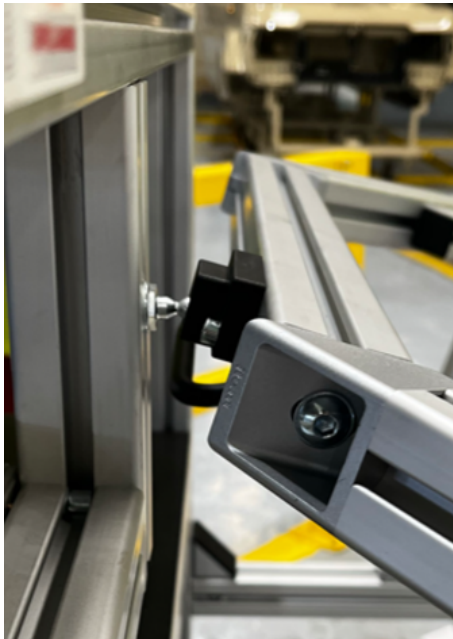
Figure C.24: Locking pin

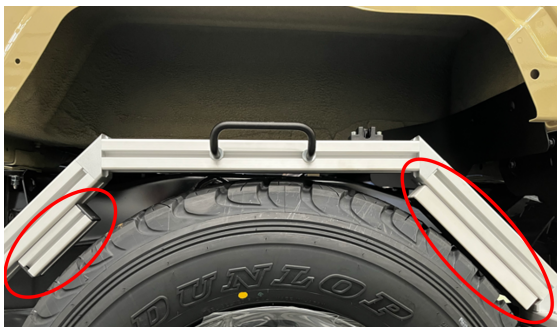
Figure C.26: Buffer installation

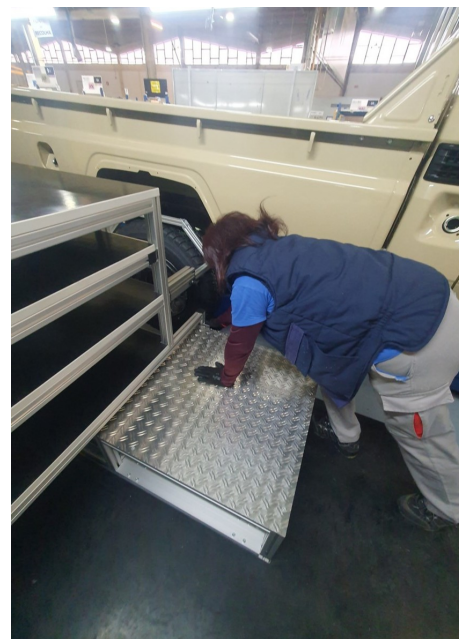
Figure C.27: Step locking system, before - Ergonomic risk

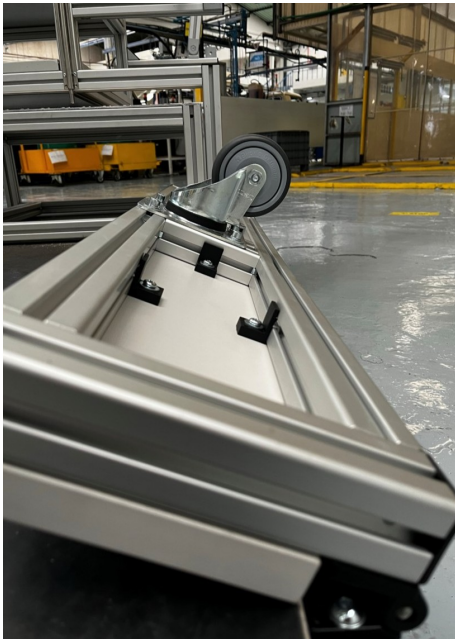
Figure C.28: Wheel support for side step

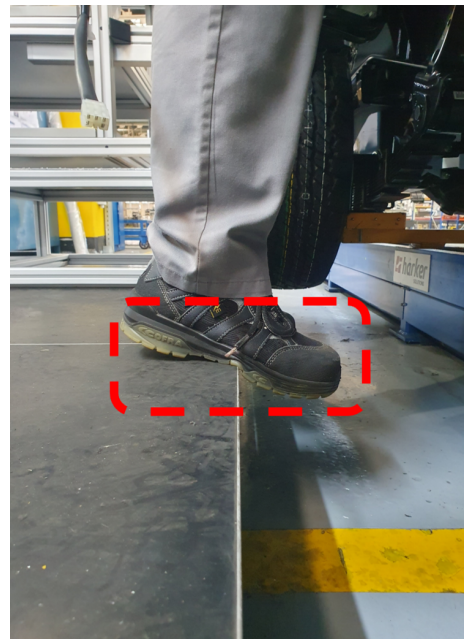
Figure C.29: Operator safety risk, when close to the car – need for additional step
