**FACULDADE DE ENGENHARIA DA UNIVERSIDADE DO PORTO**

# **Influence of materials and fabrication process in partial discharges in medium and high voltage underground cables**

Mestrado em Engenharia Eletrotécnica e de Computadores

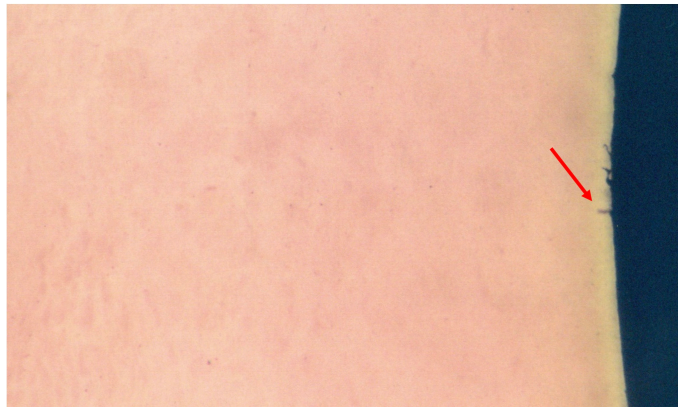
Figure 2.6: Vented water tree  $120\ \mu\text{m}$  long (indicated by the red arrow) approximately 2% of the insulation thickness [52]

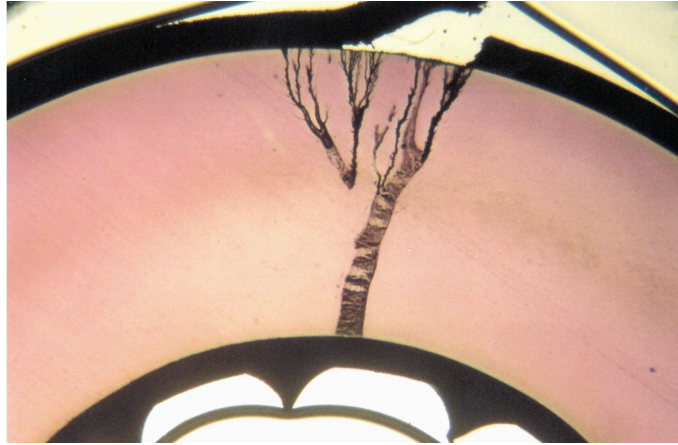
Figure 2.7: Electrical tree directed toward the insulation screen, indicating breakdown initiated from a bow tie tree or from the conductor screen [52]
