# Experimental testing, numerical modelling and seismic strengthening of traditional stone masonry: comprehensive study of a real Azorian pier

Alexandre A. Costa · António Arêde · Aníbal Costa ·  
João Guedes · Bruno Silva

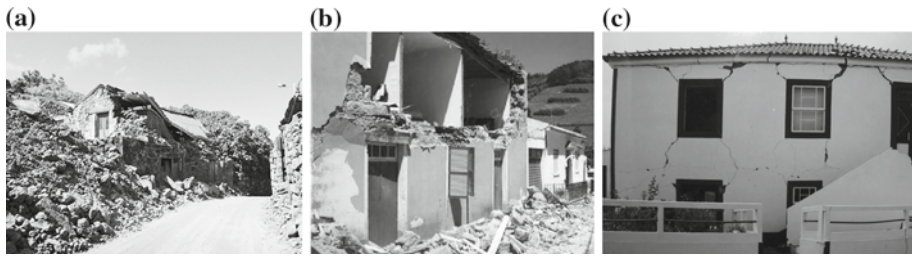
**Fig. 1** Earthquake induced damages in Azores: **a** total collapse; **b** partial out-of-plane collapse; **c** in-plane damage

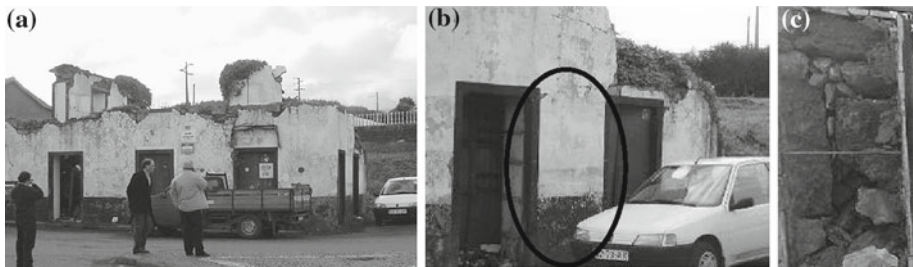
**Fig. 2** Original location of the wall: **a** general view; **b** pier location; **c** wall cross-section

As mentioned before, the seismic assessment evaluation of typical poor-type stone masonry of Azorian constructions was complemented by performing experimental laboratory tests on a real existing masonry pier recovered from a two storey house located at the Pedro Miguel parish, Horta council, Faial Island, hit by the 1998 Azores earthquake. This pier was located at the ground floor between two main doors of a house façade, as shown in Fig. 2.

This specimen is part of a traditional double-leaf stone masonry wall common to most of the old constructions in the Archipelago, mainly built of basalt blocks, cohesionless infill material (small stones, soil type material, etc.) and with an extremely poor bond between materials. It essentially consists of dry joints between basalt blocks and very weak joints between blocks and infill, as illustrated in the picture of the wall cross-section included in Fig. 2c.

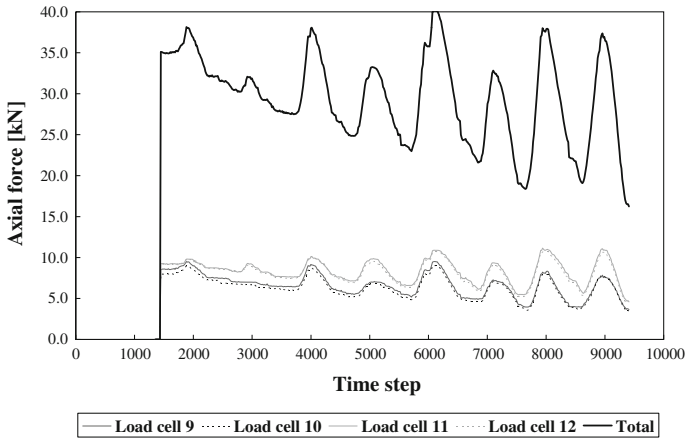
Fig. 4 Axial force during the experimental test

However these hydraulic jacks were not force-controlled and, consequently, a significant variation of vertical compression was observed during the experimental test, as depicted in the time history of vertical load included in Fig. 4. This non-negligible load variation was due to absence of oil volume correction inside the hydraulic jacks to compensate for the cyclic uplifting and the progressive vertical deformation of the specimen. The peaks in the plots of Fig. 4 refer to the pier uplift, whereas the clear global decreasing trend is due to the average compressive deformation for which no correction was provided on the total axial force. For completeness, Fig. 4 includes records of each of the four load cells that are summed up to provide the total vertical force, corrected for the small angle of the steel rods where load cells were mounted on.

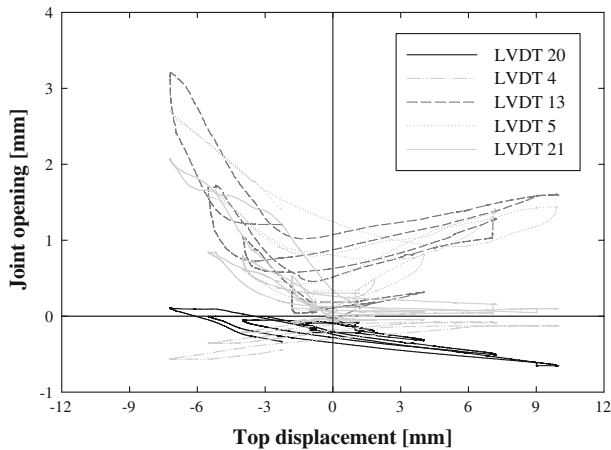
**Fig. 9** Top displacement vs. joint opening

This behaviour is further highlighted in Fig. 9, where joint movements are plotted against the top displacement; these results show the response of LVDTs 13 and 5 as the most representative of shear/sliding behaviour with uplifting effect since the opening of joints has occurred for all peak displacements regardless of their sense. At the base level, there was no joint opening which means that no flexure/rocking response occurred; instead, the base joints (LVDTs 4 and 20) essentially moved towards closure due to the destruction of cohesion and to the smoothening of irregularities at this level. It should be also referred that results related to LVDT 12 are not presented due to the damage occurred at the top right corner of the wall that is possible to observe in Fig. 7b.

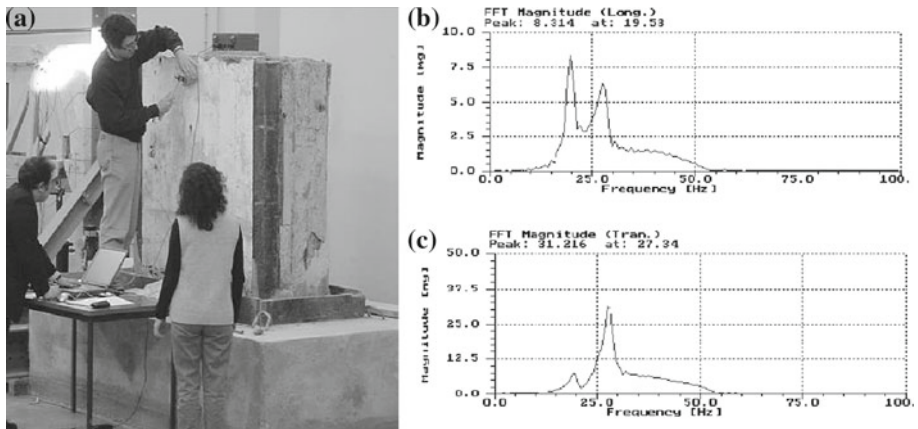
**Fig. 11** Modal analysis: **a** free vibration test; FFT of acceleration record in **b** transversal and **c** longitudinal directions

Based on these results, the numerical model was calibrated in the linear elastic range of material behaviour in order to match the obtained first two modes of vibration presented in Table 1. This was done by taking values obtained by Costa (2002) for the blocks and infill; concerning the parameters for joints, the initial trial values were based on results of a previous work, where experimental shear tests on dry joints were carried out (Almeida 2000). Successive corrections led to the final joint parameter values used in the calibrated numerical model, listed in Table 2 together with the initial values.

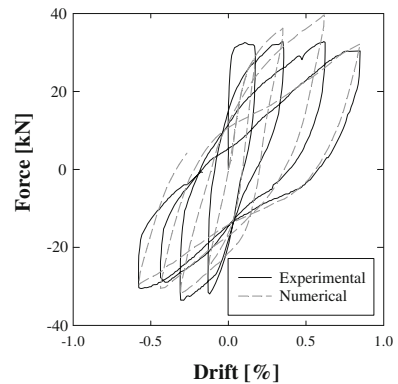
**Fig. 15** Force drift diagrams:  
Experimental compared to  
numerical results

The numerical simulation was carried out on the calibrated model as described in Sec. 4.1 and the infill nonlinear parameters were adjusted to better match the experimental results resorting to a trial and error process (with the final values listed in Table 3), which led to final numerical results very close to the real ones as shown in Fig. 15.

The simulation output evidences that the hysteretic behaviour is globally well described by the model, since it is able to approximately reach the maximum strength (although slightly overestimated), also accounting for the observed stiffness/strength decrease and dissipated energy. Indeed, a comparison between energy dissipation capacity of the numerical and real model is presented in Fig. 16, confirming the accuracy of the numerical simulation.

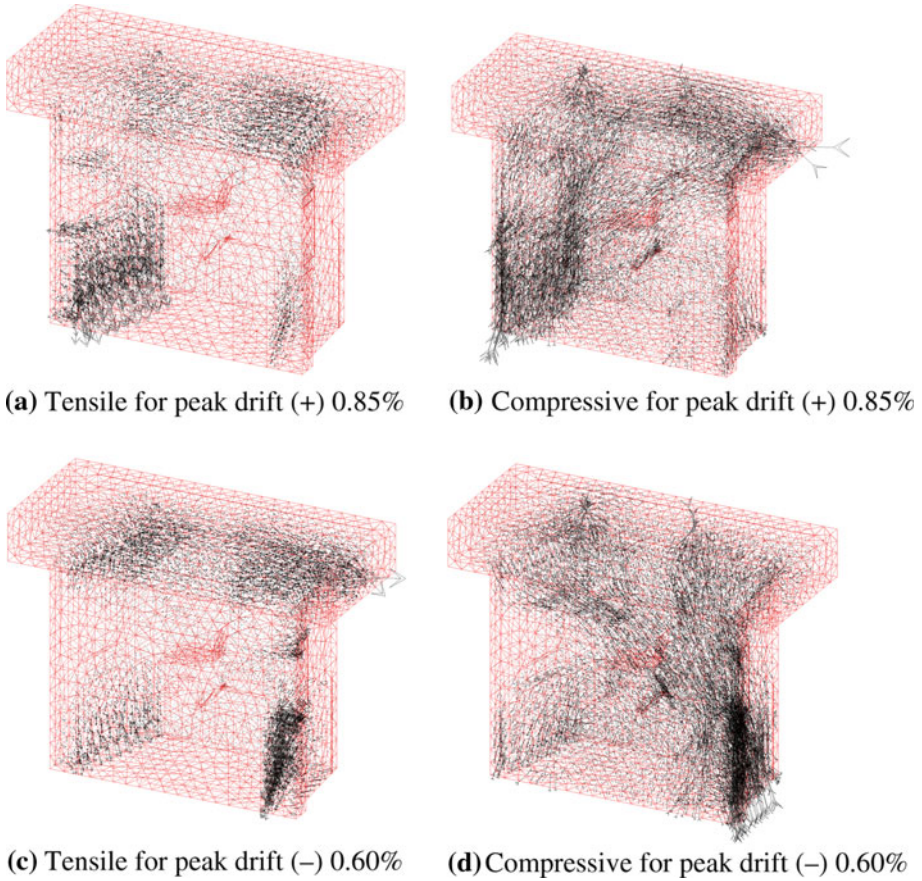
**Fig. 19** Principal tensile and compressive stress distributions: **a** and **b** for peak positive displacement, **c** and **d** for peak negative displacement

can be observed throughout the wall as evidenced in Fig. 19 concerning the distribution of principal tensile and compressive stresses over the entire wall for the peak positive and negative displacements (0.85 and  $-0.6\%$  drifts).

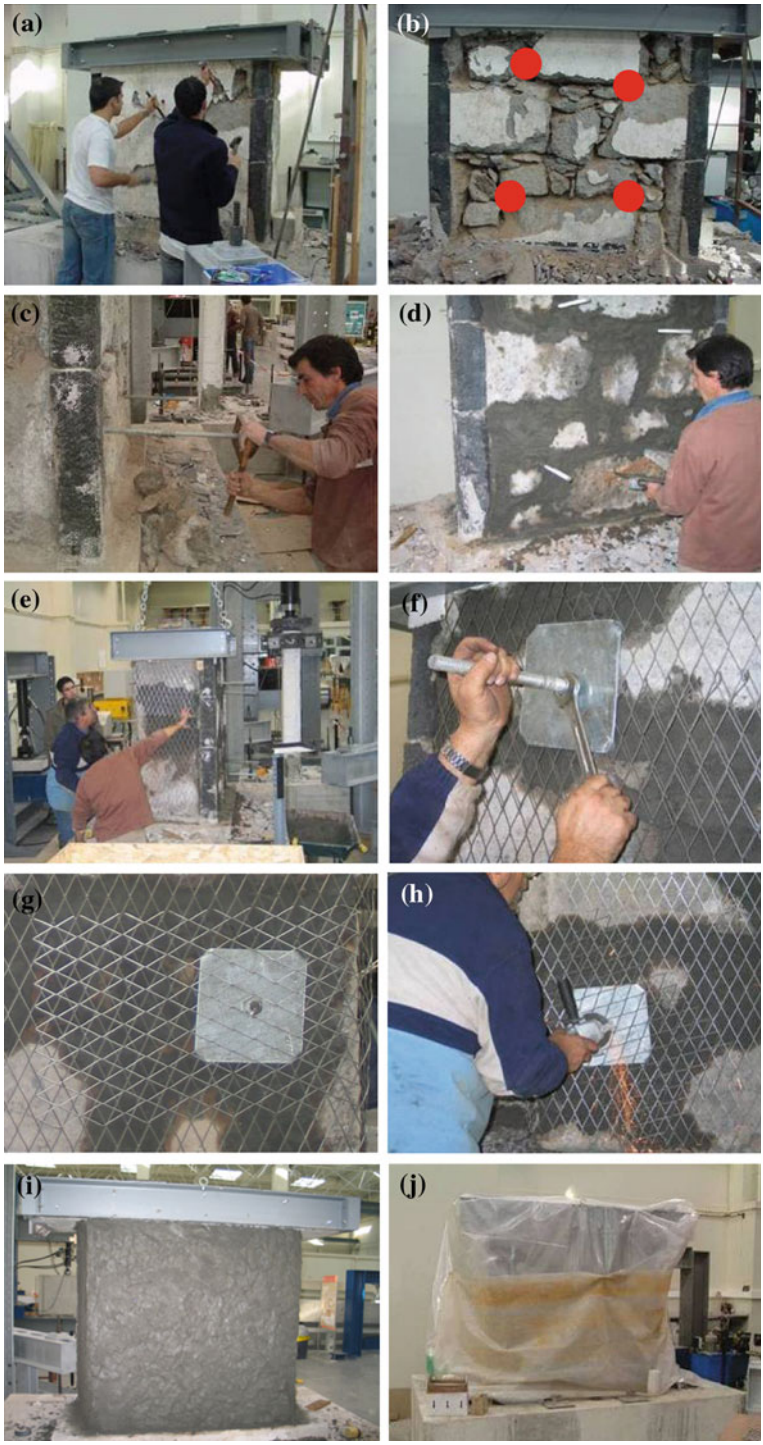
**Fig. 22** Retrofitting technique used on the tested pier: from a–j as detailed in the text

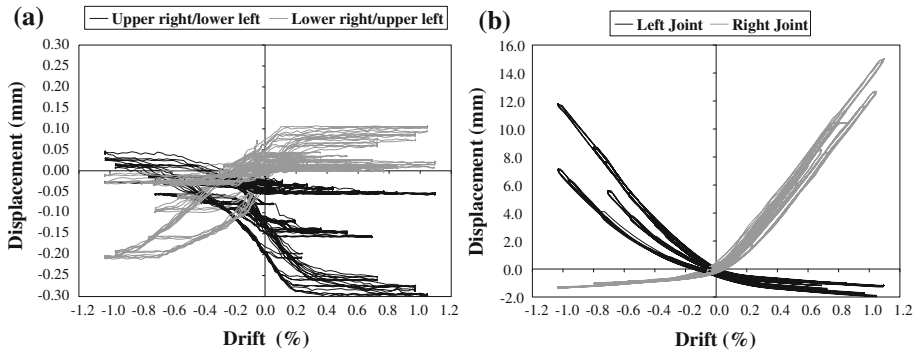
**Fig. 25** Retrofitted pier behaviour: **a** diagonal displacement; **b** base joints opening

Another interesting result was obtained from the analysis of the diagonal and base joint displacement transducer readings plotted in Fig. 25 in terms of top drift vs. diagonal or base joint motion (opening or closing). These results are fully consistent with the observed monolithic behaviour of the wall, also inferred from the response diagrams included in Fig. 24 that are typical of a rigid block type.

Indeed, Fig. 25a shows the evolution of the diagonal displacements of the wall that is directly related to the shear influence on the global response; it is quite apparent that considerably low displacement values were found (maximum =  $0.30 \text{ mm}$ ), allowing to conclude that shear behaviour did not influence the wall response. Similarly, Fig. 25b exhibits the joint

opening/closing during the experimental test, where the rocking behaviour is perfectly clear also in accordance with Fig. 24.

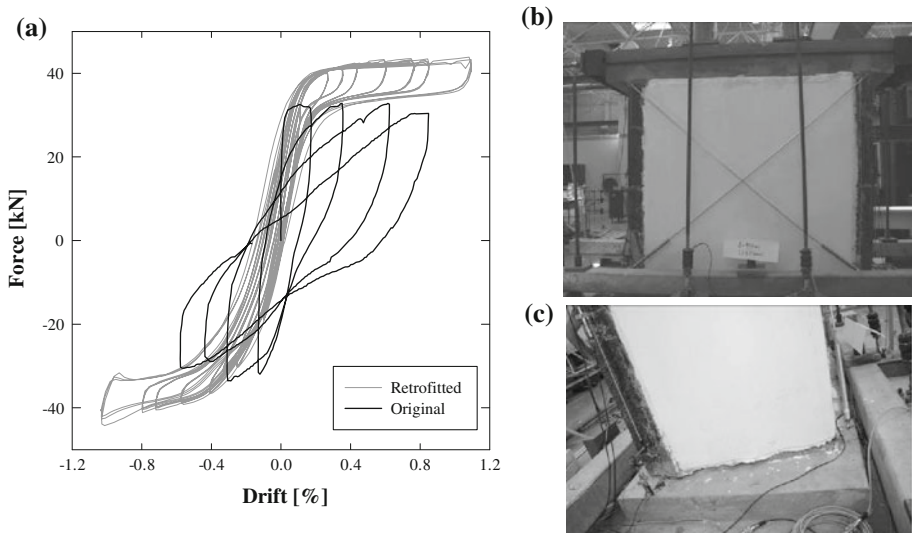
**Fig. 26** Retrofit efficiency: **a** original vs. retrofitted results, **b** global and **c** local views of final stage of retrofit test

been actually performed, the post-peak strength decrease was significant (to about 80–85%) for maximum drift level of 0.85%. Moreover the wall did not keep its integrity during the in-plane loading, which was in fact one of the main problems related to the strength decrease (about 20%) for a constant displacement level. Therefore, it is possible to conclude that the wall did not behave satisfactory during the test.

It can be observed that the modification of the wall behaviour has changed completely the energy dissipation capacity, the maximum drift reached (retrofitted: 1.15% vs. original: 0.85%) and the wall integrity, bearing in mind that larger displacements could be easily achieved with the retrofitted specimen as explained before. Thus, it can be concluded that this retrofit/strengthening technique, used in Faial and Pico islands after the 1998 Azores earthquake, is adequate and effective to ensure the integrity of the wall as evidenced in Fig. 26b and c where no damage is found in the wall, except in the connection to the foundation. In addition, since this technique was adopted in-situ for all the elements in a given building, rather than just on piers or spandrels, a good behaviour of the complete structure may be expected with more energy dissipation.
