# anexo 1

Pontos de referência da bacia  
hidrográfica da ribeira da Laje no  
concelho de Oeiras

### Cartas dos fatores biofísicos e antrópicos da bacia hidrográfica da ribeira da Laje no concelho de Oeiras

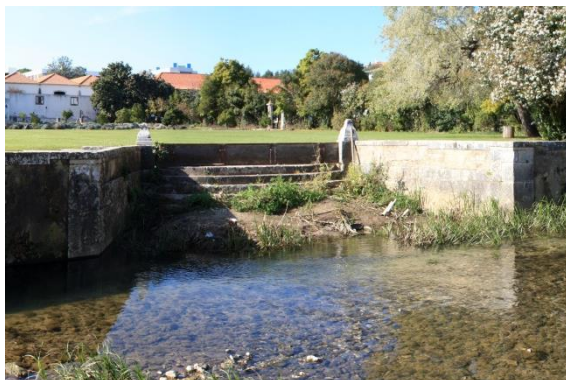
Figura 1 – Embarcadouro do canal da Quinta dos Marquesses de Pombal. Fonte: Arquivo pessoal, Fevereiro de 2013

A destruição provocada pelo terramoto de 1755 levou a que, também em Oeiras, tenham sido feitas obras de reconstrução pela equipa técnica de Lisboa, da qual saliento o arquiteto húngaro Carlos Mardel e o Engenheiro Manuel da Maia, tendo em conta uma perspetiva de desenho mais sóbrio e aproximado dos grandes projetos europeus da altura [42]. Especificamente, e apesar de nunca ter sido possível confirmar, o projeto do palácio e do complexo sistema hidráulico (aqueduto, canais e tanques) está atribuído a Carlos Mardel, como uma obra tardia do autor, para a qual traçou as linhas mestras das obras que se viriam a executar após a sua morte em 1763, ou seja, entre 1749 e 1770. Assim, em prol deste projeto, a ribeira da Laje foi transformada num canal navegável dentro dos limites da quinta dos Marquesses de Pombal, como se pode ainda constatar pelo embarcadouro existente junto ao palácio, como ilustra a figura 1 [43].

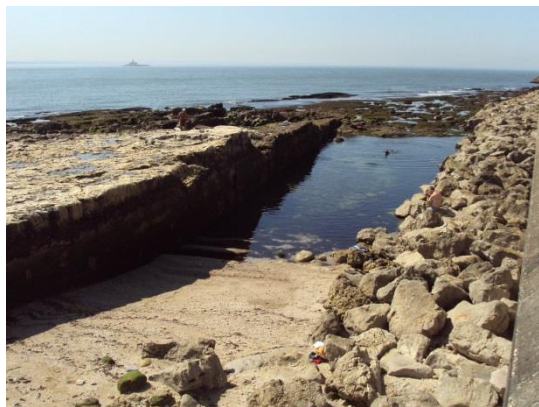
Figura 2 – Vestígios da obra de ligação do canal ao porto. Fonte: Arquivo pessoal, Junho de 2013

A autoria desta obra de grande envergadura coube ao Engenheiro Louis d'Alincourt, que a partir de 1763 começou por cortar a zona rochosa do porto e abrir parte do canal projetado, onde ainda hoje restam vestígios notáveis do seu esforço (fig. 2).

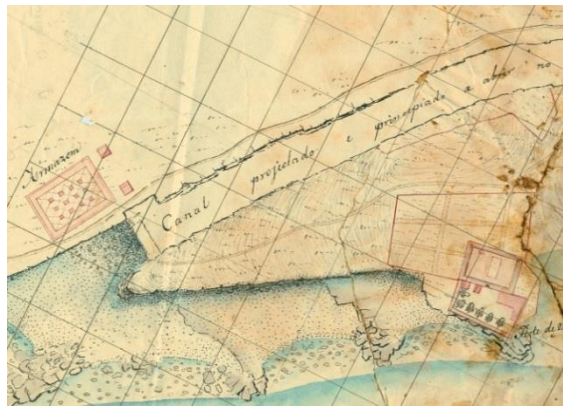
Figura 3 – Projeto do canal, pormenor do Mappa hydrotopographico da desembocadura do rio d'Oeiras, Henrique Niemeyer, inícios séc. XIX, Instituto Geográfico Português. Fonte: 1755: A Terra Tremeu, o Mar Transbordou [40]

É de notar que a confluência da ribeira da Laje com o rio Tejo seria claramente movida para Oeste cerca de 500m, facto justificado pelo engenheiro devido à grande quantidade de areia que as correntes marítimas acumulavam na praia de Santo Amaro, o que provocaria problemas de assoreamento do canal. No entanto, propôs construir uma comporta que permitisse limpar regularmente o leito do canal [42]. O desenho projetado encontra-se ilustrado na figura 3.

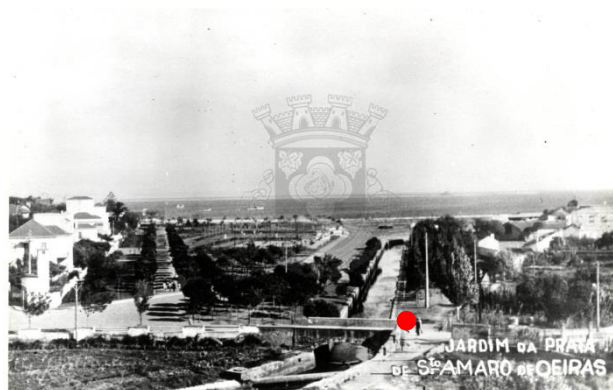
Figura 5 – Fotografia do Jardim da praia de Santo Amaro, da autoria de António Passaporte, 1940. Fonte: Arquivo Online CMO [45]
