Load-carrying capacity test of a long-span timber truss

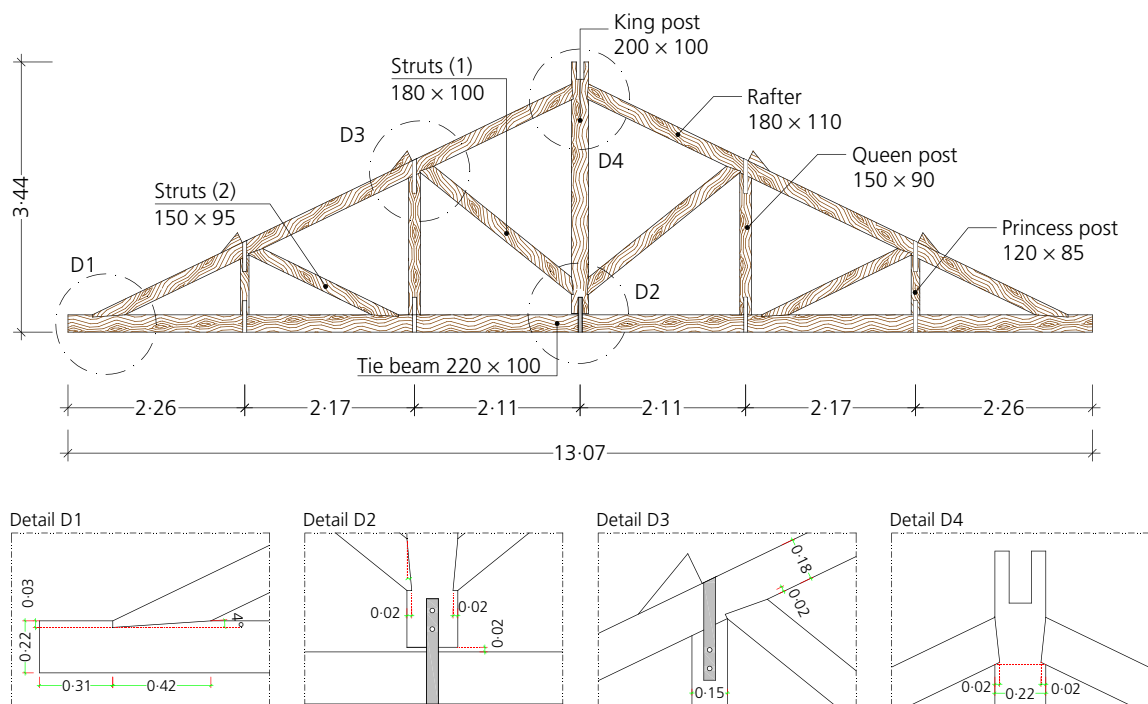
Figure 1. Timber truss studied (dimensions in metres and cross-sections in millimetres)

During the visual inspection, it was evident that one side of the truss presented a more pronounced degradation. This is mainly a consequence of the cutting process of the timber elements that compose the truss. In fact, all of the timber elements present an eccentricity of the pith in relation to the cross-section, resulting in different durability of the timber element faces. According to EN 350-2 (CEN, 1994) and FICHA M2 (1997), this wood species is moderately to slightly resistant to fungi but susceptible to beetles, termites and marine borers, with the heartwood being extremely difficult to treat, whereas the sapwood is easy to treat. However, for the service class corresponding to an industrial roof under cover and not exposed to the weather, practice shows that, in the

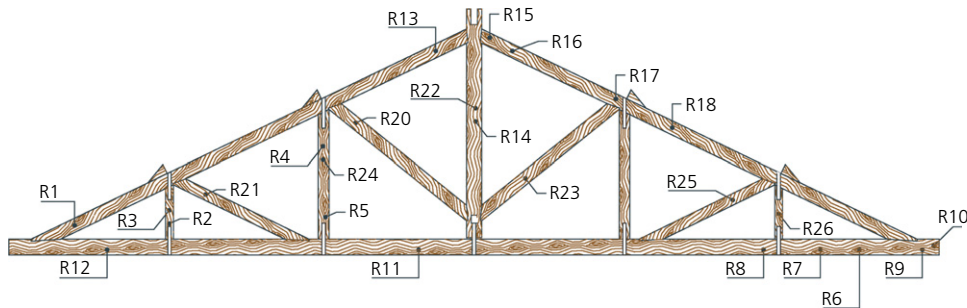
Figure 7. Identification and location of the Resistograph tests performed

In total, 26 Resistograph tests were performed on the truss under study, evaluating the depth of deterioration in representative points previously identified, based on the Pilodyn penetration depth results, and assessing the internal projection of anomalies visible from the exterior (Figure 7).

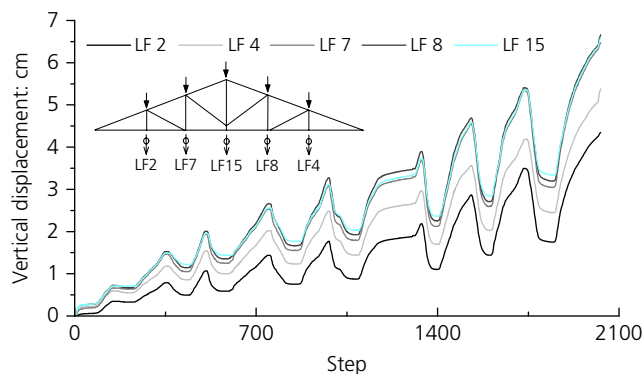
Figure 18. Evolution of vertical displacements of truss tie beam registered during load-carrying test

The load was applied with an approximately symmetric distribution, with small differences, as is acceptable in tests of this complexity and scale. Despite the symmetric load distribution, the truss tie beam presented a non-symmetric vertical deformation with a maximum value of 6.7 cm at LF8. Instrumented points LF7, LF15 and LF8 registered similar values for the displacement, whereas LF4 measured a vertical displacement which was 24% higher than the corresponding value in LF2. Figure 18 presents the vertical displacement of the truss tie beam measured during the load-carrying test.

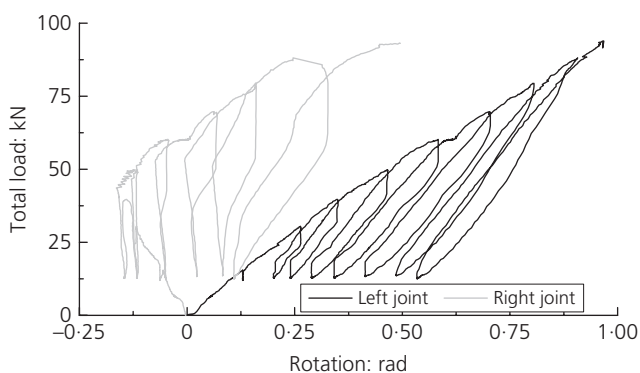
Figure 17. Relative rotation of the rafter–tie beam joints

significantly reduced the shear strength of that section. This faulty behaviour of the right joint of the tie beam–rafter explains the smaller relative rotation measured in this joint during the load-carrying test in comparison with the left joint (Figure 17).

slip (horizontal movement of the rafter) observed in the rafter-tie beam joints (see Figure 16) affects the overall deformation of the truss. With the slip in those joints, the entire superior part of the truss (above the tie beam) moved down (proved by the closing movement observed in the joints between the posts and the tie beam, see Figure 20), pushing the tie beam down and leading to an increase in the truss deformation. Moreover, this slip movement, which was more pronounced in the right rafter-tie beam joint, limited the capacity of those joints to rotate (see Figure 17).

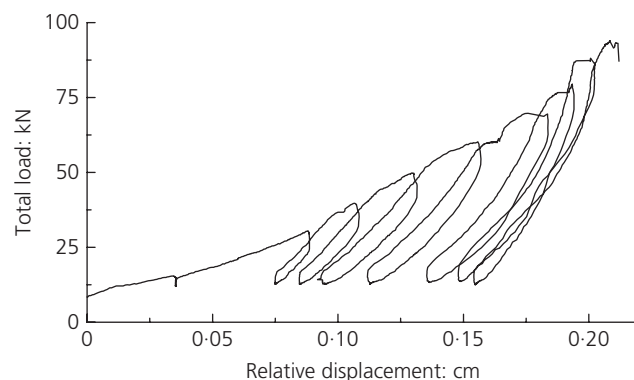
Figure 19. Relative displacement between tie beam and king post

but allowing the connection to close, or in other words, it did not curtail the movement of the king post towards the tie beam (Figure 19). This analysis also clearly demonstrated the non-linear response of the truss with unrecoverable permanent deformations, associated with the behaviour of the joints.

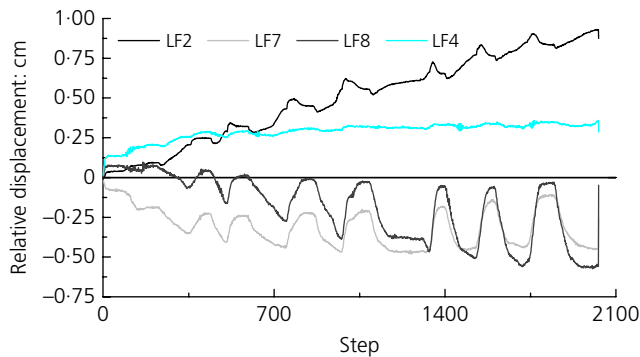
Figure 20. Response of joints between tie beam and posts

By subtracting the vertical displacements of the tie beam from the values measured by the instruments located at both rafters, it is possible to assess the behaviour of the joints between the other posts and the tie beam. Figure 20 depicts the response of the joints between the tie beam and the queen post and princess post, assuming that positive values correspond to a closing movement of the joint. Joints between the tie beam and the queen posts (LF7 and LF8) behave elastically in both directions, that is, they open and close as the load increases and decreases, respectively. The joint between the tie beam and the left princess post (LF2) presented a constant closing movement with very small opening movements during unloading. However, the right joint between the tie beam and the princess post (LF4) showed a non-linear response with unrecoverable deformation towards closing.

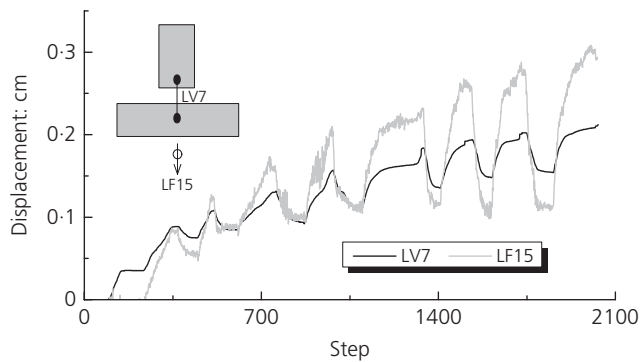
Figure 21. Response of joints between tie beam and king-post

The response of the joint between the king post and the tie beam can be assessed in two ways: subtracting the vertical displacement measured in LF15 from that in LF13 or analysing the measurements registered by LV7 (see Figure 13). Despite the differences in both measurements, the behaviour displayed is similar (Figure 21). This joint presents an elasto-plastic

response, with an unrecoverable closing movement as the load applied increases with an elastic branch (≈ 0.1 cm) which is recovered during unloading.
