# RISK MANAGEMENT POTENTIAL OF TECHNICAL DATA INVENTORIES ON BUILT CULTURAL HERITAGE: A CASE STUDY FOR THE CHURCHES OF THE PORTUGUESE ROUTE OF THE ROMANESQUE

**KEY WORDS:** risk management, data inventory, built heritage

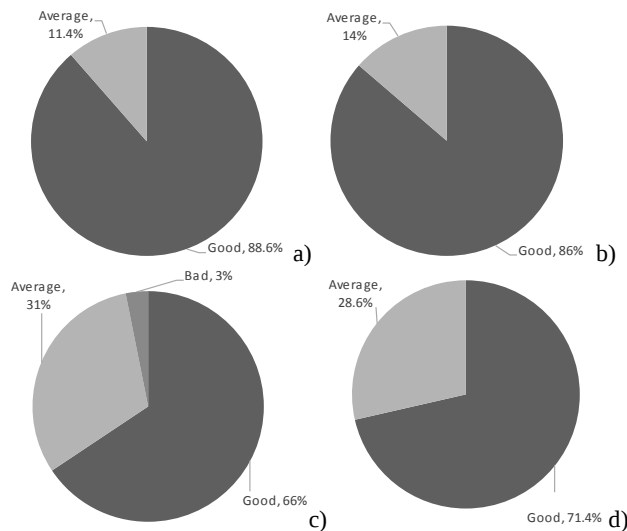
Figure 7 presents an overall view of the state of conservation of the 44 churches in general and of some of their components in particular, namely the exterior walls (Figure 7b), the ceilings and roofs (Figure 7c) and the interior pavement (Figure 7d). As can be seen, most of the churches are in good condition, due to a series of actions for restoration, conservation and risk mitigation that have been carried out in several monuments of the RR since 2003. Figure 8 shows a view the Church of São Mamede of Vila Verde before and after the restoration works. Restoration works were not carried out in some of the churches yet, but are expected to be in the near future.

Figure 7. Statistics representing the overall state of conservation of the churches a), of their exterior walls b), their ceilings and roofs c) and interior pavement d).

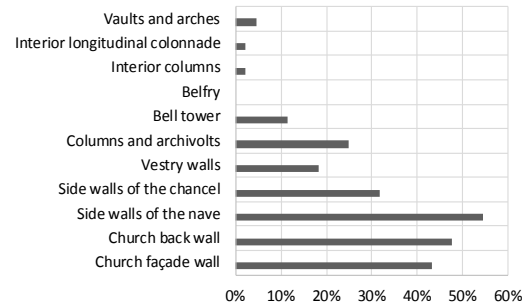
Figure 9 presents the analysis of a type of damage that is often found in these constructions: cracks or fractures. The analysis represents the percentage of cases in which this damage is found, across the several types of elements of the 44 churches. As can be seen, this type of damage is mostly found in the walls, particularly in the lateral walls of the nave. This type of damage is often an evidence of problems related to the roof, the foundations and drainage system, or to a lack of capacity of the walls to sustain out-of-plane thrusting from the roof system. However, conclusions can only be established by analysing the damage in the roof systems and the characteristics of the walls.

Figure 9. Damage statistics for cracks or fractures in the components of the 44 churches.

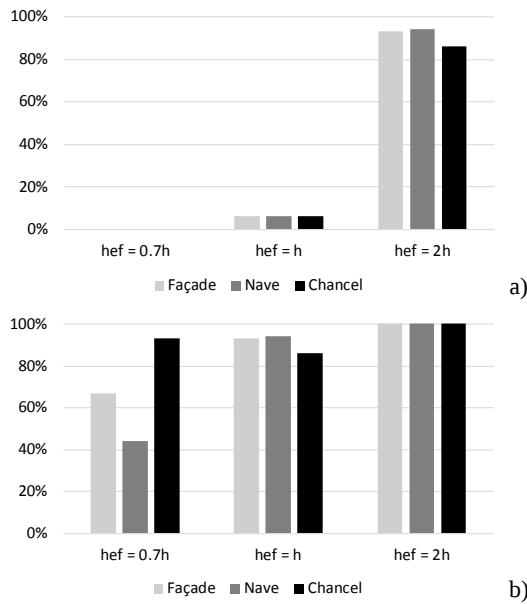
Focussing on the walls, for example, the survey of their thickness and number of leaves was carried out by analysing areas close to openings. In most cases, the thickness of the walls varies between 0.90m and 1.10m. It was also seen that 84% of the walls that were surveyed are double-leaf walls. It was however not possible to identify the type of cross section for the remaining 16%, in some cases due to the inability to access the inside of the church to analyse the zones near the openings. Future surveys will therefore need to complement the data inventory using ultrasonic wave and GPR tests. Based on this geometric survey, the walls were classified as *resistant* or *non-resistant* for out-of-plane loading. This classification was carried out by determining their slenderness ratio, one of the most relevant parameters when analysing the out-of-plane instability of these elements. These instability issues can be caused by intensive hazards such as earthquakes or wind, but also by slow-acting hazards related to the degradation of the roof system or to loads of large altarpieces leaning on these walls from the inside. The slenderness ratio of a wall is the ratio between its effective height  $h_{ef}$  (which depends on the end support conditions of the wall – free, pinned, fixed) and the effective thickness of the wall  $t_{ef}$  (which depends on the existence and the efficiency of the connection between the two wall leaves). Given the uncertainty of some of the in-situ conditions, the slenderness ratio analysis was performed for three hypotheses regarding  $h_{ef}$  and two scenarios for  $t_{ef}$  to simulate different conditions of lateral stability. Therefore, aside from the reference case where  $h_{ef}$  is considered to be the total height of wall  $h$ , cases reflecting the influence of the connection between the wall and the roof system were also considered. The cases where this connection is considered perfect ( $h_{ef} = 0.7h$ ) and where this connection is considered to be non-existent ( $h_{ef} = 2h$ ) were thus considered as limit situations. With respect to  $t_{ef}$ , the two considered scenarios are those that involve considering  $t_{ef}$  as the total thickness  $t$  of the wall and half of it (i.e. when there is no effective connection between the two wall leaves). The slenderness ratios that were determined were then compared with the limit value defined by Eurocode 8 (EC8, 2004) stating that for a wall to be considered *resistant*, its slenderness ratio cannot exceed 10. The results obtained for the façade, nave and chancel walls are summarized in Figure 10 that represents the percentage of *non-resistant* walls found for the 44 churches, considering the different hypotheses. The results show that, despite the apparent robustness of the walls of these churches, they may not exhibit adequate behaviour for out-of-plane loading. If the connection between the two leaves is not effective, most of the church walls will behave as *non-resistant* to out-of-plane loading. Therefore, more detailed surveys need to be carried out to obtain this information and mitigation measures need to be defined, if necessary, to ensure the robustness of the walls.

Figure 10. Statistics of *non-resistant* walls for out-of-plane loading found for the 44 churches: a)  $t_{ef} = t$ ; b)  $t_{ef} = 0.5t$ .

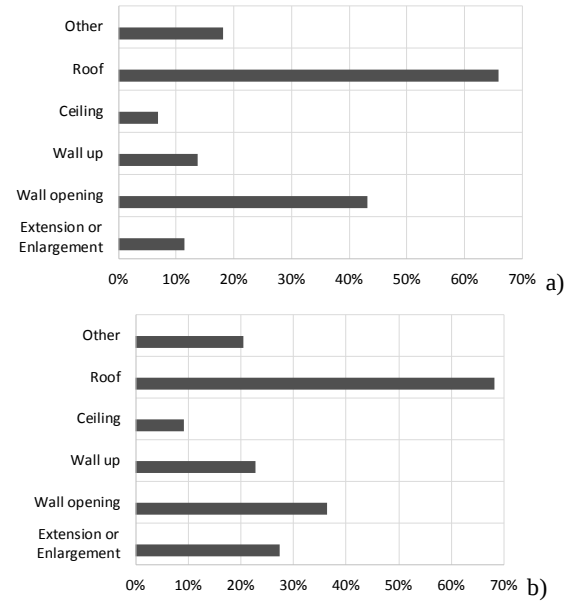
Another type of the information that is collected by the IDI Form refers to changes made to the load bearing structural components of the churches that were carried out over time. The more common modifications that were found are extensions or enlargements of a given room, the cutting of new openings, the wall up of openings, and changes to the structure of the ceilings and roofs. Figure 12 presents the results of the survey of the structural changes that were carried out in the past to the

chancel and nave of the 44 churches. As can be seen, a large proportion of the modifications involve changes in the roof structures and cutting new openings in walls. The availability of this information is particularly relevant when analysing the causes of certain existing damages to develop specific risk mitigation measures or when trying to estimate potential future damage and losses due to a hazard that depend on the global structural behaviour of the building.

Figure 12. Statistics of structural changes that were carried out in the past to the chancel (a) and nave (b) of the 44 churches.

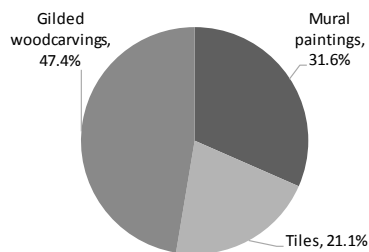
With respect to the existence of decorative cultural heritage assets attached to the buildings, the data collected by the IDI Form indicates that 84% of the churches have heritage assets attached to the walls and 34% of the churches have heritage assets attached to the ceilings. Most of these attached heritage assets are mural paintings, tiles, gilded woodcarvings or painted ceiling caissons. Figure 13 shows a few examples of these heritage assets and Figure 14 illustrates the proportion of these assets found attached to walls.

Figure 14. Statistics of cultural heritage assets attached to the walls of the churches.

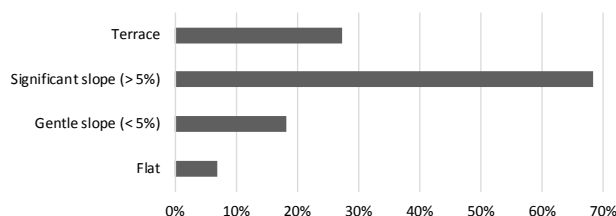
With respect to the surrounding environment of the churches, one type of information that is collected by the IDI form is the type of slope of the terrain in which the churches are built. This data is particularly relevant for risk management procedures related to hazards such as landslides, earthquakes or heavy rains. To illustrate the type situations that are found, Figure 15 represents the distribution of the churches along the four classes of slope of the terrain that were considered. As can be seen, only about 7% of the churches are located in a flat terrain. Therefore, most of the churches might be vulnerable to the previously referred hazards. In addition, it was also seen that, when in the presence of a terrace, about 25% of the cases do not have retaining walls or have retaining walls in bad conditions (Figure 16). As such, this data needs to be accounted for when performing risk analyses involving the referred hazards.

Figure 15. Slope of the terrain where the churches are built.

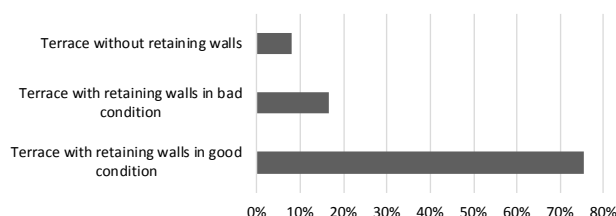
Figure 16. Existence and conditions of retaining walls when the terrain where the churches are built is a terrace.
