¹Esmeralda Paupério, ²António Arêde, ³Susana Moreira
CONSTRUCT-LESE, Faculty of Engineering,
University of Porto, Porto, Portugal
¹Civil Eng., MSc
email: pauperio@fe.up.pt
ORCID: 0000-0001-9370-2199
²Associate Professor
email: aarede@fe.up.pt
ORCID: 0000-0002-0901-2214
³Civil Eng., PhD
email: smtmoreira@fe.up.pt
ORCID: 0000-0002-9081-2031

CROSS-BORDER FORTRESSES IN PORTUGAL; INSPECTION AND DIAGNOSIS

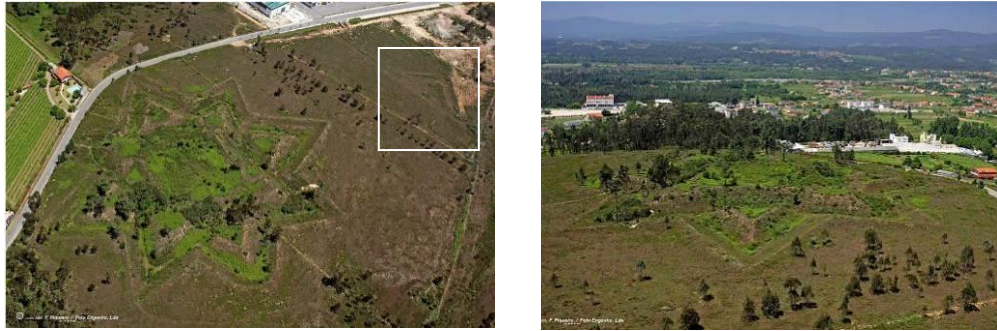
Fig. 15. Views of the Gandra Fort.

Thus, ingeniously, the well-worked and compacted soil materials were transformed into important defense and attack strongholds, with self-supporting slopes that, later, if the situation so required, could be lined with granite stonework. Of these forts, reference is made to the fort of Gandra, already identified in Figure 5 and shown again in Fig. 15, where, in addition to the well-defined star and with a point already cut by a road, it can still be seen what may have been a trench in an advanced line, this being the only trace that this fort would have dimensions much larger than what is presently seen. In an oblique photograph and taking the construction on the right side of the road as the scale, it can be assessed the dimension of the slopes of these structures.

Associating the war theories with the material that was at hand, an effective construction technique was achieved: the mixing and crushing of the “torrão”, eventually with some watering of the final layer, which translates into a material with good consistency and with a waterproofing protective layer that prevents its breakdown. Any intervention carried out in these forts will have to go through the preservation of the construction material and the filling of the existing holes with the original material, and not the uprooting of vegetation that favors the disaggregation of this material.
