# Preliminary seismic analysis and strengthening proposals of two churches in Azores

Aníbal Costa, António Arêde, Domingos Moreira & Nuno Neves  
*Faculty of Engineering at Porto University, Porto, Portugal*

**ABSTRACT:** This paper covers the seismic behaviour modelling and numerical analysis of two church structures on Pico Island, Azores, affected by the Faial earthquake on July 9, 1998. The observed damages are first described and some modelling options for the analysis are discussed, particularly in what concerns the way of including the roof as a means of bracing the bearing walls. Frequencies and vibration modes are analysed and discussed for the different types of modelling. Seismic calculations are performed considering the actually recorded accelerograms of that earthquake, and the obtained results are compared with the observed structural damages, in order to propose suitable strengthening techniques based on a better understanding of the structural aspects most directly responsible for the damages. In this context, analysis and discussion are included concerning the influence of modelling type on the peak principal stresses and their zones of occurrence. By comparing

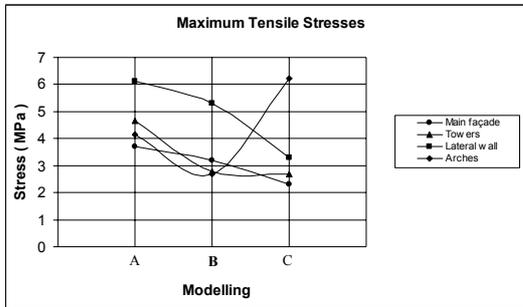
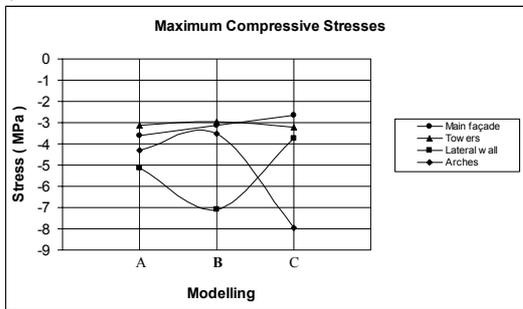
Figure 13. Comparison of stresses of the three models.

- Although stresses decrease (particularly tension) in the wall of the nave arches when the roof with rafters is added (which also mobilises the lateral longitudinal walls), the most obvious aspect is the large stress increase at the base of the central columns of the arches when the shell model is applied for the roof. As already indicated, this increased stresses occur because all the vibration

modes of significance in the earthquake critical range show predominant deformation of the arch walls.

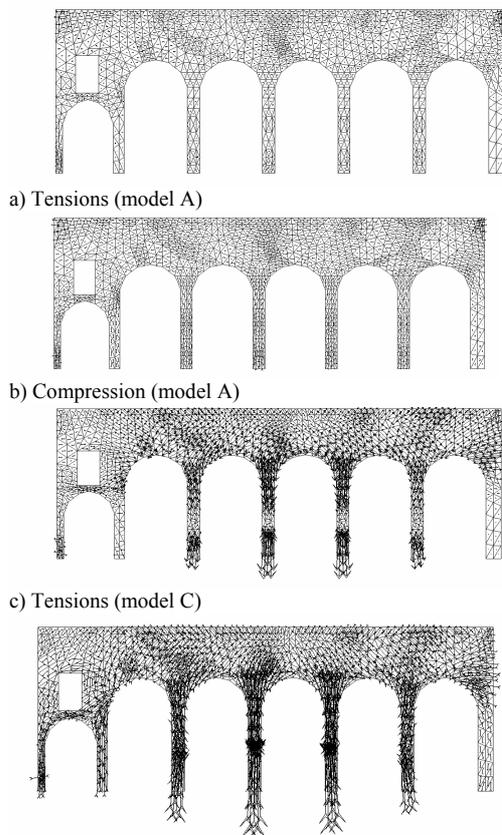
d) Compressions (model C)  
Figure 15. Principal tensile stress directions in the nave arch walls (models A and C).

For model A, some stress concentration was found in the top-ends connecting to the facades and in the bases of arch columns. Switching to model C, it can be noted a significant stress increase, particularly in the arch columns. From this increase, it can be inferred that the columns are subject to vertical bending associated to a fixed-end bending moment in the base that progressively decreases until reaching an opposite sense moment in the column mid-height; this is consistent with the fact that columns are supported on the base and on the roof's shell.

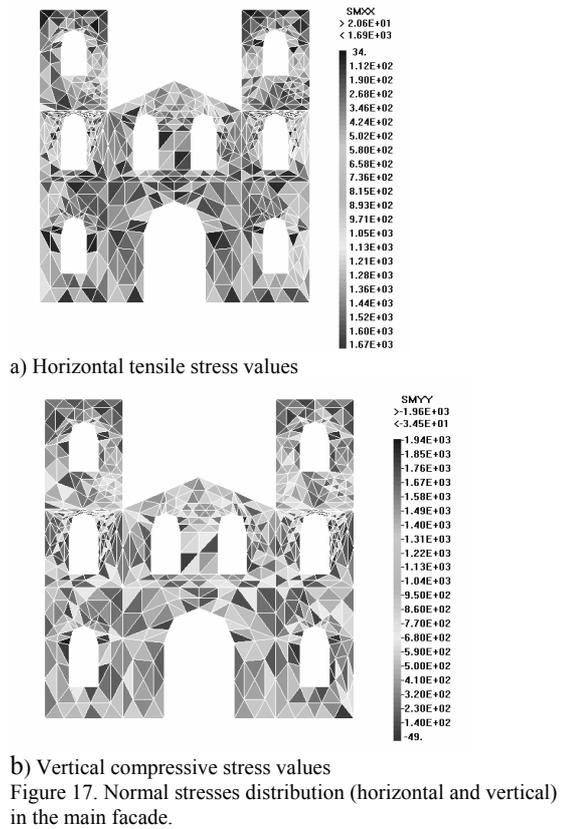
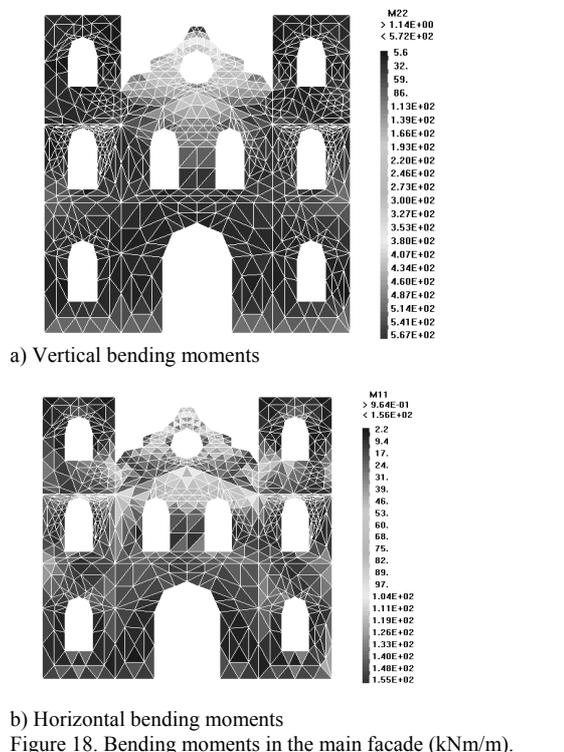
Figure 17. Normal stresses distribution (horizontal and vertical) in the main facade.

*Vertical and horizontal tensile stresses* are low in the *main facade*, except in specific points, namely in the frontispiece connection to the towers and in some arches, where values reached 1.69 MPa for horizontal tensions (Fig. 19a), and of 1.70 MPa for vertical tensions. Average values of *vertical compression stresses* (Fig. 19b) were about 1.6 MPa at the wall base, whereas the *horizontal compression stresses* were very low, except in the frontispiece-tower connections where values reached 2.0 MPa. The *vertical moments*, which would correspond to the vertical reinforcement in a reinforced wall, were found with very large values (Fig. 20a) in the zone where the frontispiece connects to the roof and also in the connection to the cross (indicating that the cross must be well connected). The *horizontal moments*, which would correspond to a horizontal reinforcement, reach their maximum values in the frontispiece-tower connection zone (Fig. 20b), whilst the other values are much lower and uniform.

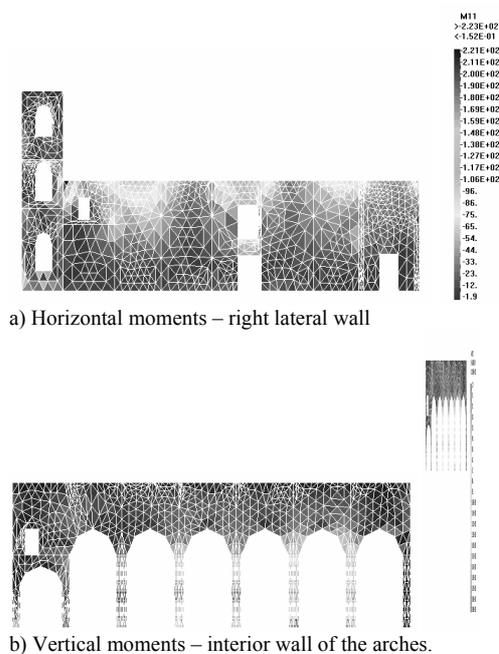
Figure 19. Bending moments in the right lateral wall and in the arch wall.

The *nave arches* have low *horizontal tensions* where the highest values (1.12 MPa) appear where they connect to the towers and in the arches connecting to the altar arch wall (0.60 MPa). *Vertical tensions* are also low, with the highest values in the 1<sup>st</sup> and 2<sup>nd</sup> arch next to the towers. *Horizontal compressions* are also reduced, the highest values being detected where the nave arches connect to the towers (1.05 MPa) and in the arches next to the altar arch wall (1.00 MPa). *Vertical compressions* reach a maximum value of 1.45 MPa in the first arches associated to the towers. The *horizontal moment distribution* indicates that the arches at the middle of the nave and their connection to the altar arch wall are the zones corresponding to the maximum moments (136 kN.m/m). Finally, the distribution of *vertical moments*, illustrated in Figure 21b, shows that the respective maximum values (175 kN.m/m) occur in the columns of the intermediate arches.
